## Facilities Assessments

## Facility Assessment – Fire Station #1

## Architectural Report

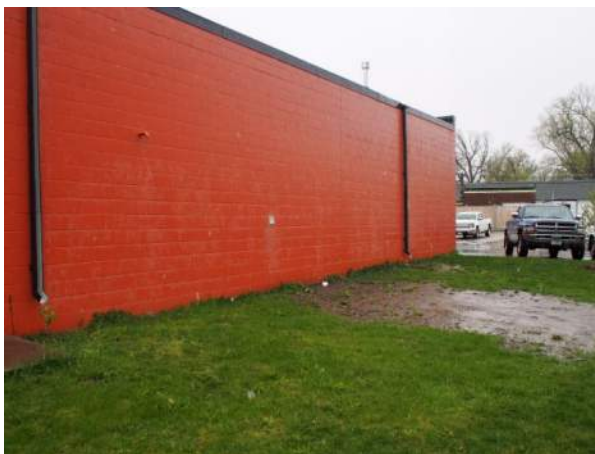
1. Topography
  - a. The site has only minor topography.
2. Storm Water Drainage
  - a. Storm water sheets flows from the site to storm sewer grates in the street.
  - b. The north downspout on the west side is missing a splashblock.
  - c. The splashblock below the downspout on the north side is not pitched away from the building, allowing water to drain back down the face of the foundation.
3. Access and Egress
  - a. The parking lot is accessed from the alley on the west side only. The east access point into the parking lot was eliminated because it was being used as a shortcut. Currently, only the east-facing apparatus bays can exit onto Laverne Street, but people unfamiliar with the building are entering from the response apron and driving

Figure FS1-B.2.b: Missing splashblock

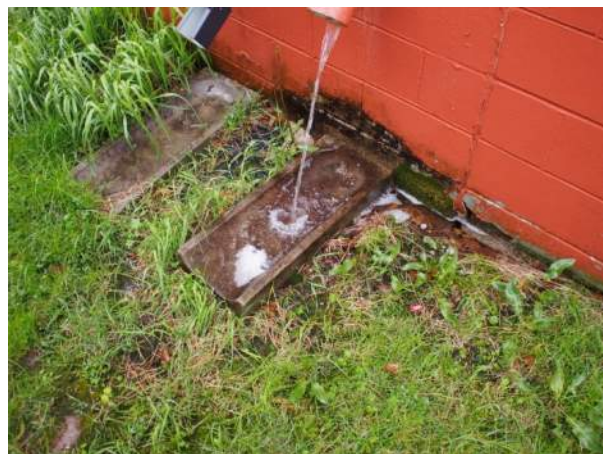
Figure FS1-B.2.c: Ineffective splashblock

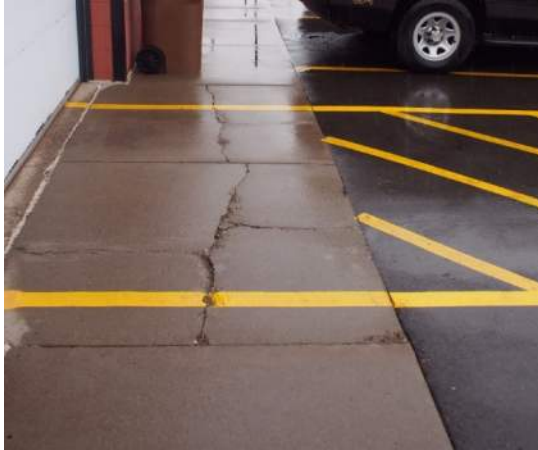
4. Paving and concrete
  - a. The asphalt parking area is in excellent condition.
  - b. The concrete apron outside the ladder truck bay is severely cracked. We recommend replacement within 6 months.

Figure FS1-B.4.b: Cracked concrete apron

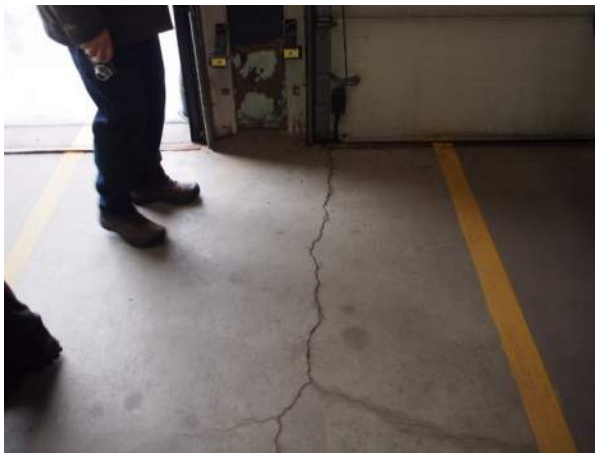
1. Foundation
  - a. The foundation system appears to be in satisfactory condition, as there is no evidence of building settlement.
2. Slab-on-grade
  - a. Where visible, the concrete floor slab has major cracking. It is still serviceable. The cracks make it impossible to completely clean the facility of fireground toxins or bacteria from medical calls. We recommend sealing the cracks with a high-quality traffic sealant.

Figure FS1-C.2.a: Cracking at floor slab

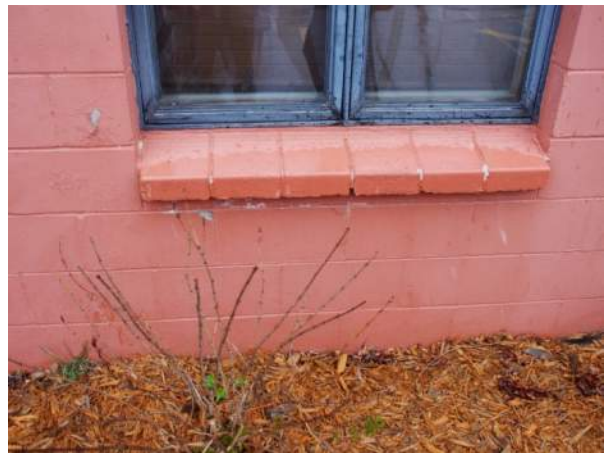
- b. The exposed concrete block on the north, west, and south sides is in good condition except for a few areas.
    - (1) The painted concrete block around the window on the south side is peeling. We recommend re-painting within six months to protect the block.

Figure FS1-C.4.b.1: Peeling paint by windows

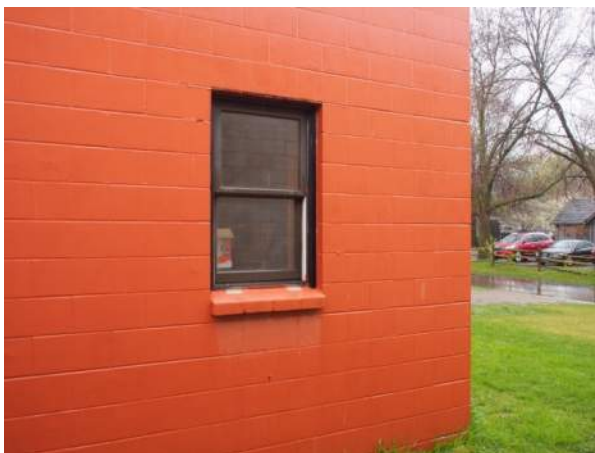
- (2) The painted concrete windows sills on the west elevation have lost paint in certain areas. We recommend re-painting within six months to protect the block.

Figure FS1-C.4.b.2: Missing paint at sill

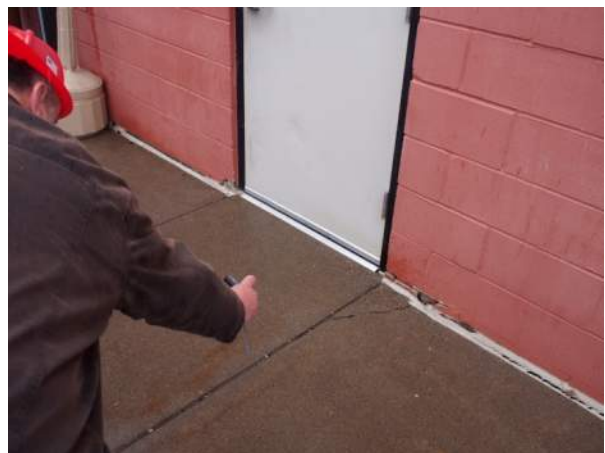
- (3) The concrete block at the base of the wall near the side entrance door is crumbling. This is likely due to free-thaw cycles of water trapped between the sidewalk and the wall. We recommend repairing the block with concrete and sealing the joint between the sidewalk and the wall within six months. If necessary, remove and replace the concrete sidewalk to pitch away from the building.

Figure FS1-C.4.b.3: Cracked block at base of wall

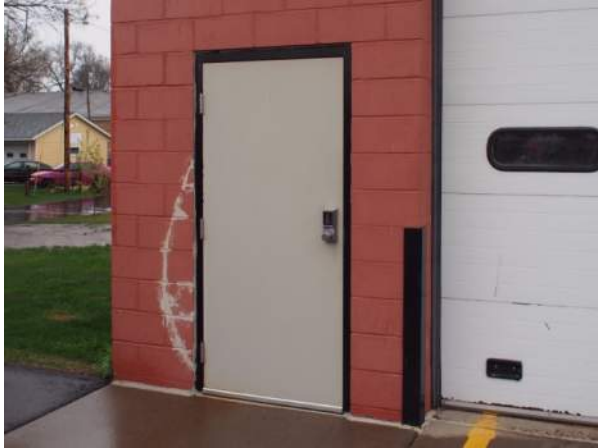
- (4) There is a major crack in the masonry at the man door into the truck bay that resulted from an impact. It appears to have been repaired properly, but should be painted to protect from moisture infiltration.

Figure FS1-C.4.b.4: Crack at man door into truck bay

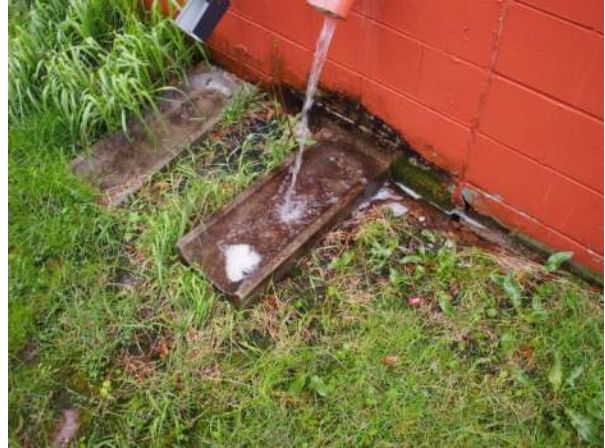
- (5) Where the rainwater leader and downspout discharges at the north side of the building, water has splashed back against the wall and damaged the concrete block. We recommend pitching the splashblock away from the building and patching/painting the damaged block.

Figure FS1-C.4.b.5: Damage to block from water splashing

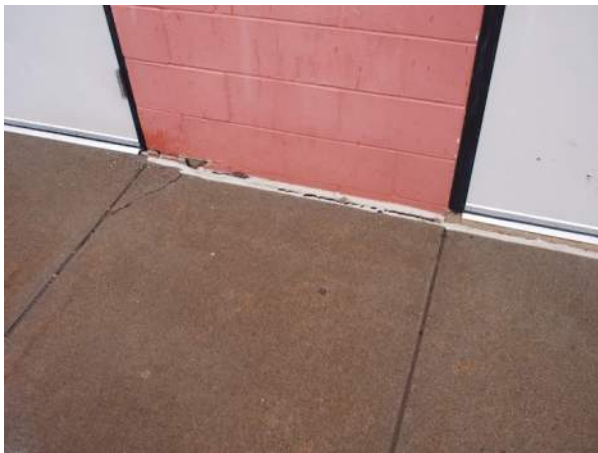
- d. The sealant joint between the exterior wall and the concrete sidewalk on the south side of the building is failing. We recommend replacement within two years.

Figure FS1-C.4.d: Failing sealant at base of wall

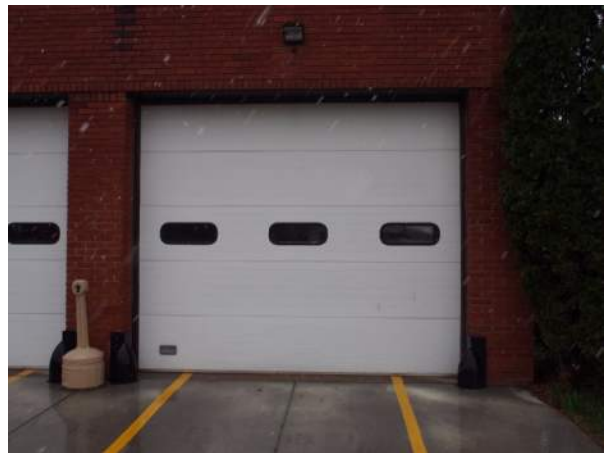
- 5. Windows and Doors
  - a. There are dents and scratches in the finish of the three front overhead doors. They are in otherwise good condition.
  - b. The glass windows in the overhead doors are in good condition.

Figure FS1-C.5.a: Damage to overhead door

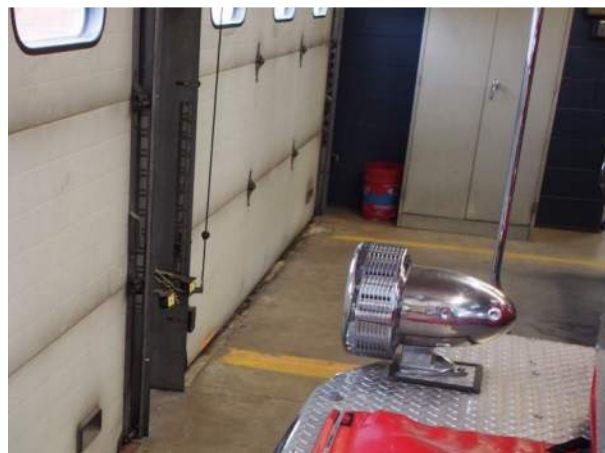
- e. The steel corner bollards at the front apparatus doors are in good condition.
  - f. The steel angle at the sill of the south overhead door in the main apparatus room rusted away and had to be removed. The concrete was damaged by the process and patched.

Figure FS1-C.5.f: Steel sill removed

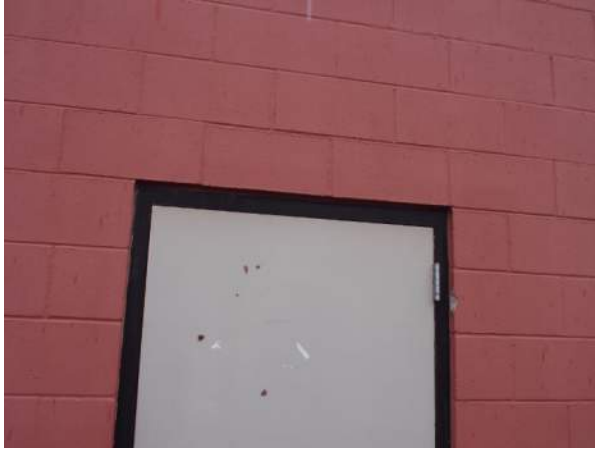
- g. The hollow metal man doors and frames are showing signs of rust where the paint has scratched off. We recommend scraping loose rust and re-painting.

Figure FS1-C.5.g: Scratched paint at man doors

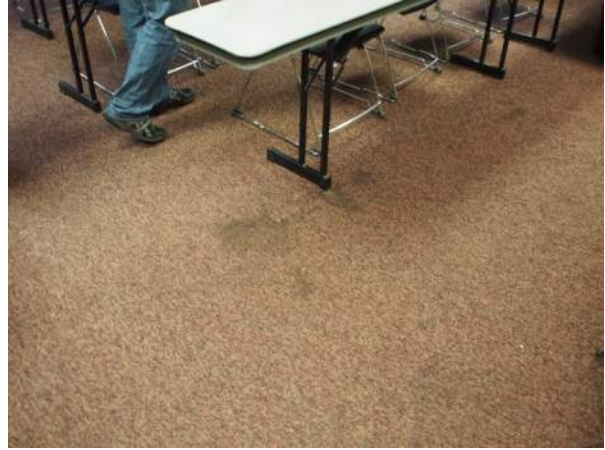
- 1. Flooring
  - a. The carpet in the training room and the chief's office is heavily worn and should be replaced within two years.
  - b. The ceramic tile floor in the open office area is in good condition.
  - c. The quarry tile in the restrooms is in good condition.
  - d. The mosaic tile in the radio room and kitchen is in good condition.

Figure FS1-D.1.a: Worn carpet

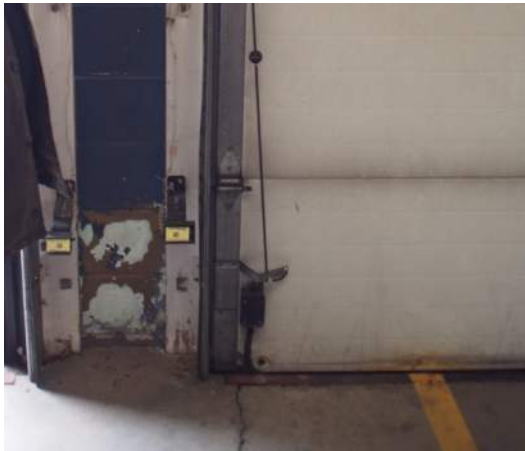
- a. The painted masonry is in excellent condition.
  - (1) The paint at the bottom of the walls between the bay doors has peeled off. We recommend re-painting to protect the block.
  - (2) The paint adjacent to the range has been burned and should be scraped off and re-painted.
  - (3) The masonry above the side entry door has cracked. This is likely the result of minor building movement and the lack of a control joint. We recommend sealing the crack.
- b. The painted wood-look paneling in the training room is in decent condition.
- c. The wood-look paneling in the Chief's Office is in decent condition.

Figure FS1-D.2.a.1: Paint damaged at base of wall

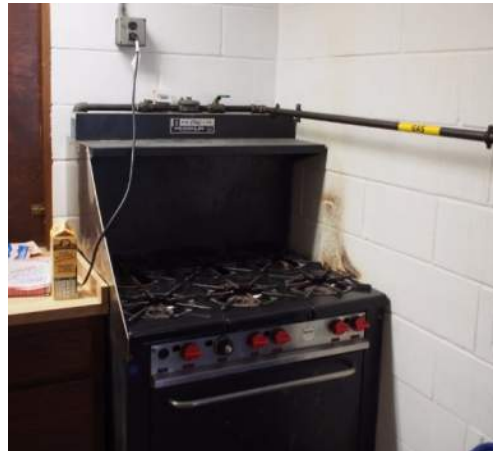
Figure FS1-D.2.a.2: Damaged paint at range

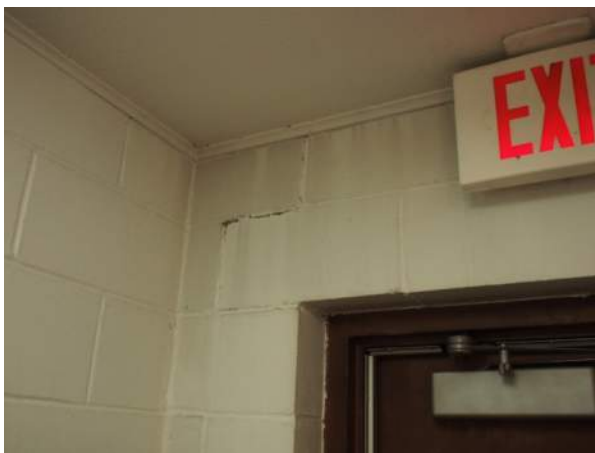
Figure FS1-D.2.a.3: Crack in masonry above side door

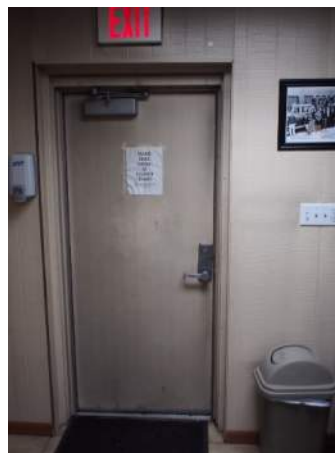
- a. The interior of the public entry door is peeling and should be re-painted.
- b. The windows between the offices and the truck bay are showing signs of wear. We recommend stripping and staining or removing the windows and infilling with concrete masonry.
- c. The window between the radio room and the main apparatus room is in good condition.
- d. The overhead door operators are reported to be in good condition.

Figure FS1-D.3.a: Peeling paint at doors

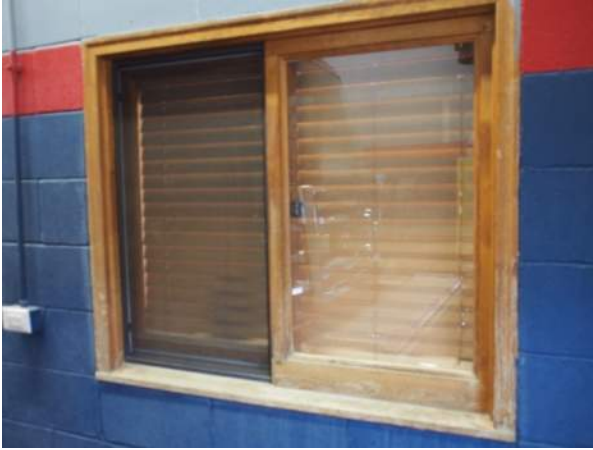
Figure FS1-D.3.b: Damage at interior windows

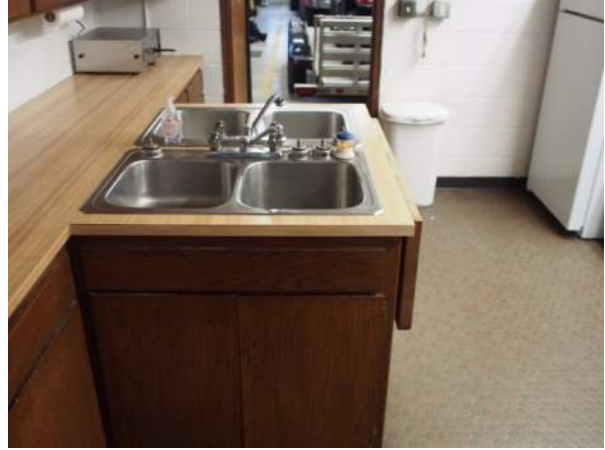
- a. The build in worksurface in the radio room is in decent condition.
- b. The countertops in the kitchen are in decent condition. The cabinets in the kitchen are nearing the end of their service life and should be replaced within five years.

Figure FS1-D.5.b: Cabinets at end of service life

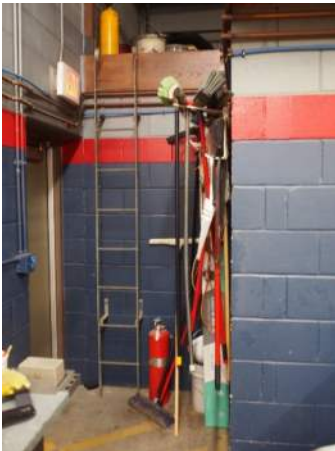
- 1. There is a retractable ladder and ceiling hatch for access to the mezzanine storage area. It is in good condition.
- 2. The ladder to a mezzanine area above the kitchen is wobbly.

Figure FS1-E.2: Ladder not secure

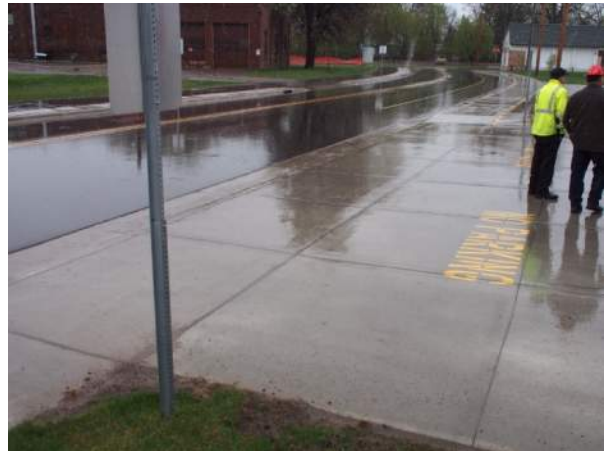
1. There are no truncated dome detectable warning strips where the sidewalk crosses the front apparatus apron.
2. The men's restroom is not accessible. The door is too narrow, the lavatory supply and waste valves are unprotected, the lavatory faucet requires twisting of the wrist, the flush control is on the wrong side of the toilet tank, the toilet seat height is too low, there is insufficient maneuvering clearance around the toilet, the mirror is mounted too high, and there are no grab bars.

Figure FS1-G.1: No truncated dome detectible warnings

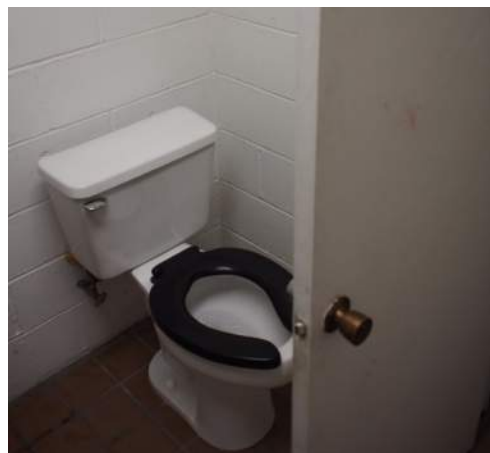
3. The women's restroom is not accessible. The door is too narrow, the lavatory supply and waste valves are unprotected, the lavatory faucet requires twisting of the wrist, the flush control is on the wrong side of the toilet tank, the toilet seat height is too low, there is insufficient maneuvering clearance around the toilet, the mirror is mounted too high, and there are no grab bars.

Figure FS1-G.3: Women's Restroom not accessible

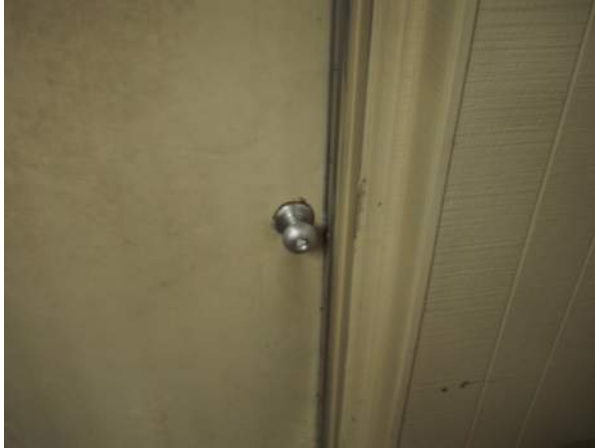
4. Doors throughout the facility have knob hardware instead of lever hardware.

Figure FS1-G.4: Door hardware not accessible

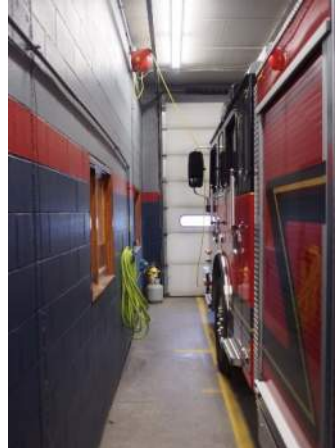
1. There is insufficient space to fit fire apparatus comfortably within the building. The apparatus is parked very close to the rear walls, very close to the side walls, and very close to other apparatus. These proximities increase the risk that a firefighter will be injured by moving apparatus, whether it is backing into the station or whether it is responding while firefighters are getting onto the adjacent rig. We typically recommend that our clients move all equipment stored along the side of the apparatus bays to another location. In this instance, there is no alternative location without building a significant addition.
2. The downspout from the training room roof discharges onto the sidewalk near the side entry door. This can create slippery conditions.
3. The overhead doors do not meet the provisions of UL325 because they do not have a photoeye within 6" of the floor.

Figure FS1-H.1: Insufficient space in apparatus bays

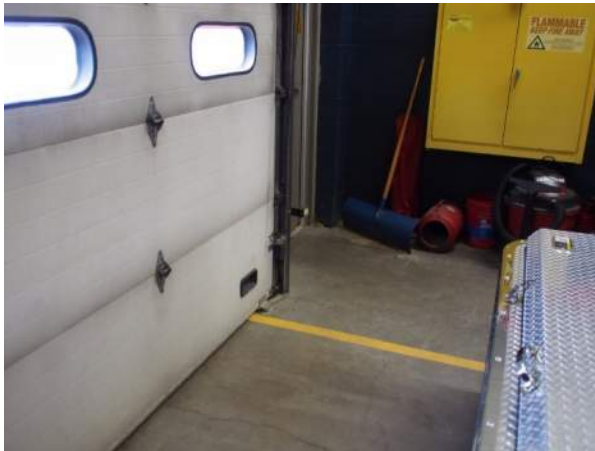
Figure FS1-H.3: Overhead doors do not meet UL325

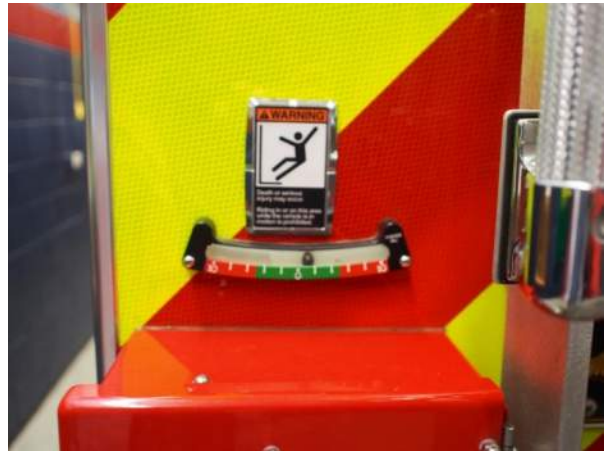
- d. The HVAC systems are located in the apparatus bays, creating significant cross contamination issues between clean and dirty spaces.
6. The floor drains in the ladder truck bay are centered in the room and not on the overhead door, so the truck rests at a 1 percent slope when parked. This causes long-term damage to the suspension and will cause the ladder truck to need replacement early.

Figure FS1-I.6: Ladder truck parked at angle

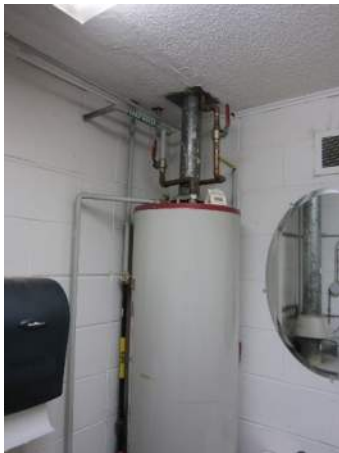
- a. A 40-gallon water heater, located in the Women's restroom, serves the entire building. No recirculation pump is installed. The water heater is over 25 years old and beyond its service life (Figure FS1-L.2.a).

- b. Life Expectancy: According to the latest ASHRAE Equipment Life Expectancy information, water heaters of this type have a 10-year service life.
    - (1) Install Date: 25+ years ago

Figure FS1-L.2.a: Water heater in Women's Restroom

- (1) Estimated Efficiency: 80% AFUE
    - (2) Regulatory Efficiency: 80% AFUE
  - d. Typically, water heaters are placed within normally unoccupied areas where they may be serviced. We recommend replacement within two years, with relocation occurring at that time. A new location may be on the mezzanine.

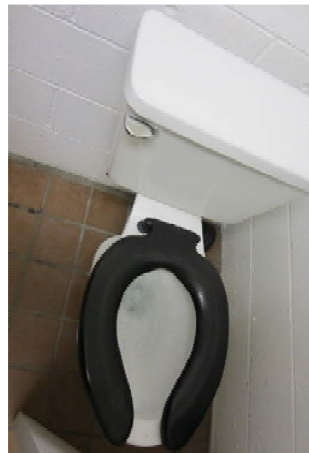
3. Plumbing Fixtures
- a. The plumbing fixtures were in fair condition except as noted below.
  - b. The water closet in the Women's restroom has a valve which sticks and does not allow for water to shut off when the tank is full. A new valve is required (Figure FS1-L.3.b).

Figure FS1-L.3.b: Women's toilet valve sticks

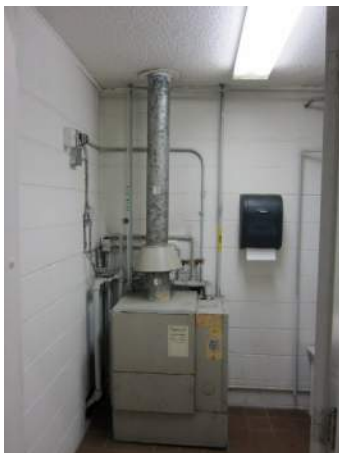
1. Boiler System
- a. A boiler system is installed within the Women's Restroom and serves the perimeter fin-tube radiation for the building. All supply and return connections appear to be operational with very few leaks. The vintage of the boiler appears to be mid-to-late 1940s. When compared to the values listed in the ASHRAE Life Expectancy Service Values, the unit has far exceeded its useful life. The hydronic piping system is also original to the building (1957) is also beyond its expected service life (Figure FS1-M.1.a).

- b. Life Expectancy: According to the latest ASHRAE Equipment Life Expectancy information, boilers of this type have a 25-year service life.
    - (1) Install Date: 1957

Figure FS1-M.1.a: Boiler in Men's Restroom

- (1) Estimated Efficiency: 77% AFUE
    - (2) Regulatory Efficiency: 80% AFUE
  - d. Typically, boilers and heat producing equipment is placed within normally unoccupied areas where they may be serviced. We recommend replacement within two years with relocation occurring at that time. A new location may be on the mezzanine.

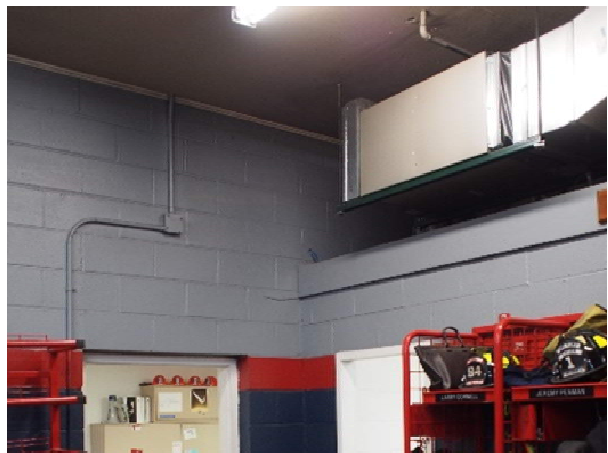
2. Furnace
- a. A natural gas fired furnace is installed in the mezzanine storage area of the apparatus bays. It is a horizontal style unit which is currently operational. The unit serves the rear

- of the apparatus bays, office areas and kitchenette. A test and balance report was not available during our observation. There were diffusers which did not receive supply air at their location. The unit appears to be around 10 years old based upon the style and the observed condition (Figure FS1-M.2.a).

Figure FS1-M.2.a: Furnace suspended from roof structure

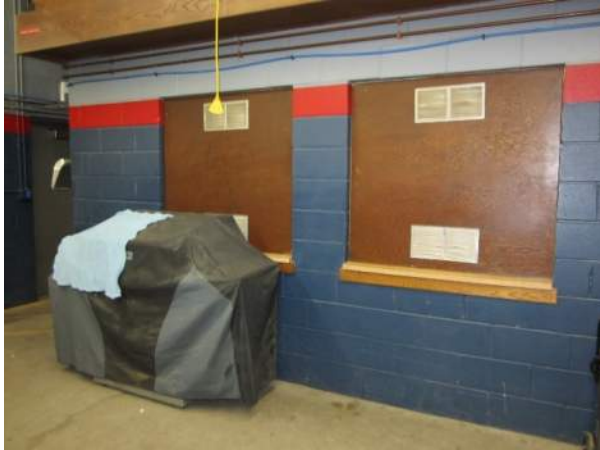
Figure FS1-M.3.a: Vents between kitchen and apparatus bay

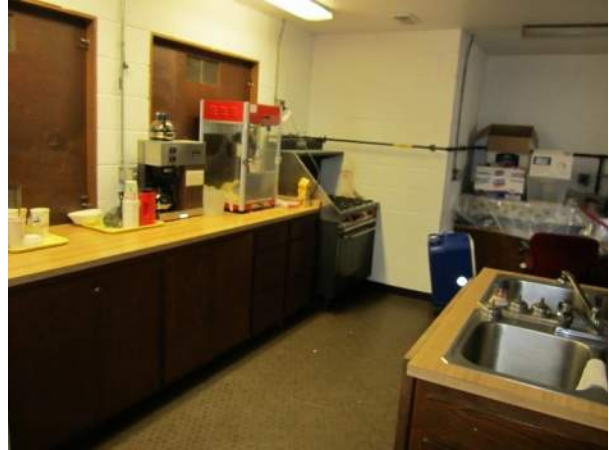
- b. Typically, kitchen areas are somewhat isolated from vehicle service areas and other areas where objectional odors are able to traverse into the space. Also, there were no ventilation hoods or other make-up air sources for the stove, griddle, or warmers. This equipment has the potential to produce a large amount of grease vapors and can be hazardous to the space and its occupants (Figure FS1-M.3.b).

Figure FS1-M.3.b: No kitchen ventilation hoods

- c. We recommend investigating a new location for the kitchen to eliminate the issue of air contamination. A make-up air and exhaust hood ventilation system shall be considered in order to provide a code-compliant environment for the kitchen/ break room areas.

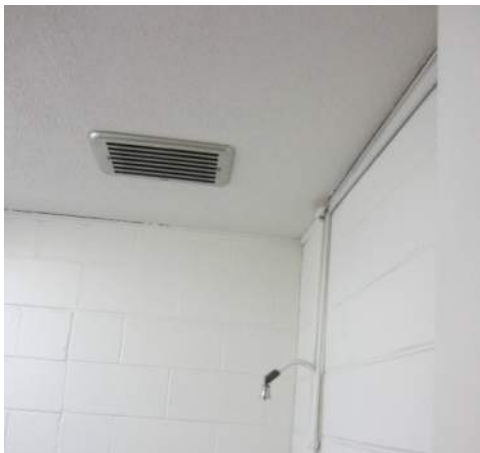
Figure FS1-M.4.a: Exhaust in Men's Restroom

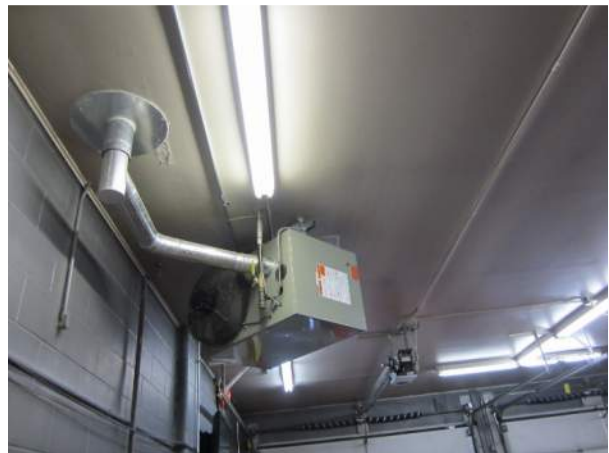
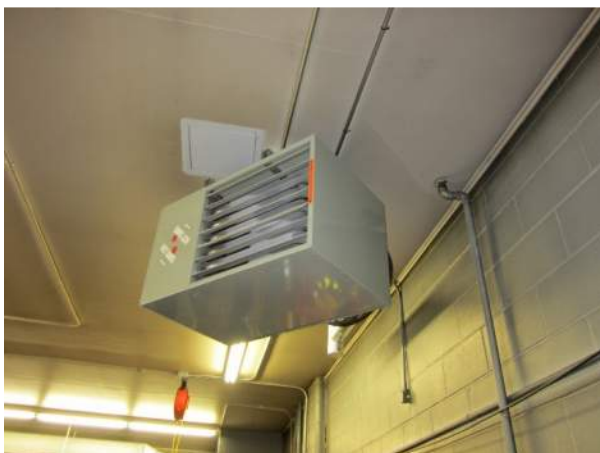
- a. The apparatus bays are heated via a natural gas unit heater (as noted). However, there was no ventilation system present. Typically, apparatus bays require an area-based ventilation system which also includes a gas detection system which engages an exhaust system to draw in fresh air upon detection of Carbon Monoxide (CO) or Nitrogen Dioxide (NO<sub>2</sub>). This a current code requirement and important for the long-term health and safety of the firefighters. We recommend providing a make-up air system which interlocks with an exhaust system and gas detection system to remove contaminated air as required.

Figure FS1-M.5.a.1: Unit heater in apparatus bays

Figure FS1-M.5.a.2: Unit heater in apparatus bays

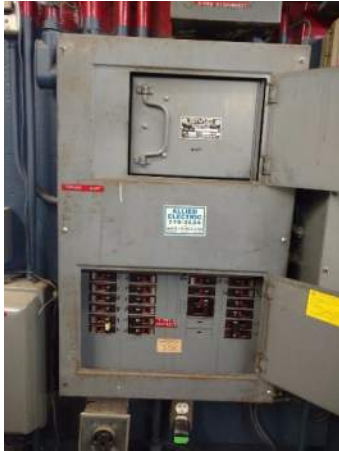
Figure FS1-O.1: Main service panel

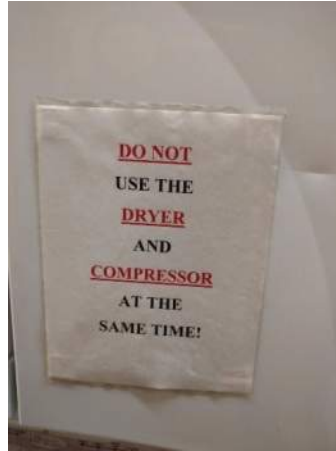
- b. The owner mentioned that the compressor and dryer could not be run at the same time without the circuit breaker tripping (Figure FS1-O.2.b). It is recommended dedicated circuits with appropriately sized breakers be run to the compressor and the dryer in the near term (0-5 years).

Figure FS1-O.2.b: Circuits have insufficient capacity

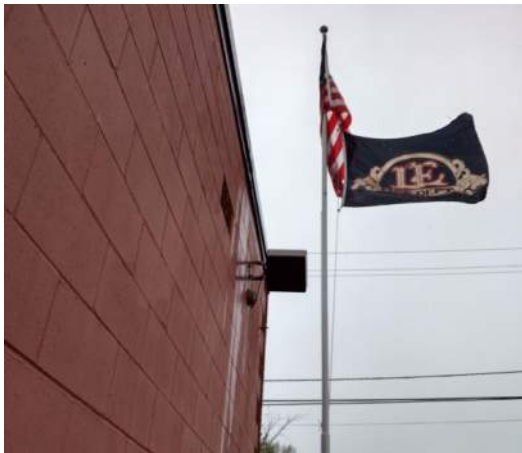
1. Exterior
  - a. Lighting for the exterior is composed of High Intensity Discharge (HID) wall pack fixtures and an HID flood light for flag pole lighting (Figure FS1-Q.1.a).
  - b. There was no apparent damage to any of the fixtures, and the lighting control was working as expected.
  - c. Efficiency could be improved by replacing HID fixtures with LED.
2. Interior
  - a. General lighting for the interior spaces is composed of recessed fluorescent troffers and incandescent adjustable down lights in the meeting room and surface mounted fluorescent strip fixtures in the bay. All interior lighting control consists of line voltage toggle switches.
  - b. Efficiency of the interior lighting system could be improved by retrofitting all fluorescent and incandescent fixtures with LED lamps and adding occupancy sensors to appropriate spaces.

Figure FS1-Q.1.a: Exterior lighting
