RESOLUTION NO. 2017- 066

*A RESOLUTION REGARDING THE ABATEMENT OF CONDITIONS CREATING A
HAZARDOUS BUILDING, HAZARDOUS PROPERTY, AND NUISANCE EXISTING AT 9224
AND 9240 31st STREET NORTH, LAKE ELMO, MINNESOTA 55042*

Re: Property Maintenance –IMMEDIATE ACTION REQUIRED

EXHIBIT C

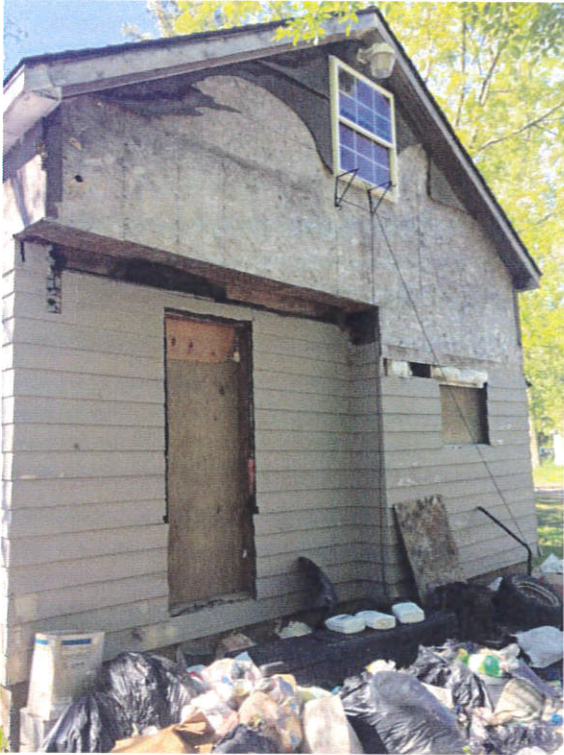
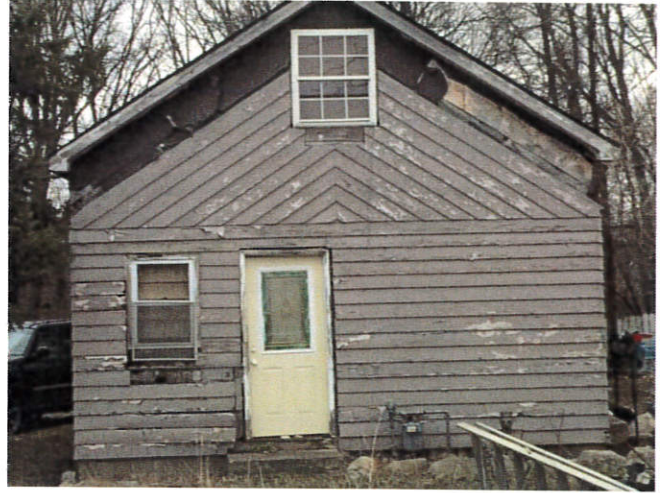
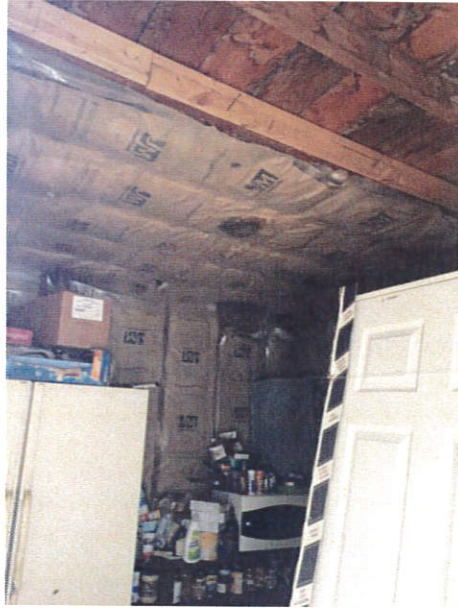
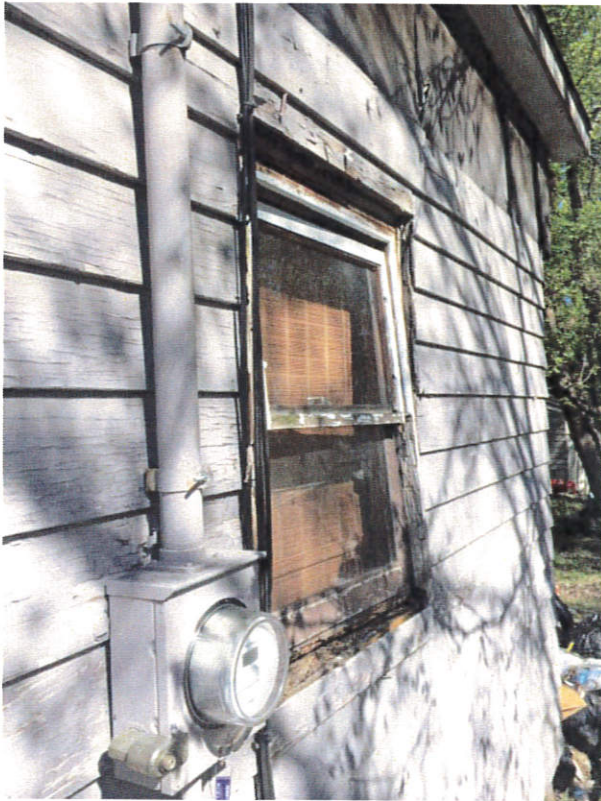
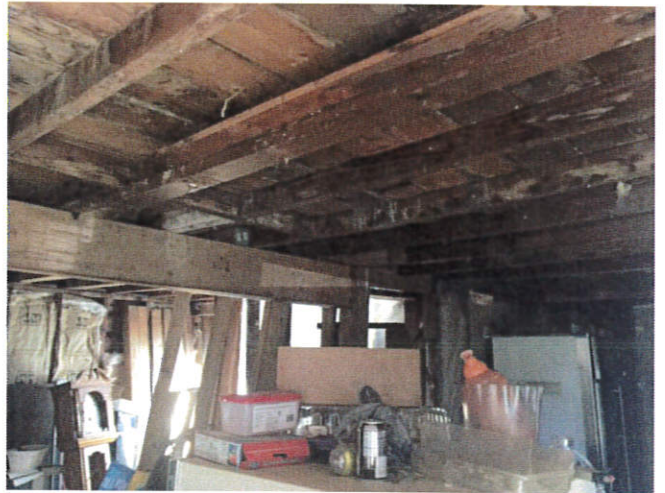
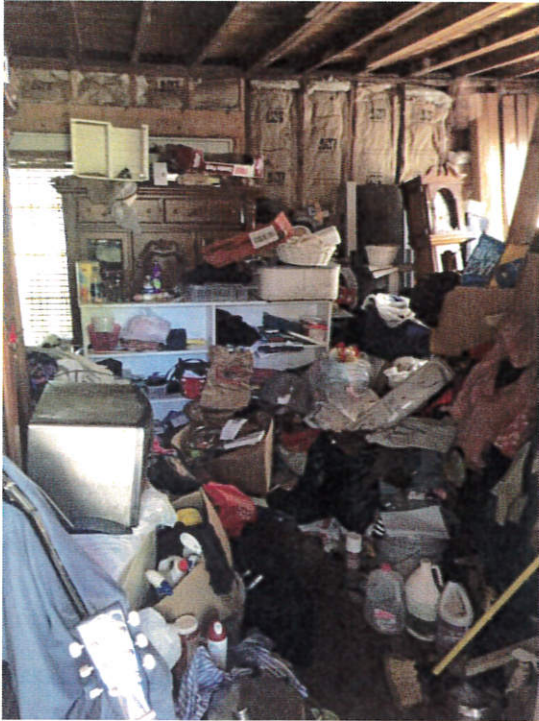
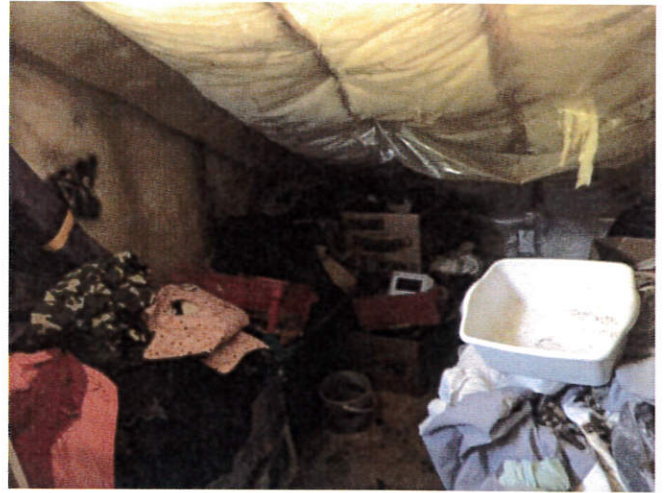
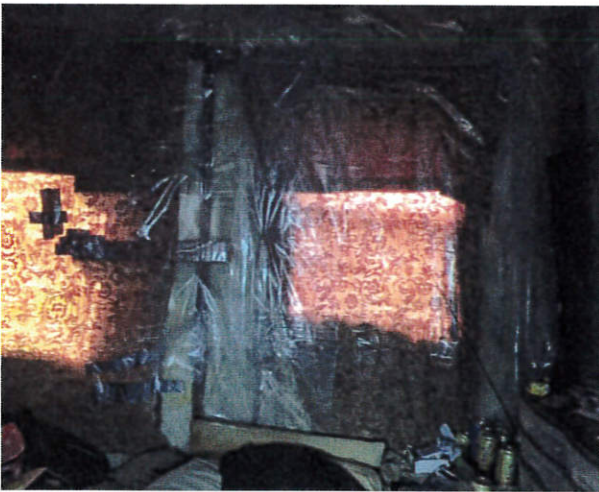
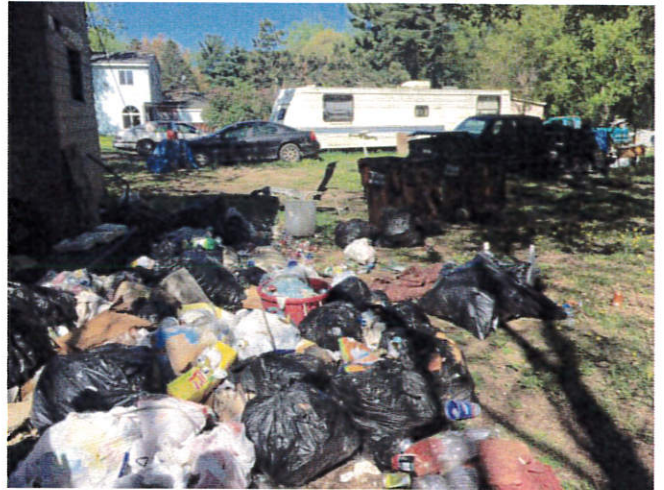
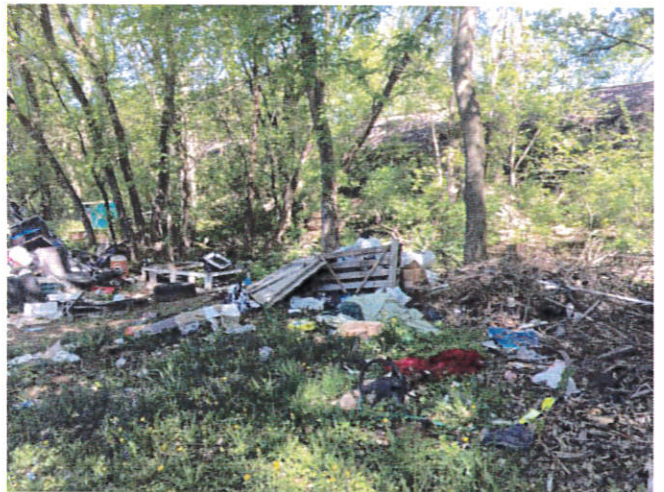
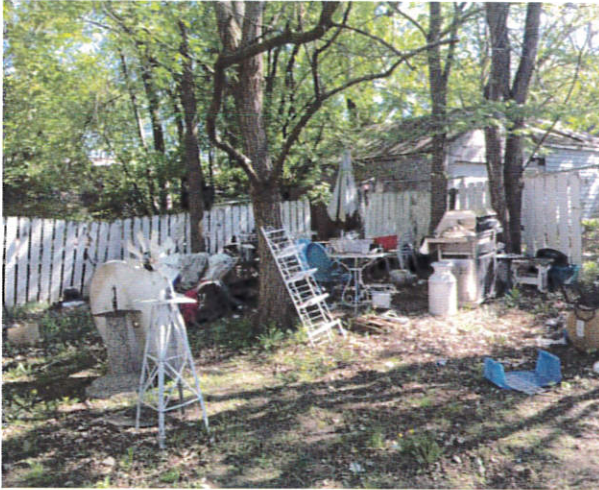
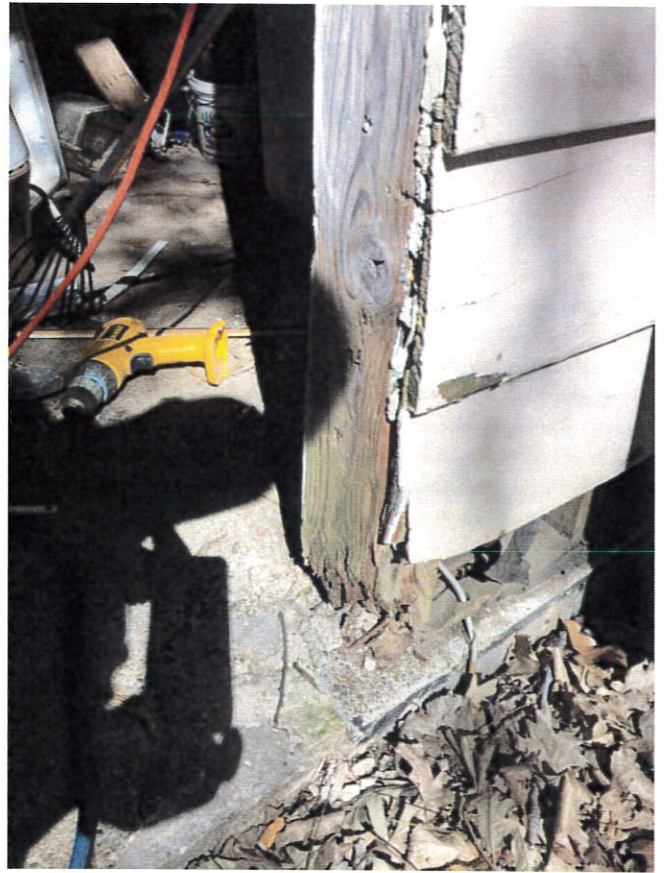
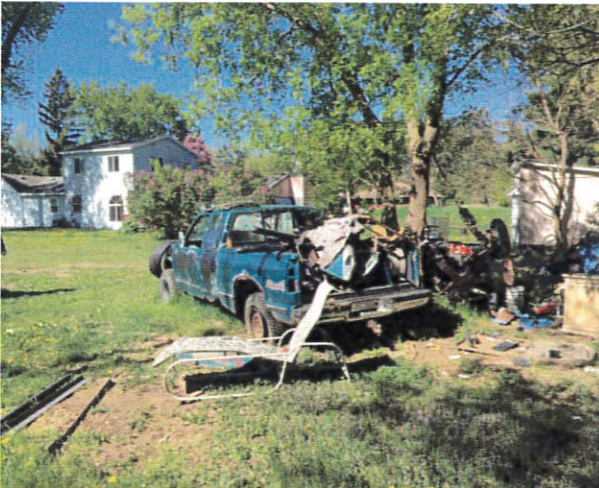
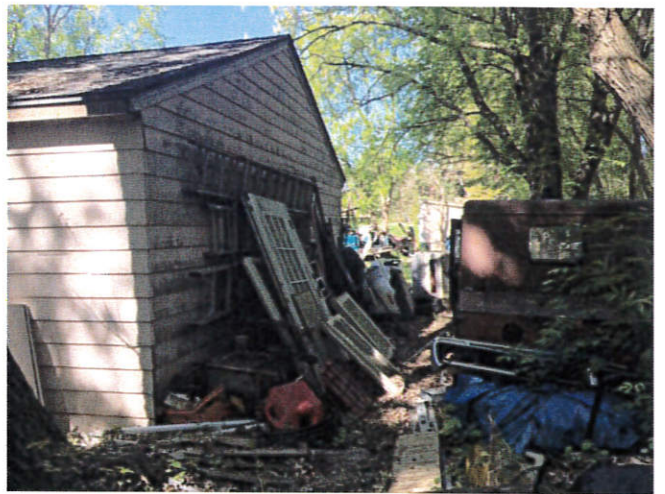
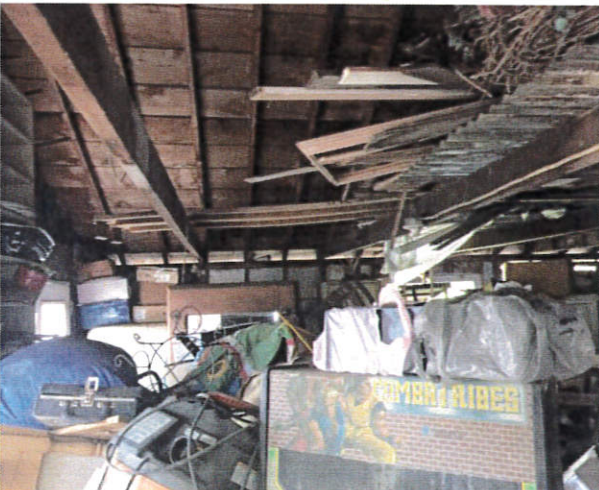
WHEREAS, the Lake Elmo Building Official took photographs of the Subject Property during the May 11, 2017 inspection, as shown in Exhibit C; and

1. East entry door is rotted and not secured in opening to home, exterior trim and flashing is missing, sill is rotted and the opening is not weather tight. (Exhibit 1, Exhibit 7)

2. Foundation is caving in east side of home below grade. Block foundation grout is missing at the concrete block foundation, block is cracked and is caving in along the east wall. (Exhibit 2, Exhibit 3, Exhibit 4 & Exhibit 5)

3. The sill and floor joist area of the main floor east wall is exposed to the weather, no siding or protective weather barrier nor is flashing present in any area along the east wall. The main floor system rim and joists are rotted and structural integrity is compromised on the east exterior wall. (See Exhibit 3 & Exhibit 5)

4. The double hung window to the north of the electric meter on the east wall is rotted and falling into the house. There is no flashing present, the wood is rotted and not weather tight. (See Exhibit 6, Exhibit 8 & Exhibit 9)

5. The siding and trim boards on the east wall of the house is rotted and does not extend to the top of the wall. (See Exhibit 10 & Exhibit 11)

1. Foundation grout is missing at the concrete block foundation, block is cracked and is separating along the length of the north wall. (See Exhibit 12)

2. Structural framing of the wood frame floor system and walls above foundation is not flashed or weather tight. (See Exhibit 12)
3. Door opening on the north wall is missing the door, plywood pieces nailed over opening from the interior. Opening is not weather tight. Structural framing at the floor framing is rotted at the door opening. (See Exhibit 12)

4. Window opening on the north wall is missing the window, plywood has been nailed over the opening from the interior. Opening is not weather tight. (See Exhibit 12)

5. Exterior sheathing is missing along the north wall near the window opening. (See Exhibit 12)
6. Siding and trim missing from the north wall, sheathing is exposed to the weather and approx. top half of the exterior wall is not flashed or protected from the weather or weather tight. (See Exhibit 12)

7. Window at the top of the wall is not flashed or weather tight. (See Exhibit 12)

1. West patio door is not weather tight in opening, exterior siding, trim and flashing is missing, the opening is not weather tight. (See Exhibit 13 & Exhibit 14)
2. Foundation grout is missing at the concrete block foundation, block is cracked and is separating along the length of the north wall. Multiple location block is

broken and missing at the foundation. (See Exhibit 15, Exhibit 16, Exhibit 17 & Exhibit 18)

3. The siding and trim boards on the west wall of the house is rotted and does not extend to the top of the wall. (See Exhibit 13)

1. Foundation grout is missing at the concrete block foundation, block is cracked and is separating along the length of the south wall. Multiple location block is broken and missing at the foundation. (See Exhibit 18)
2. The siding and trim boards on the west wall of the house is rotted and does not extend to the top of the wall. (See Exhibit 11)
3. South entry door is rotted and not secured in opening to home, exterior trim and flashing is missing, sill is rotted and the opening is not weather tight. (See Exhibit 19)
4. Window opening on the south wall is rotted and not secure in opening. Opening is not weather tight.(See Exhibit 20)

1. Debris and garbage is stacked throughout the main floor at all floor/walking areas. There is no discernable walking area or paths on the main floor. The arear where the floor was found and visible, there is no finish flooring and multiple areas had sub flooring missing and plywood sitting over floor opening. (See Exhibit 23, 24, 25, 26, 27, 28, 29, 34, 38, 45,48, 49)

7. The main floor beam that runs north and south in the center of the home and supports the second floor framing is bowing in the center from excessive load. Beam is showing signs of structural failure and requires verification of sizing, additional support needed and verification of support through to the footings in the basement. (See Exhibits 22, 23, 36)

8. The floor joists to the second floor are bowing uniformly from the front to back due to excessive load. Multiple joist have split and broken and have had sister 2 x 4 framing added incorrectly along the side but have not been added full length and add little additional support. The second floor system is unsafe and should be evaluated by a structural engineer for the required additional structural support needed. The same floor joists are rotted on the ends in multiple areas along the east wall at the plate due to the lack of a weather tight exterior. (See Exhibits 21, 22, 23, 32, 33, 46, 47, 50)

9. Stair to the second floor area is loose and not secure. No handrails or guards are present and top stair treads are broken off. (See Exhibits 34, 36, 40, 41)

11. Guard is missing along the stair opening. (See Exhibits 40, 41)
 12. High voltage electrical wiring is present and exposed throughout the second floor. There are open and exposed wires and electrical boxes throughout. (See Exhibits 37, 42, 43)

1. The bottom chord of the roof trusses are bowing and near breaking in several locations, likely due to the large amount of storage placed in the roof system. Trusses are spaced 4' on center and are not designed for storage. Sills and framing near the bottom plates are rotted and structurally unsound.
2. High Voltage Electrical wiring and open electrical boxes throughout the building.
3. Siding is rotted and decayed.
4. Door and window openings are not flashed and rotted allowing weather inside the structure further creating damage and rot to the framing structure.
5. (See Exhibits 56, 57, 58, 59, 60, 61, 62, 63, 81, 82)

1. Install water service, sewage disposal facilities, and heating facilities, including a working bathroom, kitchen sink, and heating source;
2. Remove all excess junk, garbage, and unnecessary articles from inside and outside the dwelling and the detached garage;
3. Ensure proper ingress and egress exists throughout the dwelling;
4. Clean and sanitize the dwelling and the detached garage;
5. Obtain an assessment from a licensed structural engineer to determine what needs to be done to remedy the numerous structural deficiencies throughout the dwelling and the detached garage;
6. Obtain permits and begin work on needed structural repairs according to structural engineer's assessment;
7. Interior walls of the dwelling need to be finished including but not limited to adding proper insulation and interior finish;

8. Stairs to the second floor must be repaired including adding stair treads where missing and adding handrail or guards and make the stairs structurally sound;

9. Repair rotten windows and install window in opening where window is currently missing and ensure all windows are operable;
10. Install a door where the current opening has plywood nailed over it;

13. Install doors to interior rooms;
14. Repair and cover high voltage wiring and electrical boxes currently exposed in the dwelling and detached garage in accordance with the Minnesota Electrical Code;
