**CITY OF LAKE ELMO
WASHINGTON COUNTY
MINNESOTA**

RESOLUTION NO. 2017- 066

*A RESOLUTION REGARDING THE ABATEMENT OF CONDITIONS CREATING A
HAZARDOUS BUILDING, HAZARDOUS PROPERTY, AND NUISANCE EXISTING AT 9224
AND 9240 31st STREET NORTH, LAKE ELMO, MINNESOTA 55042*

Re: Property Maintenance –IMMEDIATE ACTION REQUIRED

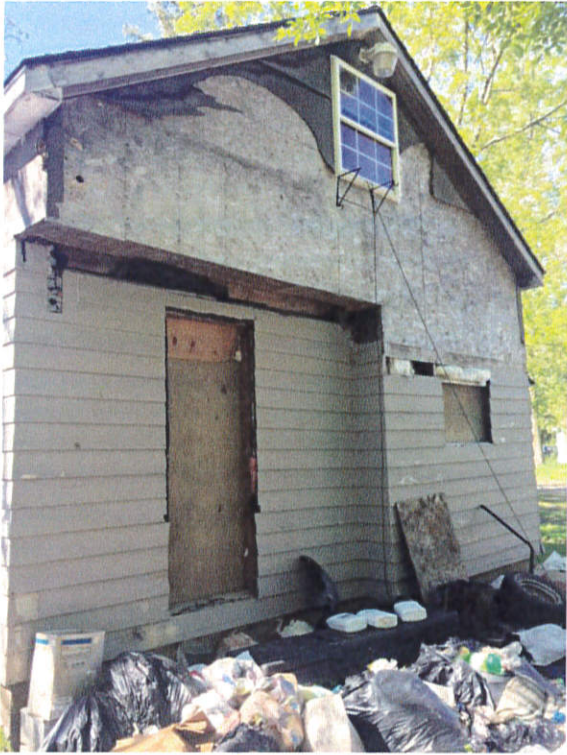
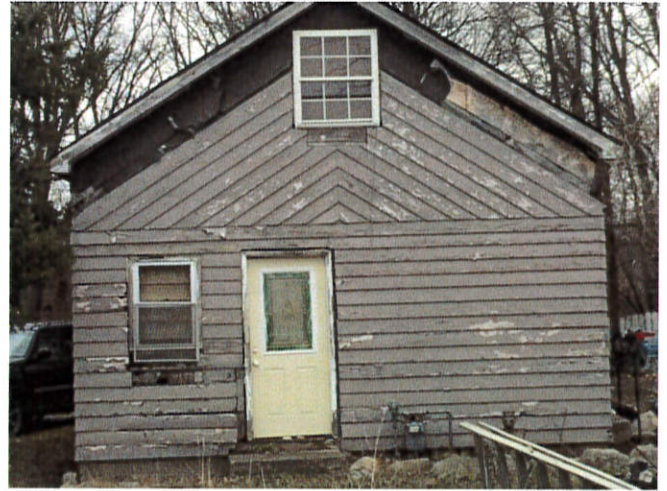
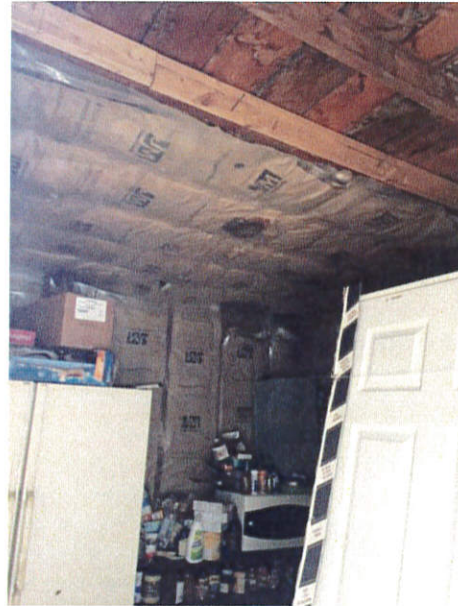
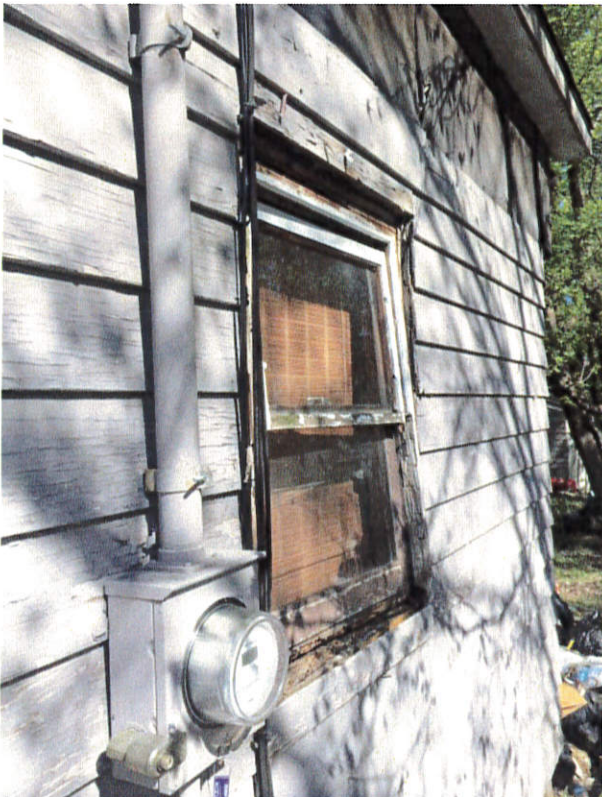
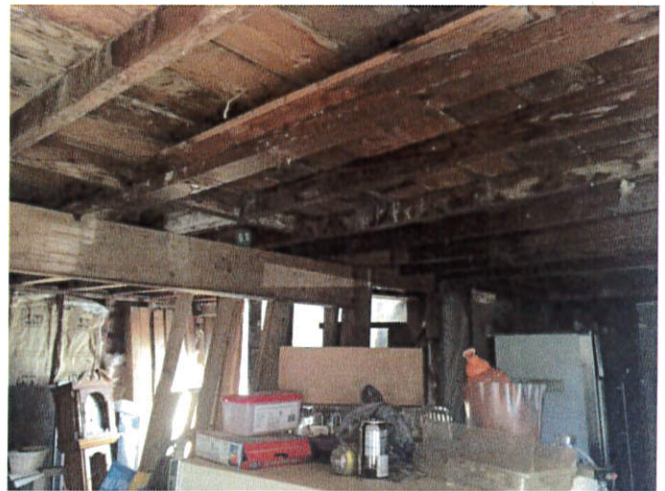
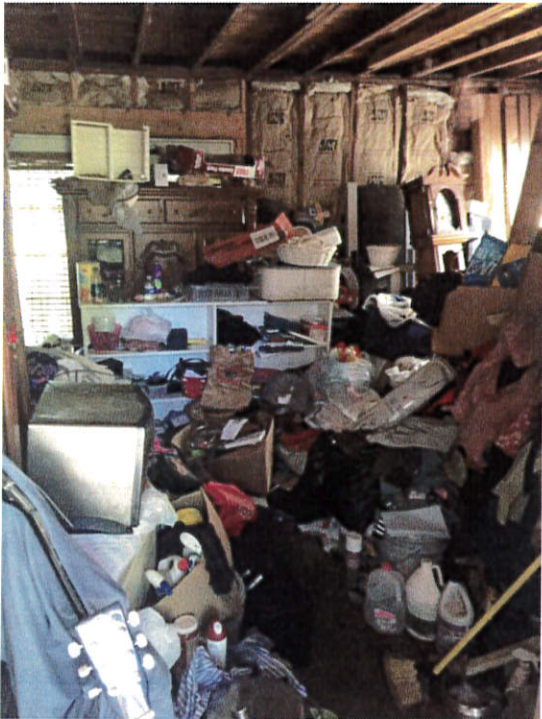
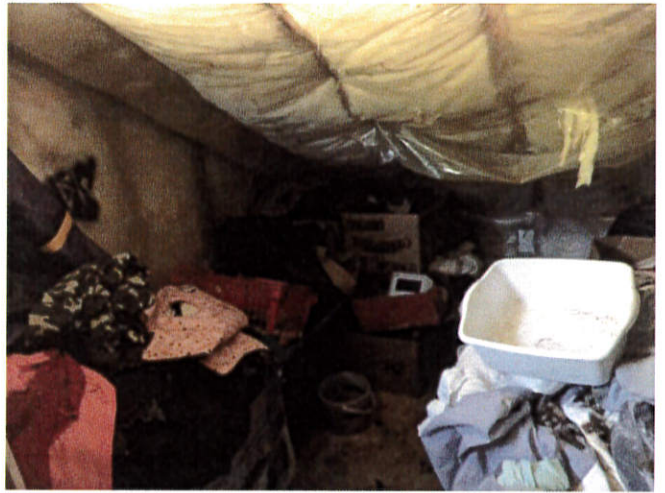
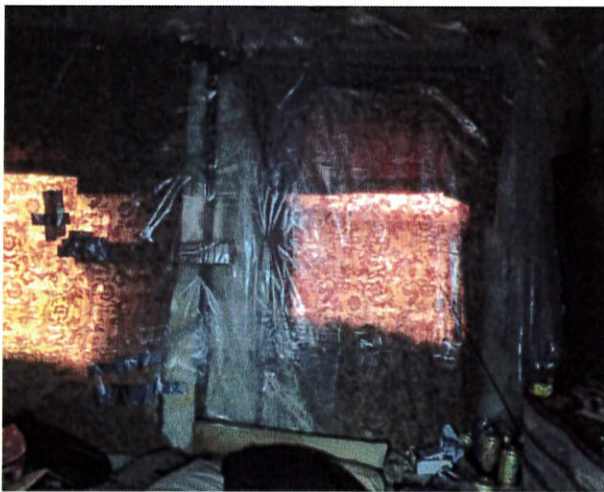
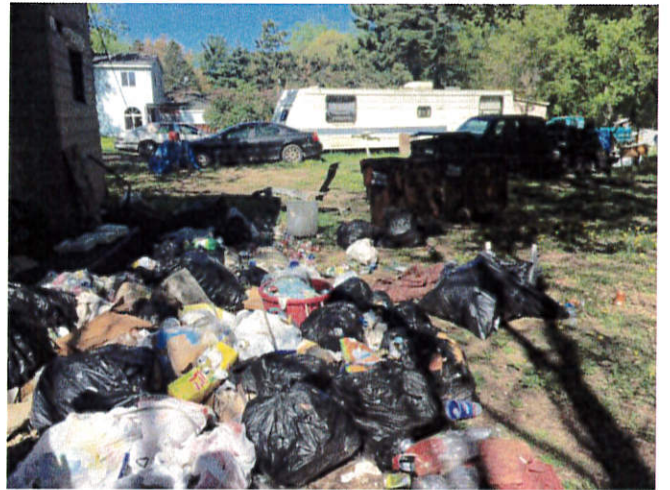
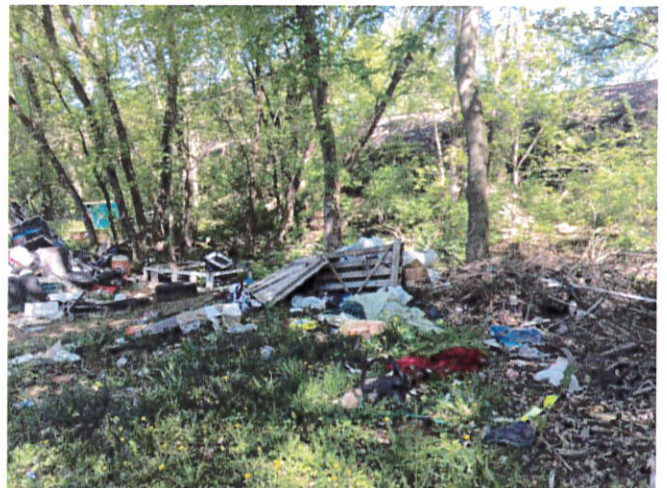
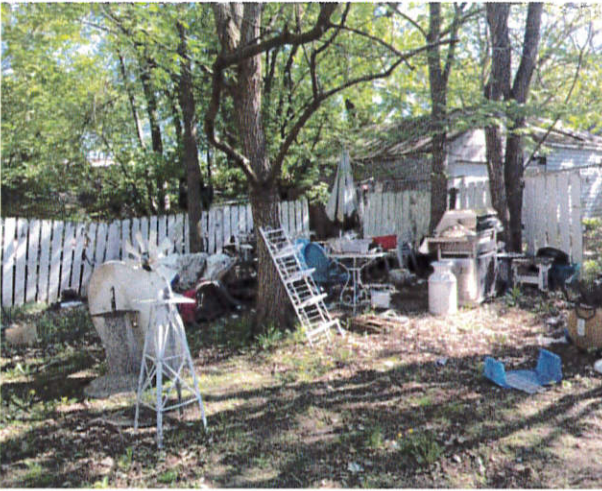
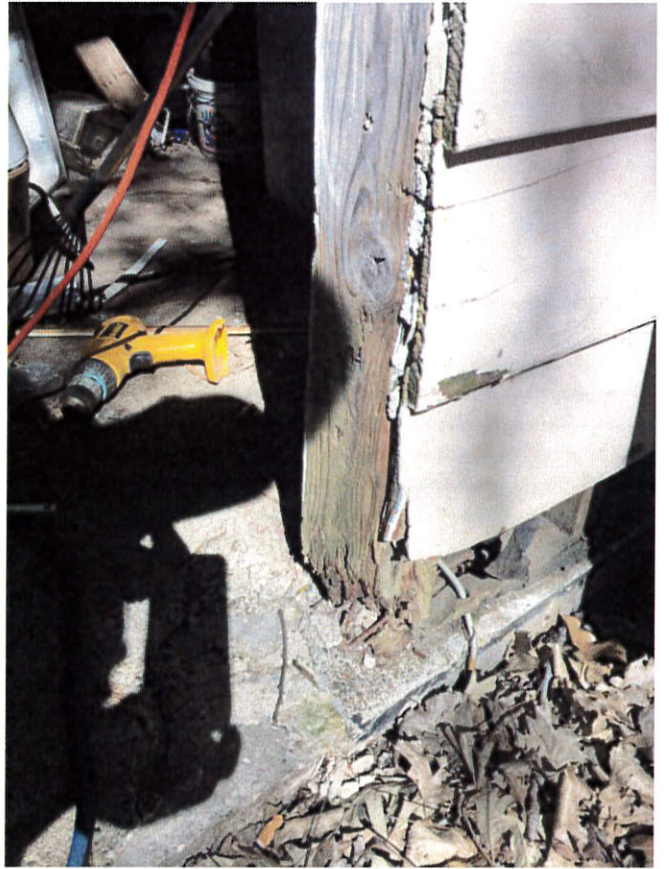
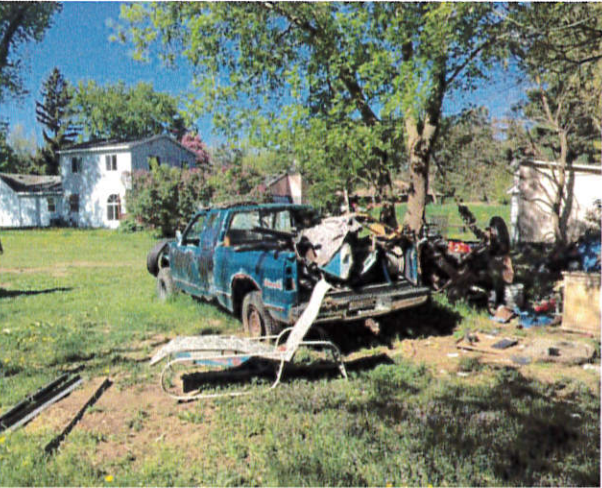
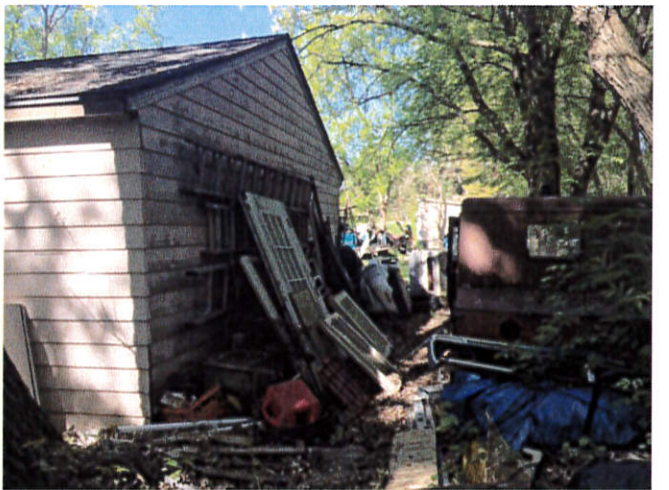
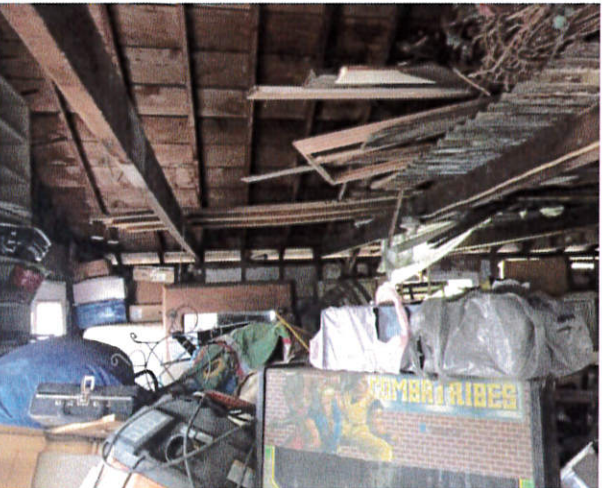
EXHIBIT C

WHEREAS, the Lake Elmo Building Official took photographs of the Subject Property during the May 11, 2017 inspection, as shown in Exhibit C; and

1. East entry door is rotted and not secured in opening to home, exterior trim and flashing is missing, sill is rotted and the opening is not weather tight. (Exhibit 1, Exhibit 7)

2. Foundation is caving in east side of home below grade. Block foundation grout is missing at the concrete block foundation, block is cracked and is caving in along the east wall. (Exhibit 2, Exhibit 3, Exhibit 4 & Exhibit 5)

3. The sill and floor joist area of the main floor east wall is exposed to the weather, no siding or protective weather barrier nor is flashing present in any area along the east wall. The main floor system rim and joists are rotted and structural integrity is compromised on the east exterior wall. (See Exhibit 3 & Exhibit 5)

4. The double hung window to the north of the electric meter on the east wall is rotted and falling into the house. There is no flashing present, the wood is rotted and not weather tight. (See Exhibit 6, Exhibit 8 & Exhibit 9)

5. The siding and trim boards on the east wall of the house is rotted and does not extend to the top of the wall. (See Exhibit 10 & Exhibit 11)

1. Foundation grout is missing at the concrete block foundation, block is cracked and is separating along the length of the north wall. (See Exhibit 12)

2. Structural framing of the wood frame floor system and walls above foundation is not flashed or weather tight. (See Exhibit 12)
3. Door opening on the north wall is missing the door, plywood pieces nailed over opening from the interior. Opening is not weather tight. Structural framing at the floor framing is rotted at the door opening. (See Exhibit 12)

4. Window opening on the north wall is missing the window, plywood has been nailed over the opening from the interior. Opening is not weather tight. (See Exhibit 12)

5. Exterior sheathing is missing along the north wall near the window opening. (See Exhibit 12)
6. Siding and trim missing from the north wall, sheathing is exposed to the weather and approx. top half of the exterior wall is not flashed or protected from the weather or weather tight. (See Exhibit 12)

7. Window at the top of the wall is not flashed or weather tight. (See Exhibit 12)

1. Install water service, sewage disposal facilities, and heating facilities, including a working bathroom, kitchen sink, and heating source;
2. Remove all excess junk, garbage, and unnecessary articles from inside and outside the dwelling and the detached garage;
3. Ensure proper ingress and egress exists throughout the dwelling;
4. Clean and sanitize the dwelling and the detached garage;
5. Obtain an assessment from a licensed structural engineer to determine what needs to be done to remedy the numerous structural deficiencies throughout the dwelling and the detached garage;
6. Obtain permits and begin work on needed structural repairs according to structural engineer's assessment;
7. Interior walls of the dwelling need to be finished including but not limited to adding proper insulation and interior finish;

8. Stairs to the second floor must be repaired including adding stair treads where missing and adding handrail or guards and make the stairs structurally sound;

9. Repair rotten windows and install window in opening where window is currently missing and ensure all windows are operable;
10. Install a door where the current opening has plywood nailed over it;
