AGENDA ITEM: 180 acres of City Property on Ideal Ave

Phase I Environmental Site Assessment

PIN #1602921240002

Lake Elmo, Minnesota

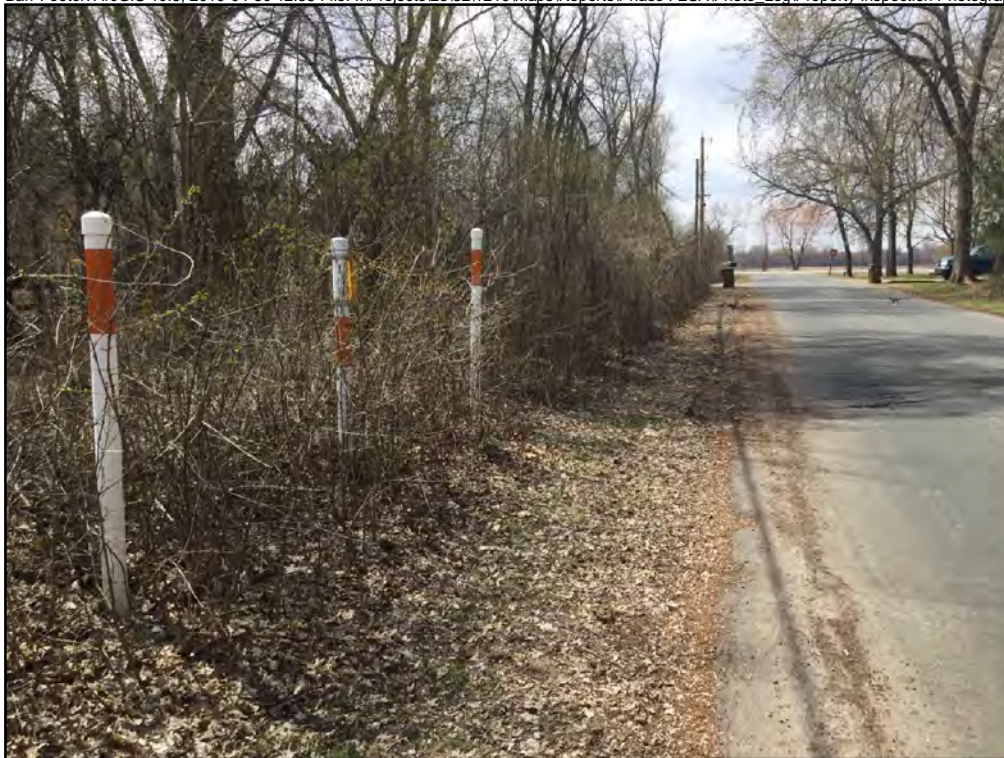
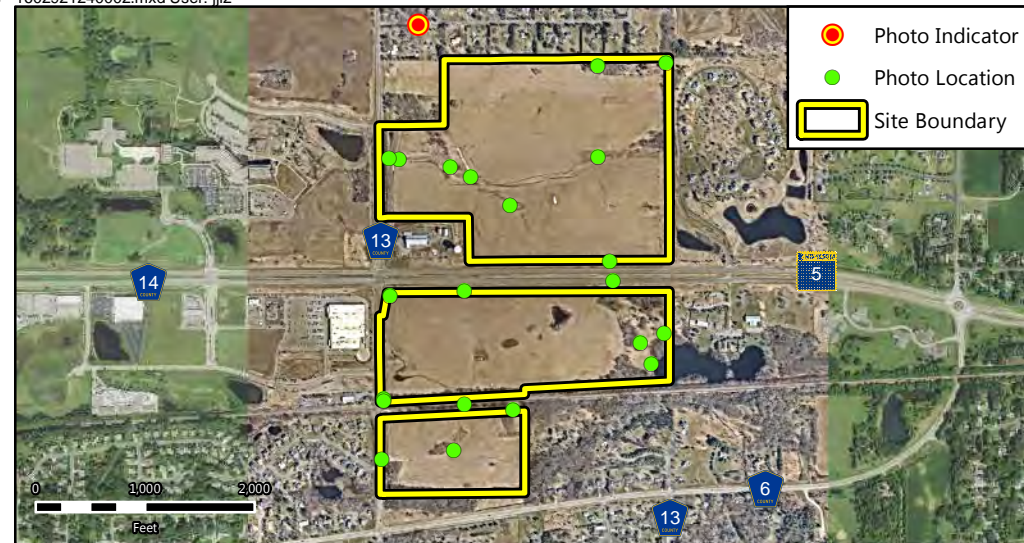
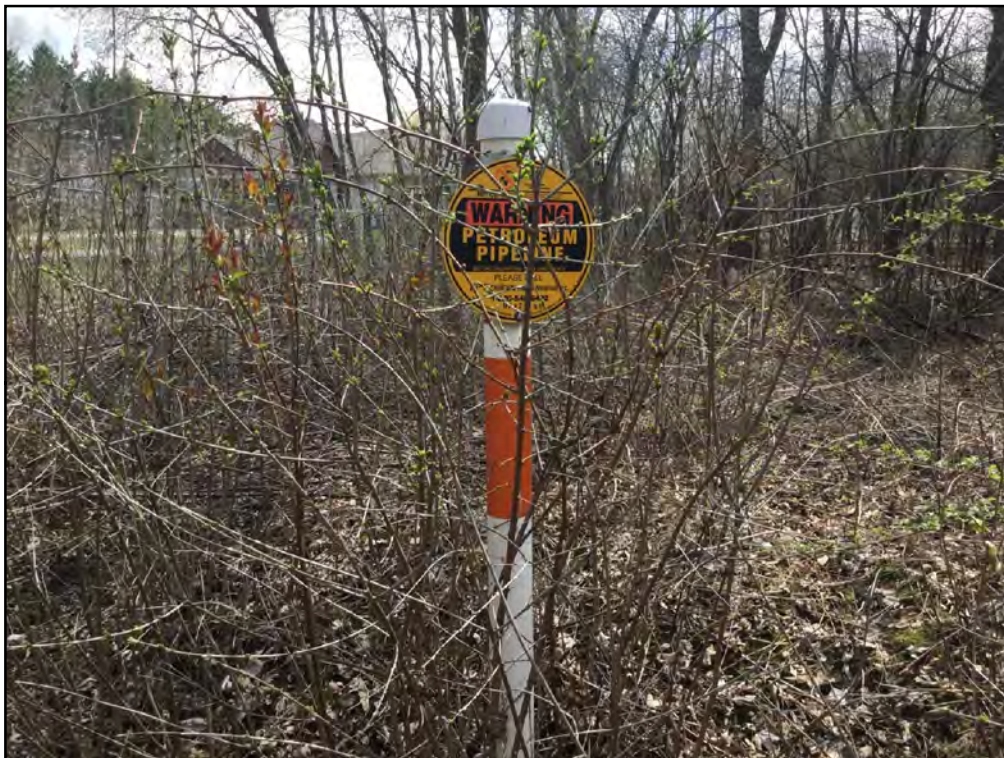
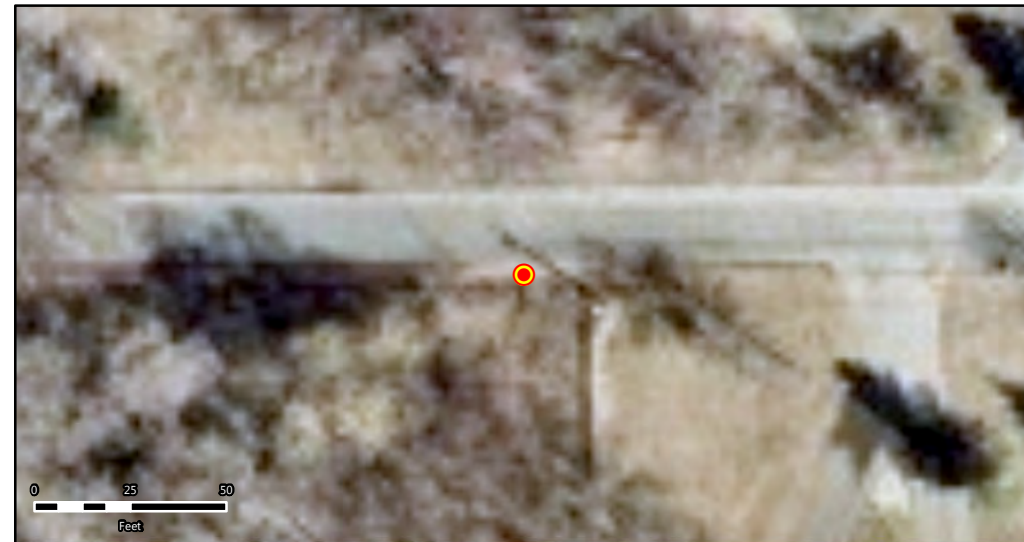
Map 1 of 22
**PROPERTY INSPECTION
PHOTOGRAPHS**
Parcel ID 1602921240002
Lake Elmo, MN

Date: 4/29/2019
Comment: Petroleum pipeline markers to
the north of property on residential street

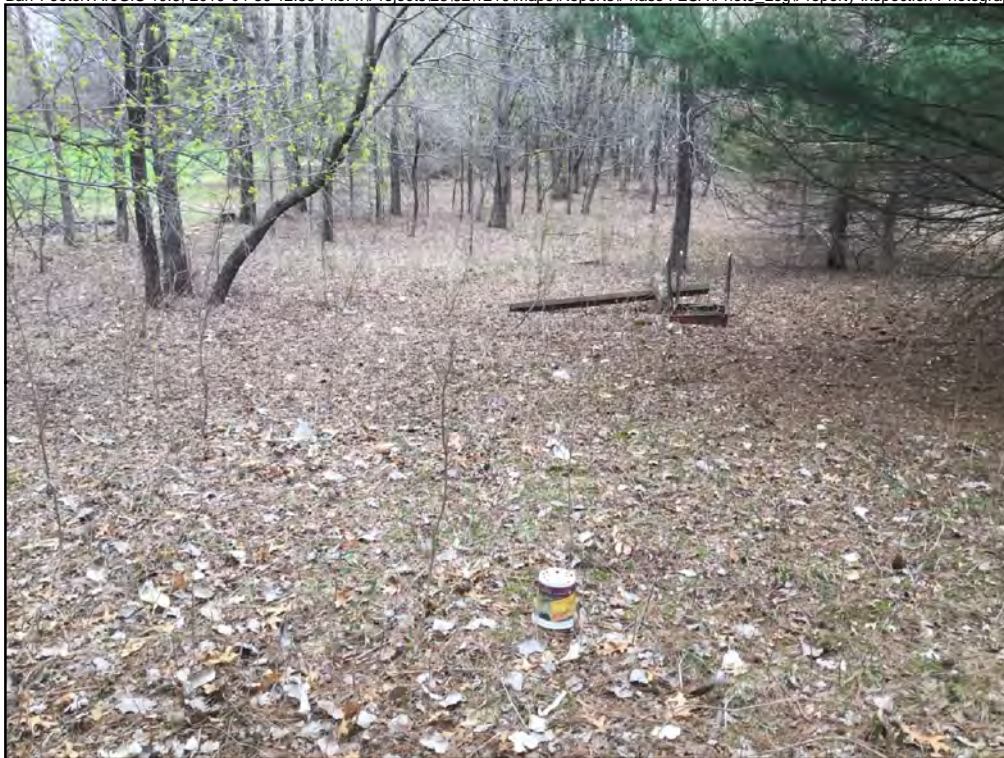
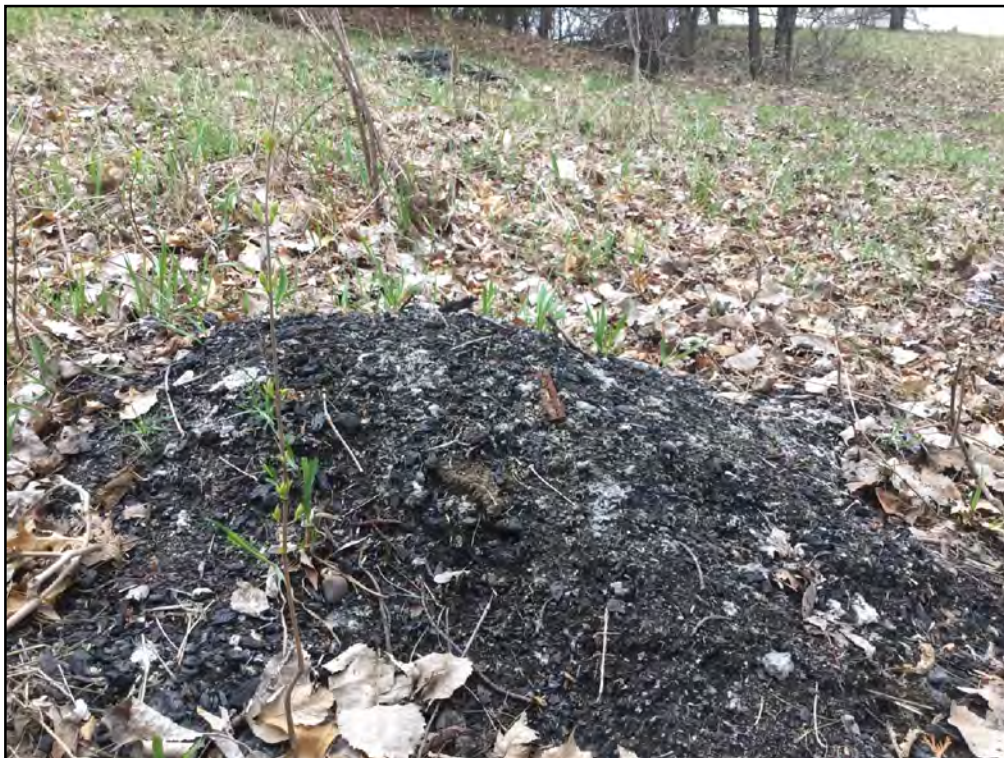
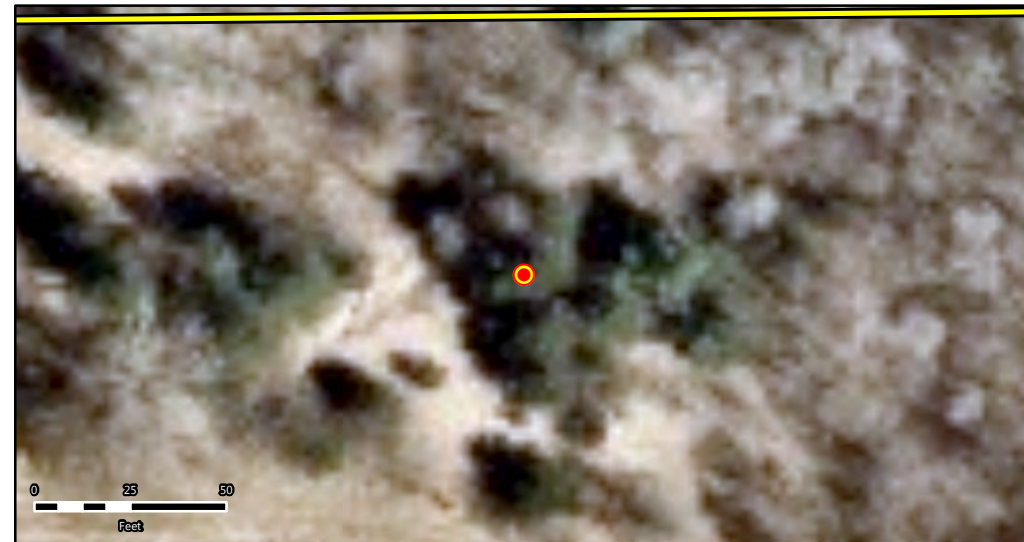
Map 2 of 22
**PROPERTY INSPECTION
PHOTOGRAPHS**
Parcel ID 1602921240002
Lake Elmo, MN

Visible evidence of filling, excavation, or burned areas: A small berm was observed at the drainage ditch in the northern portion of the Property. Small piles of burned debris were observed in the wooded area in the NE corner of the Property.

Date: 4/29/2019
Comment: NE edge of property, wooded
area, debris, small piles of burned material

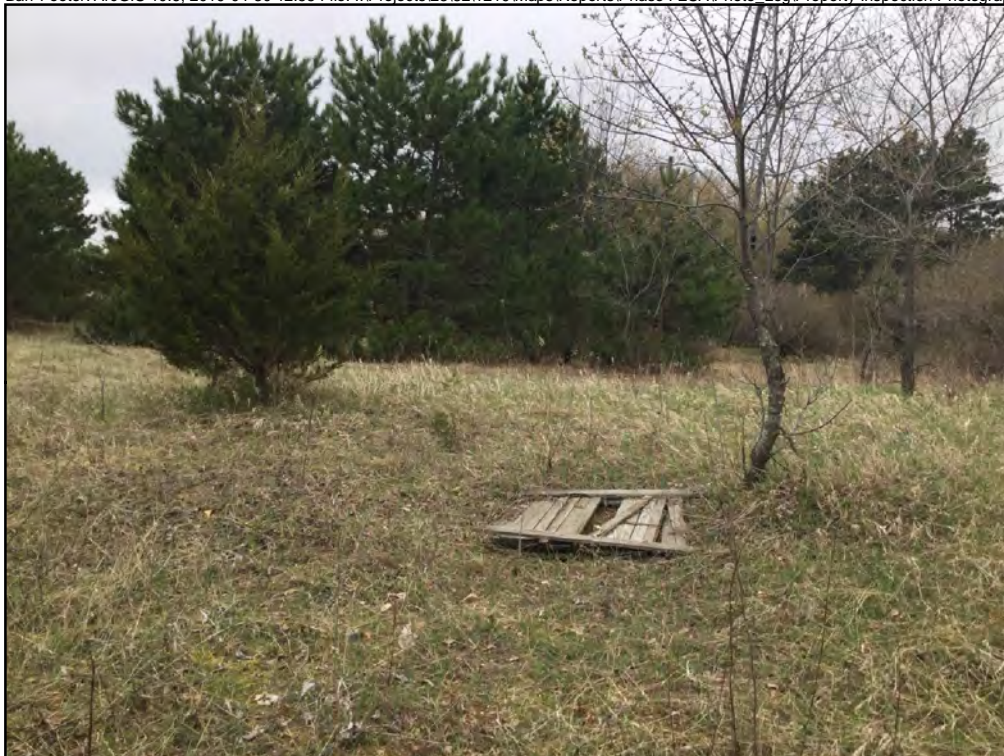
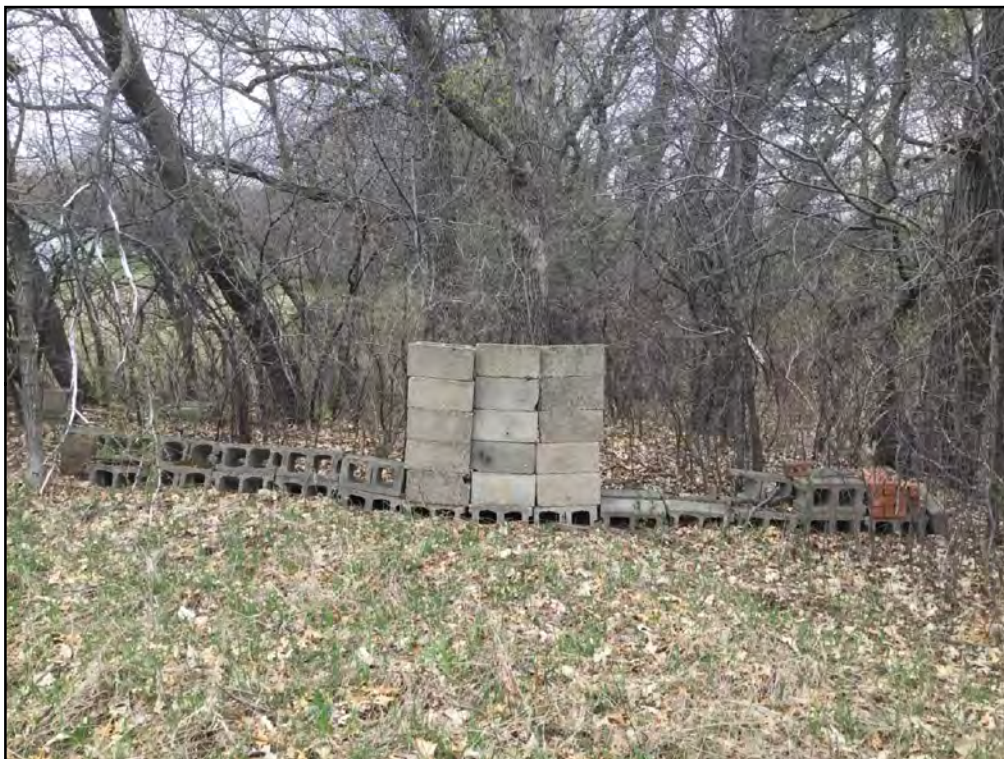
Map 3 of 22
**PROPERTY INSPECTION
PHOTOGRAPHS**
Parcel ID 1602921240002
Lake Elmo, MN

Finding #2	Miscellaneous Debris: Occasional areas of miscellaneous, inert debris were observed dispersed across the site. Observed materials included wood, metal fragments, plastic and glass shards, a small ash pile, and a stack of cinder blocks.	Based on the quantity and nature of the debris, this finding is considered a de minimis condition and is not a REC.
Finding #3	Past Agricultural Use: The Property has been used for agriculture since at least 1936 and there is potential for agricultural chemicals to have been used at the Property.	Because it is assumed that agricultural chemicals were applied using industry standard application rates, and no evidence of inappropriate agricultural chemical applications was identified, this finding is not a REC.
Finding #4	Adjoining LUST Site: One closed LUST site was reported at an east-adjointing, down-gradient parcel. Soil and groundwater contamination was reported and delineated in the regulatory records.	Based on the downgradient location of the LUST site, this finding is not a REC.

Date: 4/29/2019
Comment: NE corner of property, wooded
area, cinder block pile, wood debris

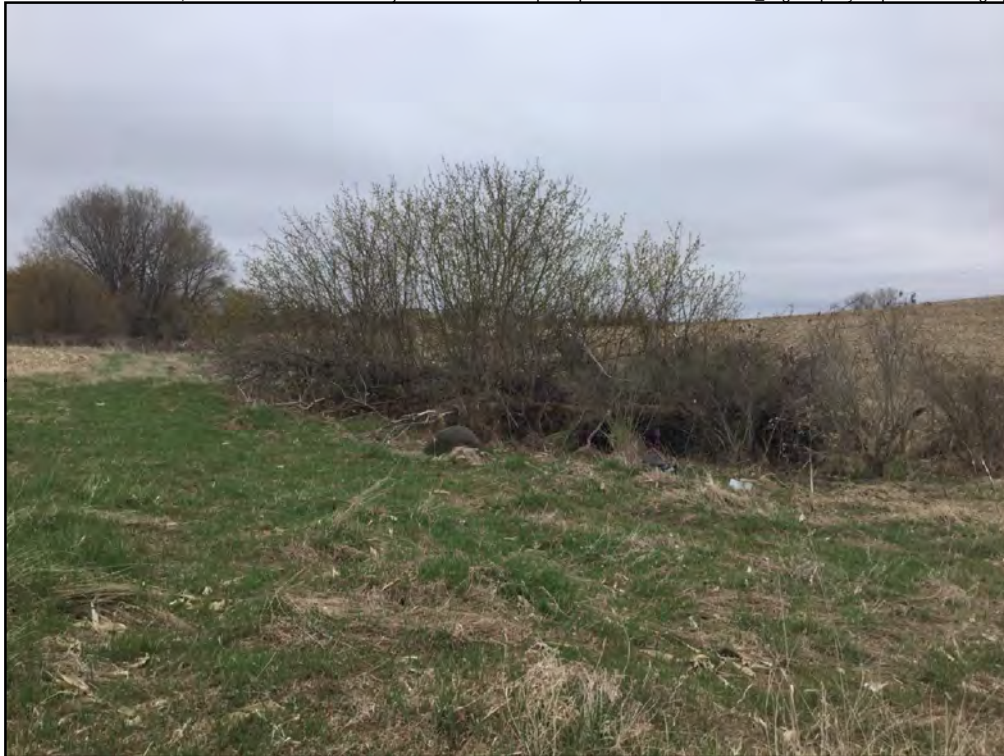
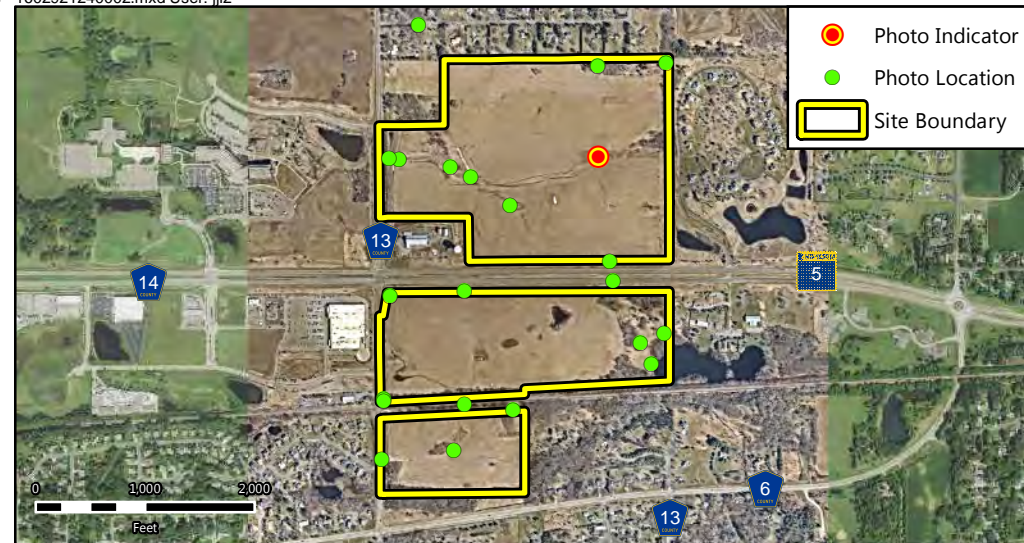
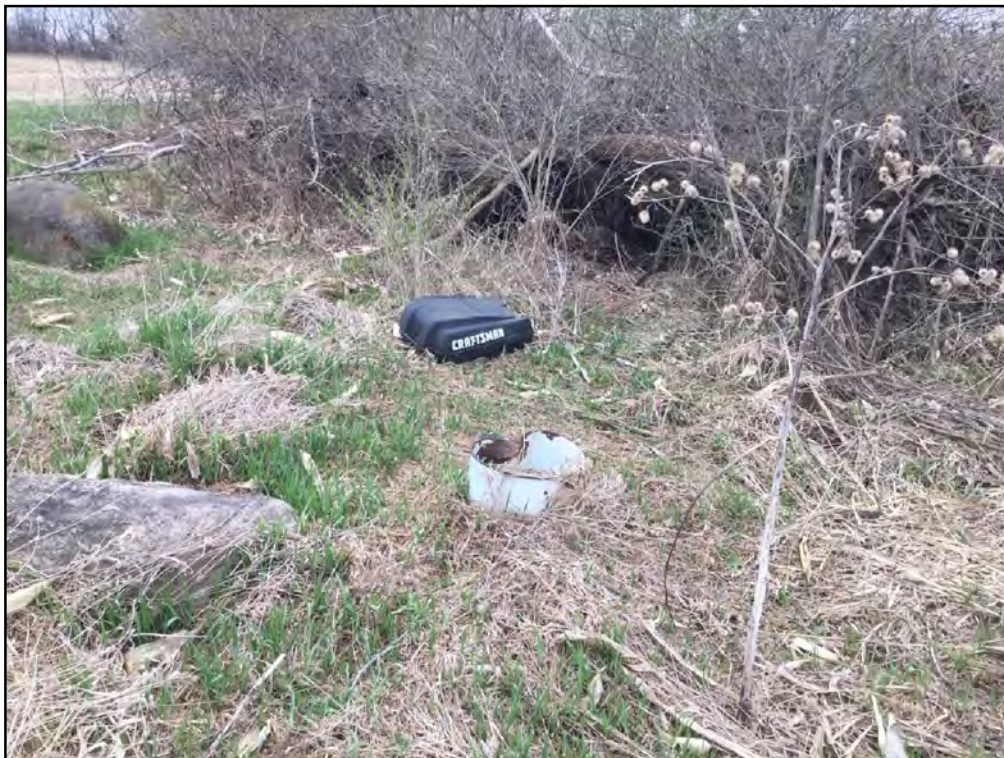
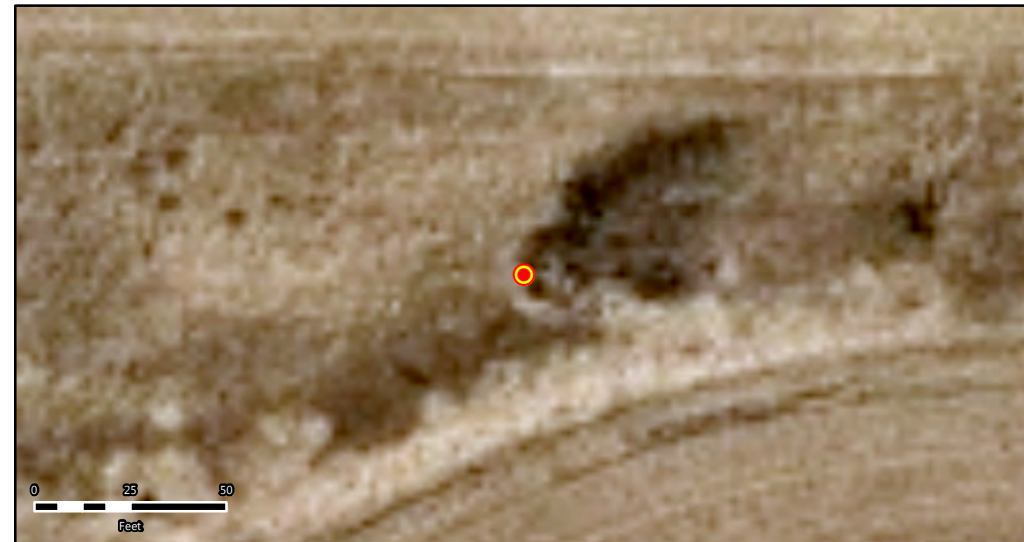
Map 4 of 22
**PROPERTY INSPECTION
PHOTOGRAPHS**
Parcel ID 1602921240002
Lake Elmo, MN

Date: 4/29/2019
Comment: Debris

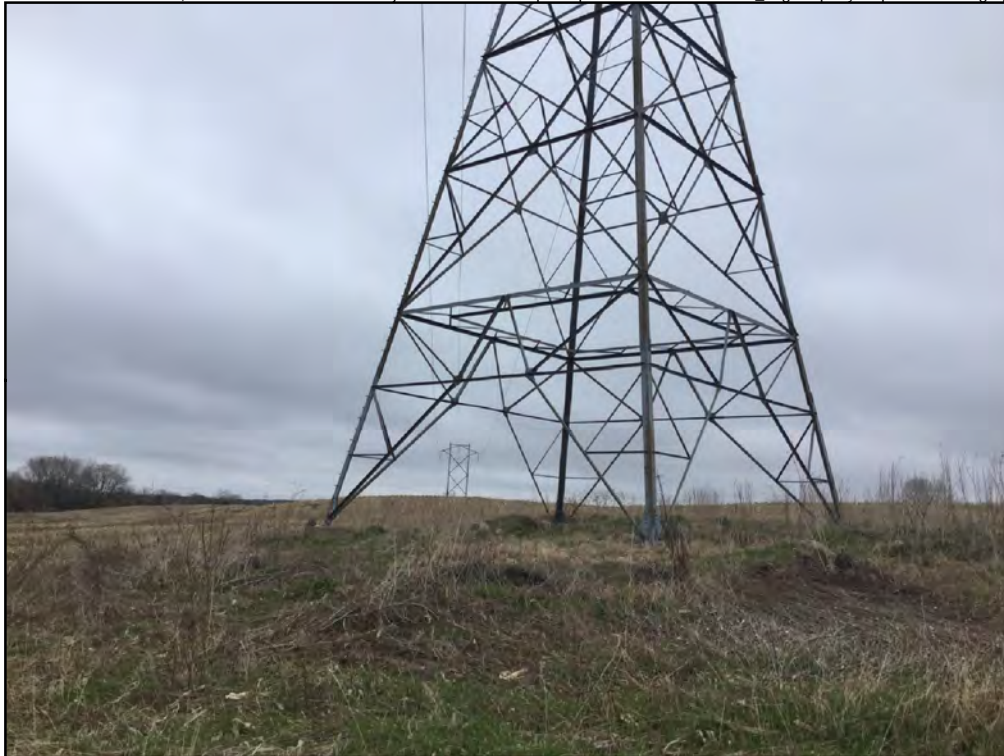
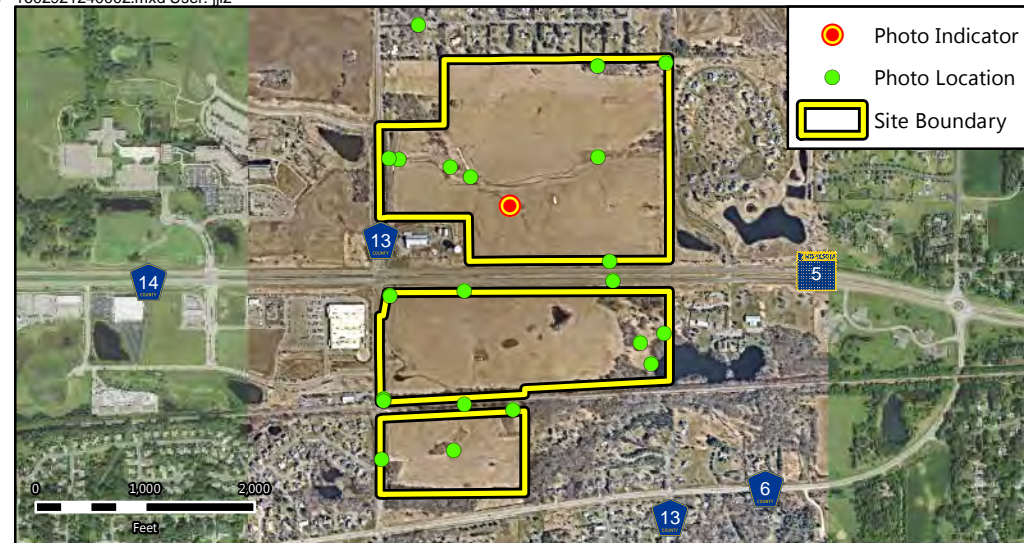
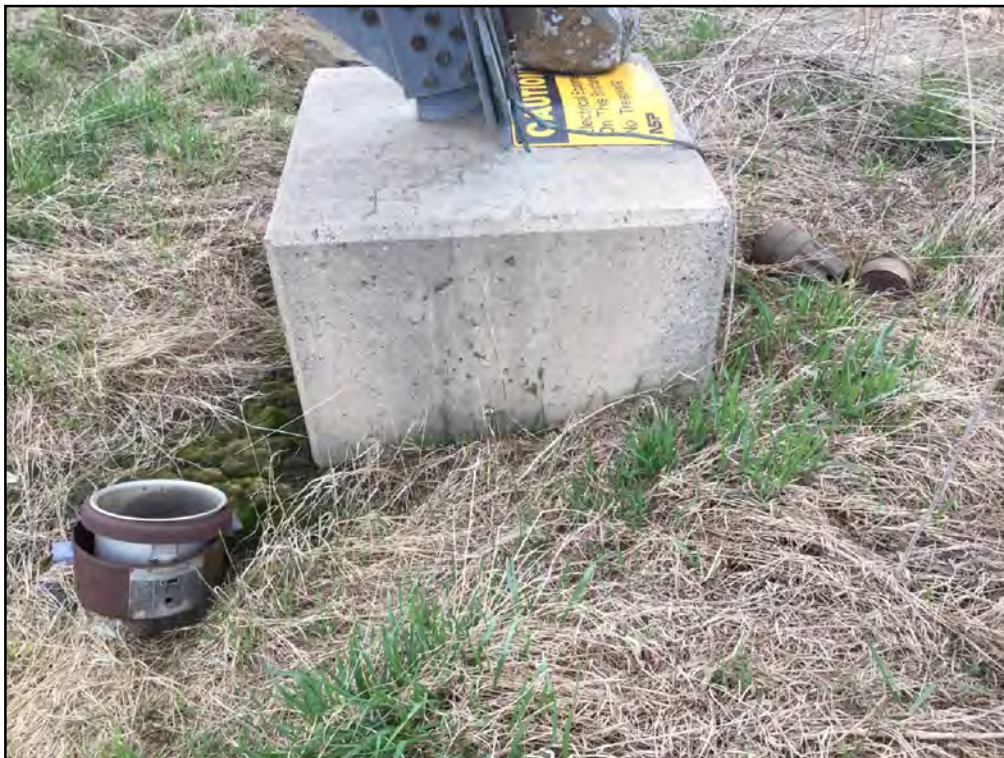
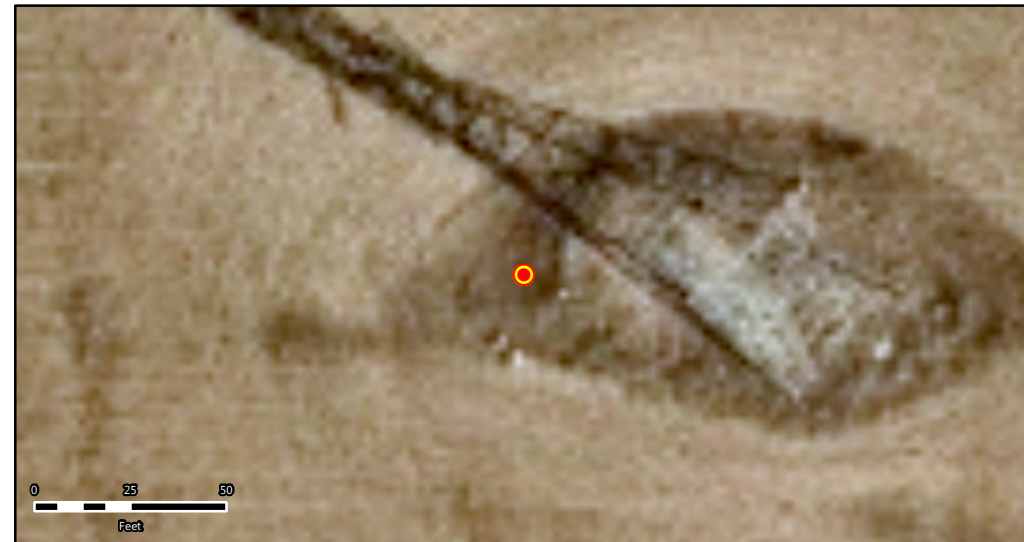
Map 5 of 22
**PROPERTY INSPECTION
PHOTOGRAPHS**
Parcel ID 1602921240002
Lake Elmo, MN

Transformers: A transformer tower was observed in the northern portion of the Property.

Date: 4/29/2019
Comment: Transmission tower, overhead
lines run to the south and to the east,
debris at base (planting pots, empty paint
can, fry cooker)

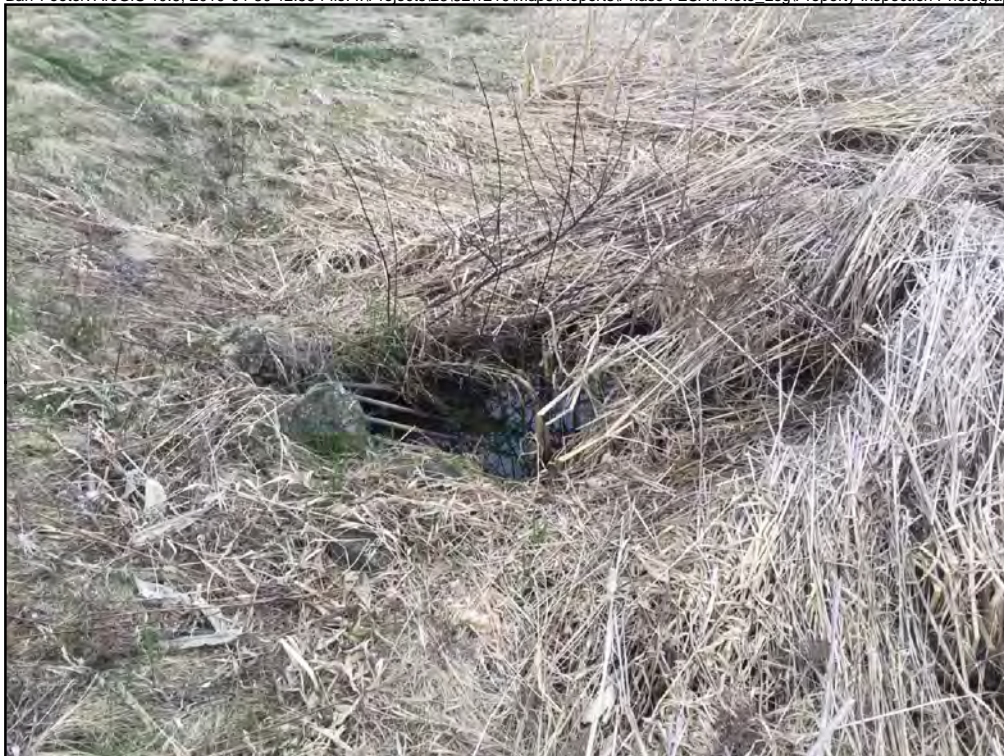
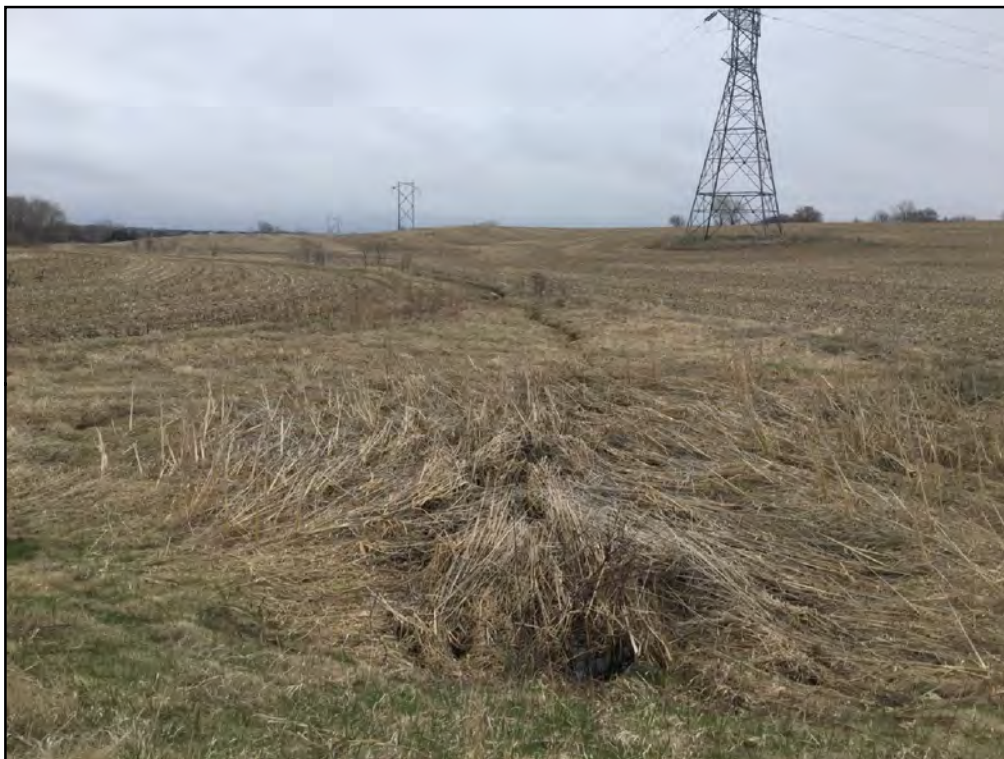
Map 6 of 22
**PROPERTY INSPECTION
PHOTOGRAPHS**
Parcel ID 1602921240002
Lake Elmo, MN

Wastewater, stormwater, and other visible liquid discharge points into a pipe, pond, ditch, stream adjoining property or the Property: Stormwater discharge was observed from the culvert located at the west edge of the Property near the Public Works access road into the drainage ditch.

Date: 4/29/2019
Comment: Culvert, drainage ditch flowing
east

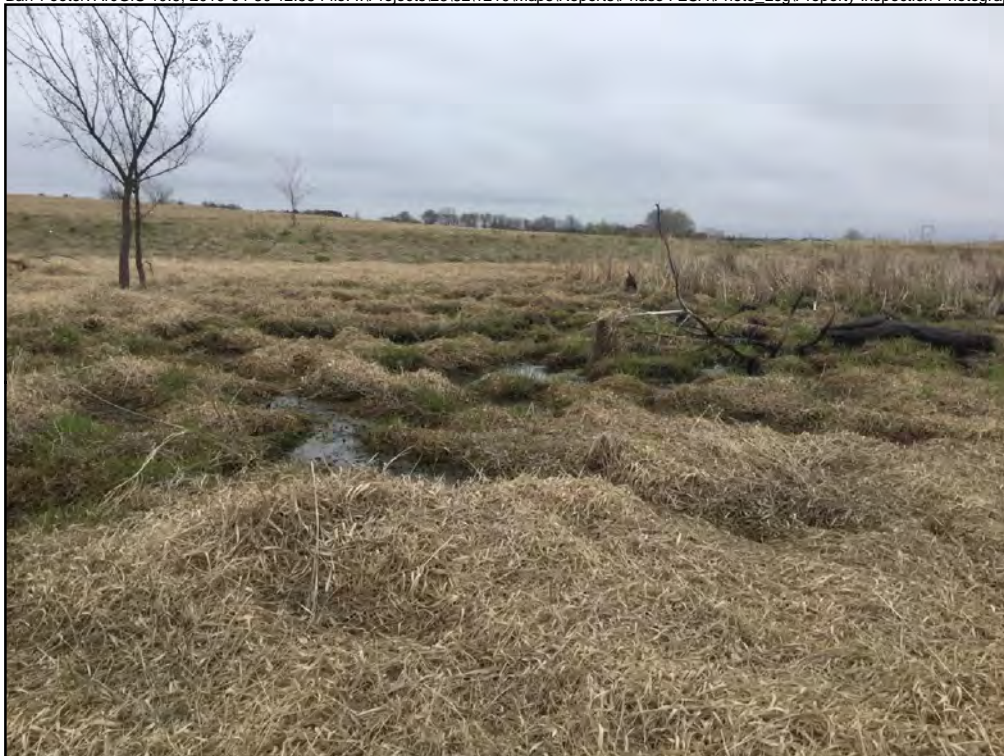
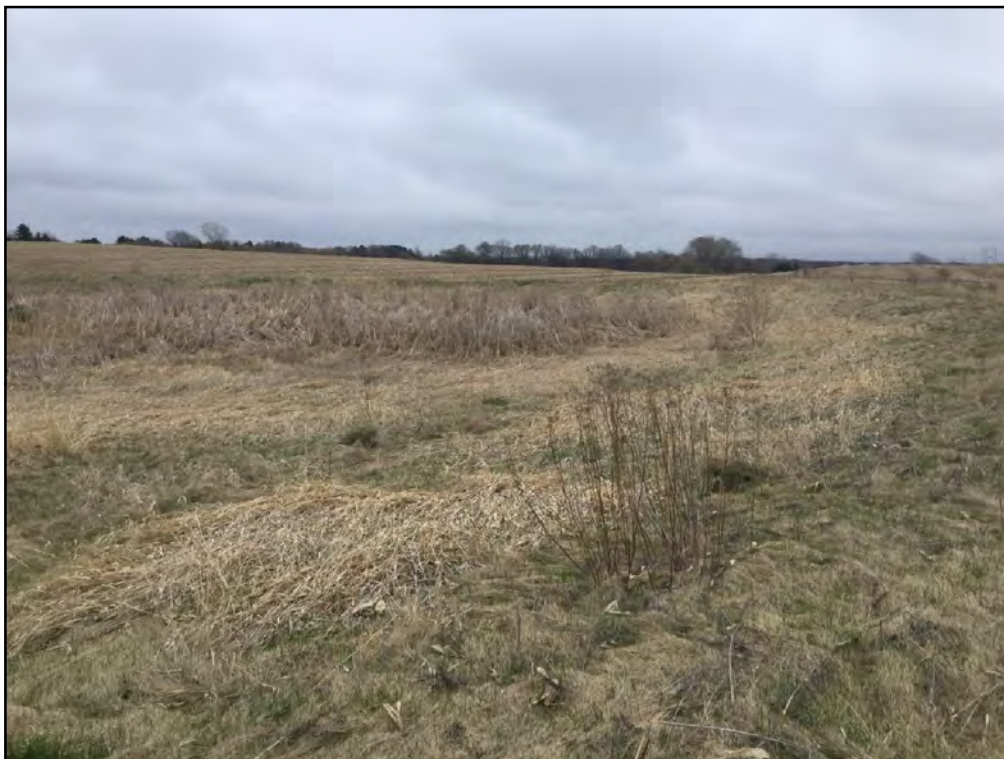
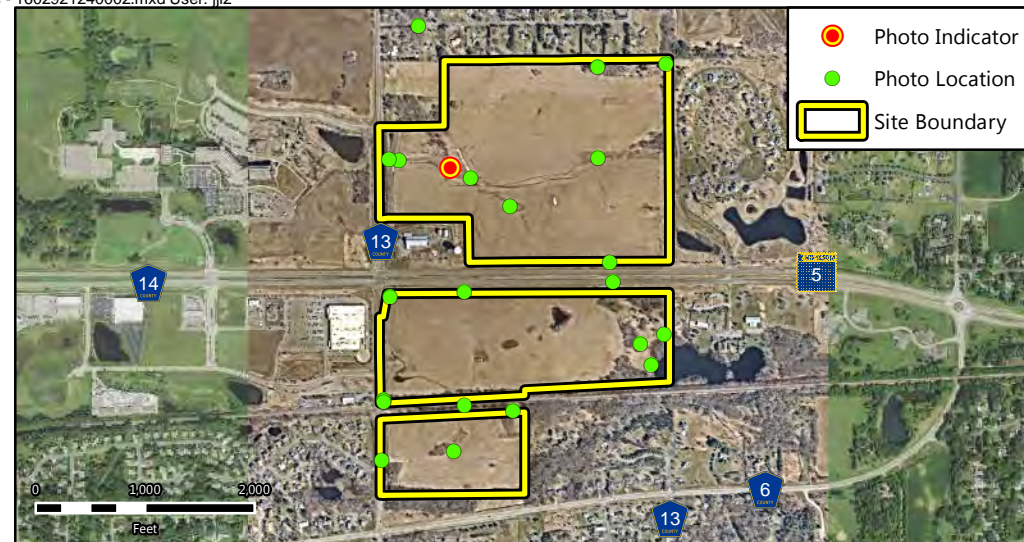
Map 7 of 22
**PROPERTY INSPECTION
PHOTOGRAPHS**
Parcel ID 1602921240002
Lake Elmo, MN

Pits, ponds, lagoons, and standing surface water: A pond is located on the east edge of the Property, immediately north of the railroad. Standing water was observed behind the berm and in the drainage ditch in the northern portion of the Property. A stormwater pond is located at the entrance of the Public Works access road.

Date: 4/29/2019
Comment: Low spot/ swamp, surrounded
by berm

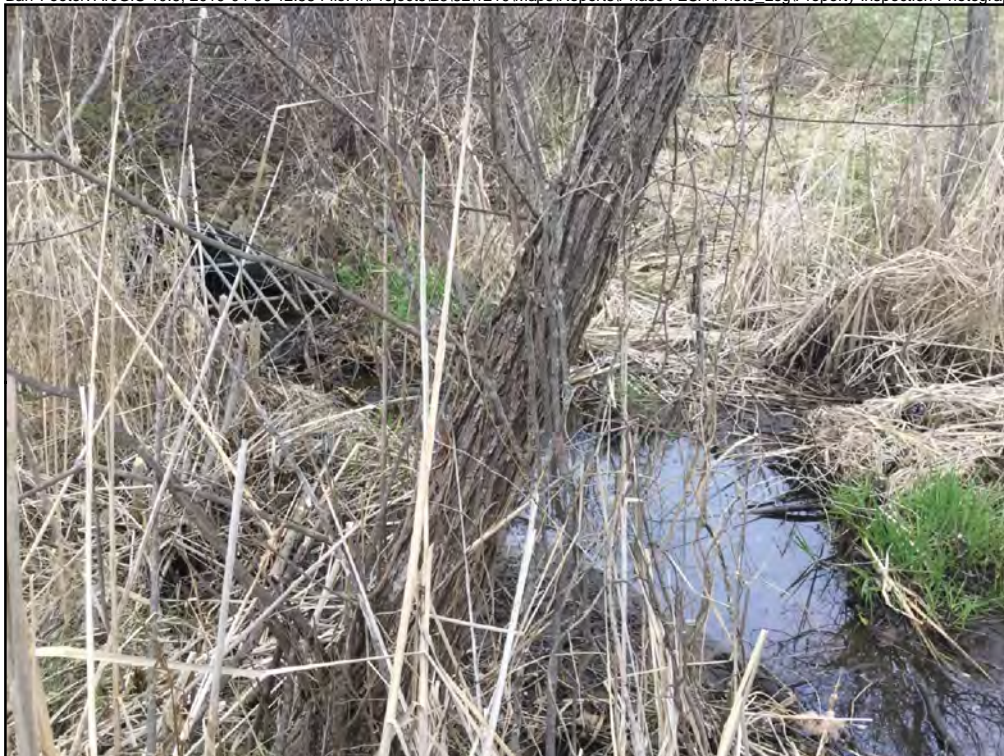
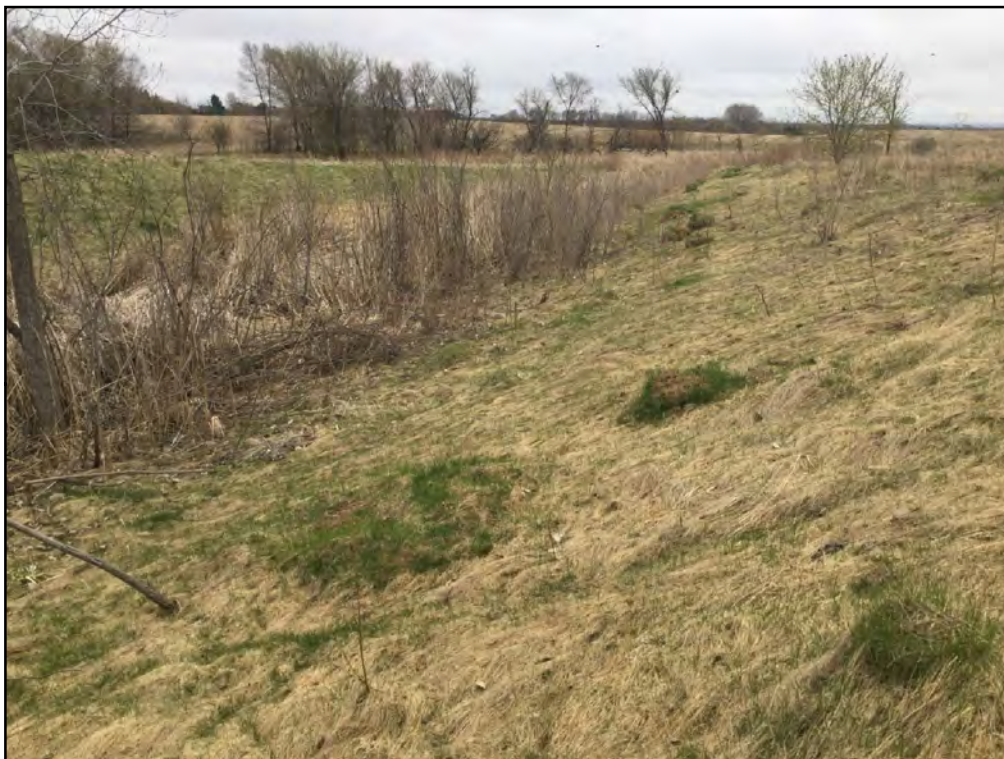
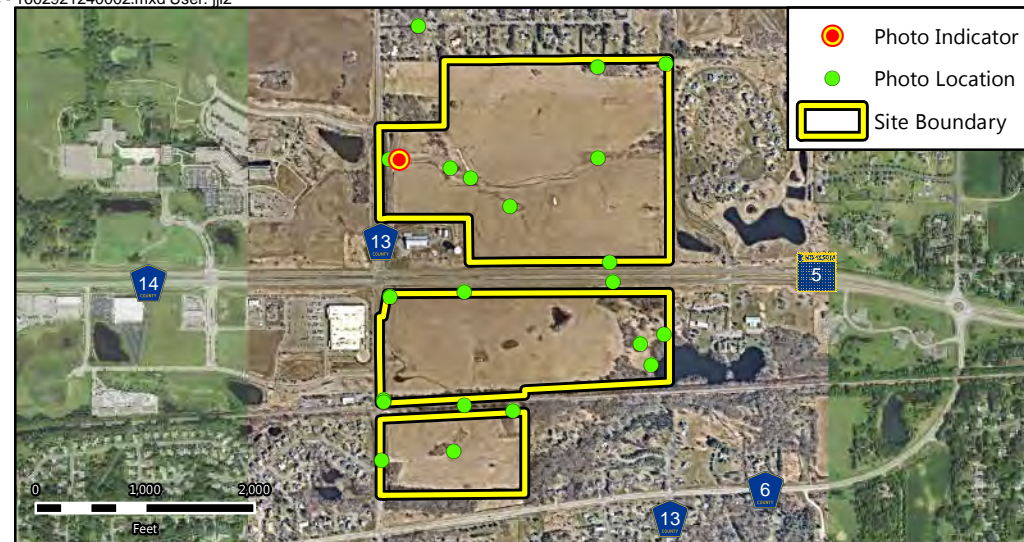
Map 8 of 22
**PROPERTY INSPECTION
PHOTOGRAPHS**
Parcel ID 1602921240002
Lake Elmo, MN

Date: 4/29/2019
Comment: Culvert, drainage ditch

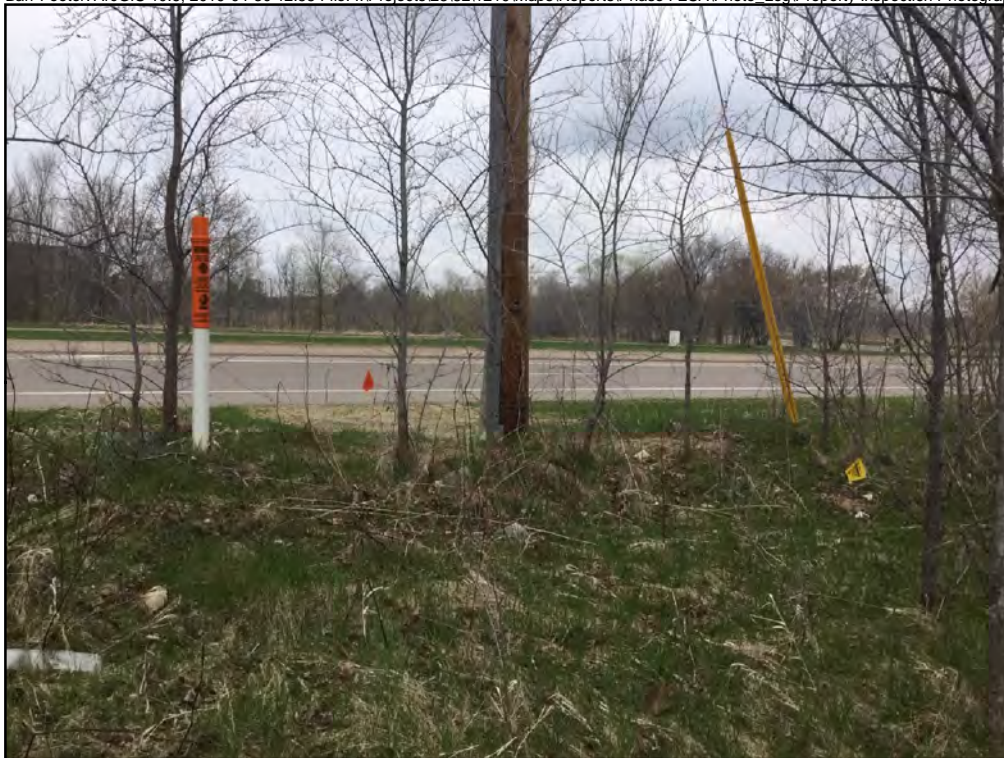
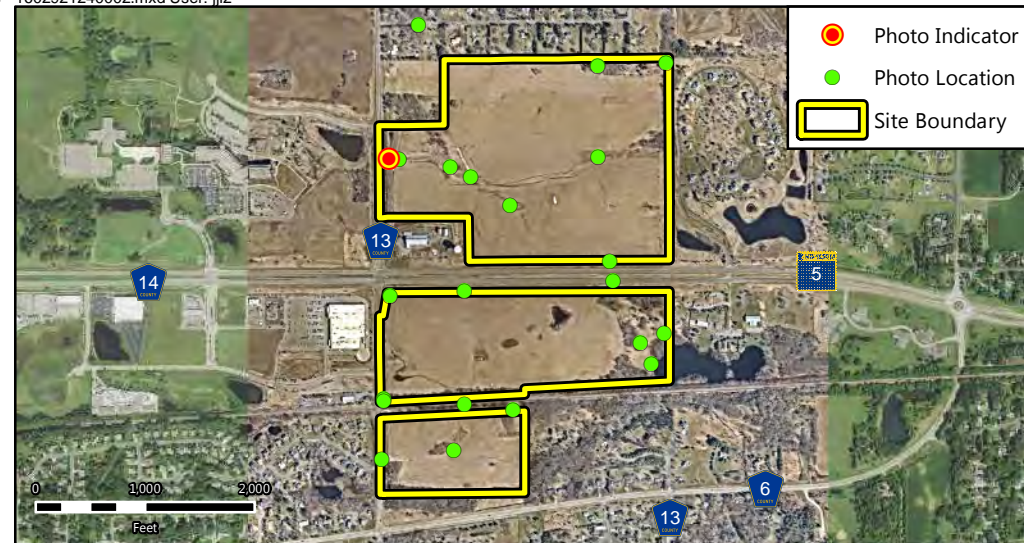
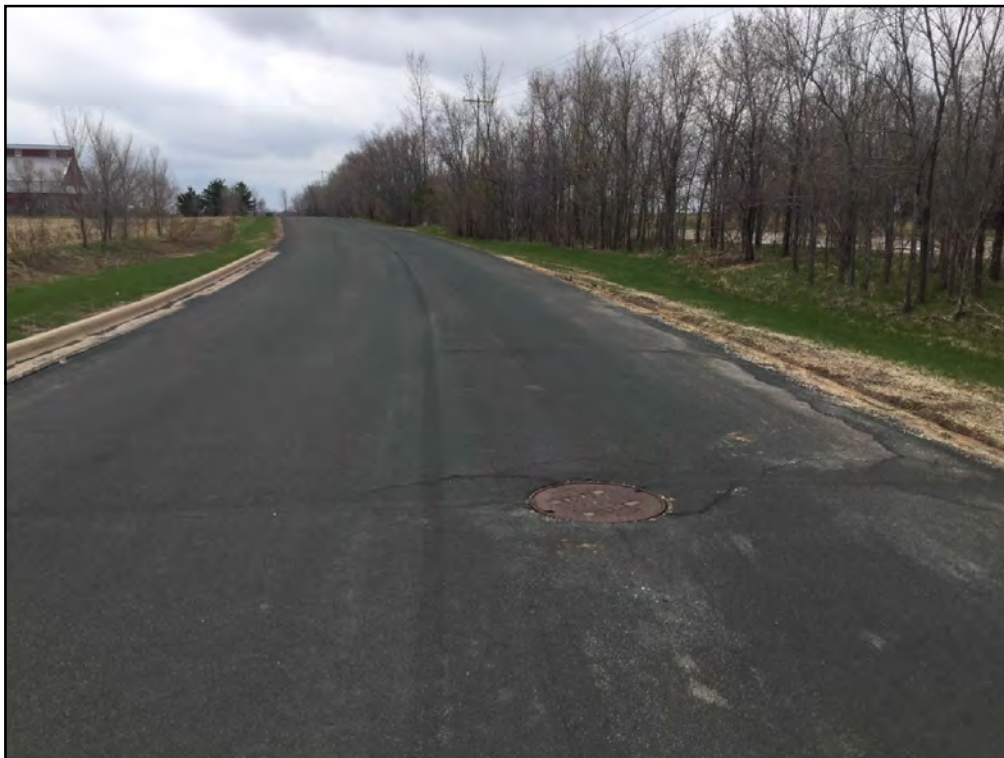
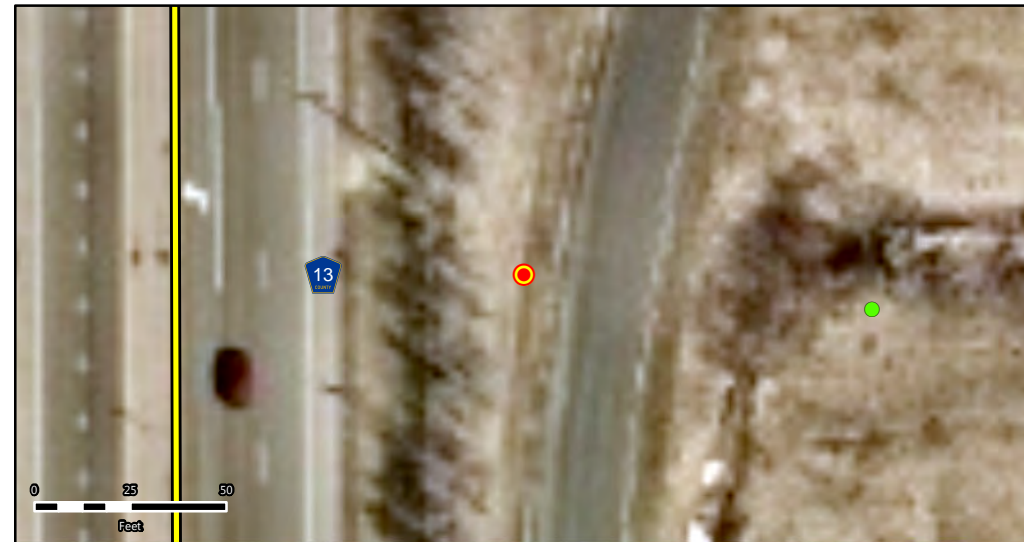
Map 9 of 22
**PROPERTY INSPECTION
PHOTOGRAPHS**
Parcel ID 1602921240002
Lake Elmo, MN

Pipelines across or into Property: A gas pipeline runs through the Property along Ideal Avenue at the west Property boundary. Markers, pipeline access points, and above ground pipeline features were observed. A petroleum pipeline runs through the Property from the NE corner to the SE corner of the Property. Pipeline markers were observed at multiple locations on the Property.

Date: 4/29/2019
Comment: Utilities along Ideal Ave and
public works roadway (gas pipeline flags,
fiber optics marker, electrical, sanitary
sewer)
