AGENDA ITEM: 180 acres of City Property on Ideal Ave

Phase I Environmental Site Assessment

PIN #1602921240002

Lake Elmo, Minnesota

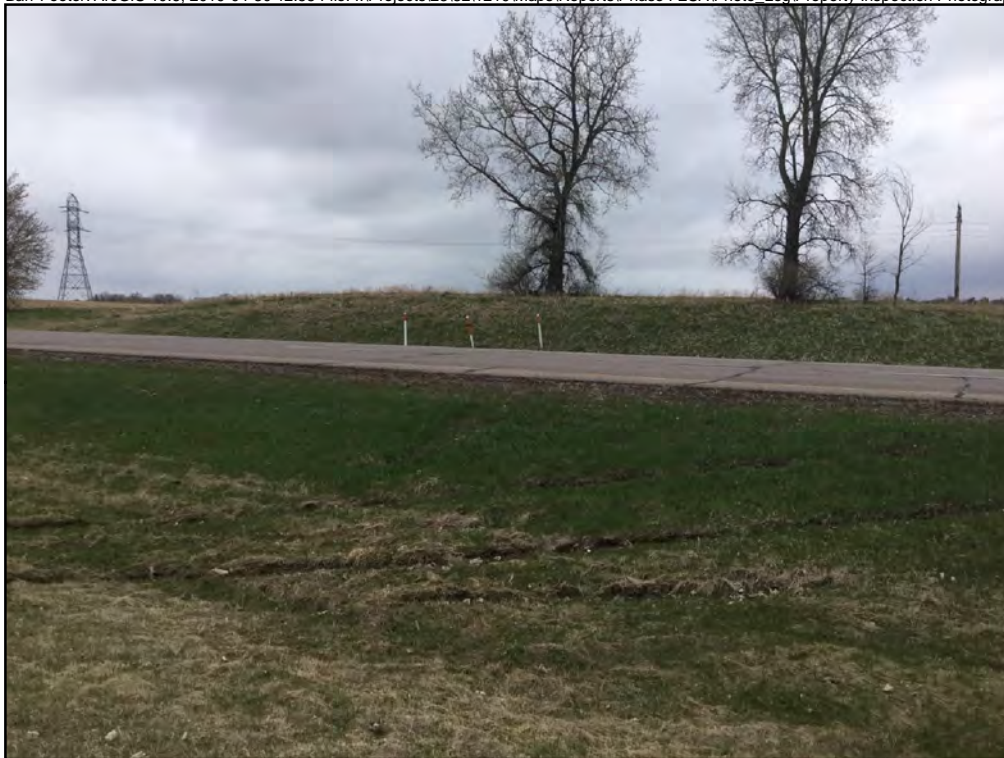
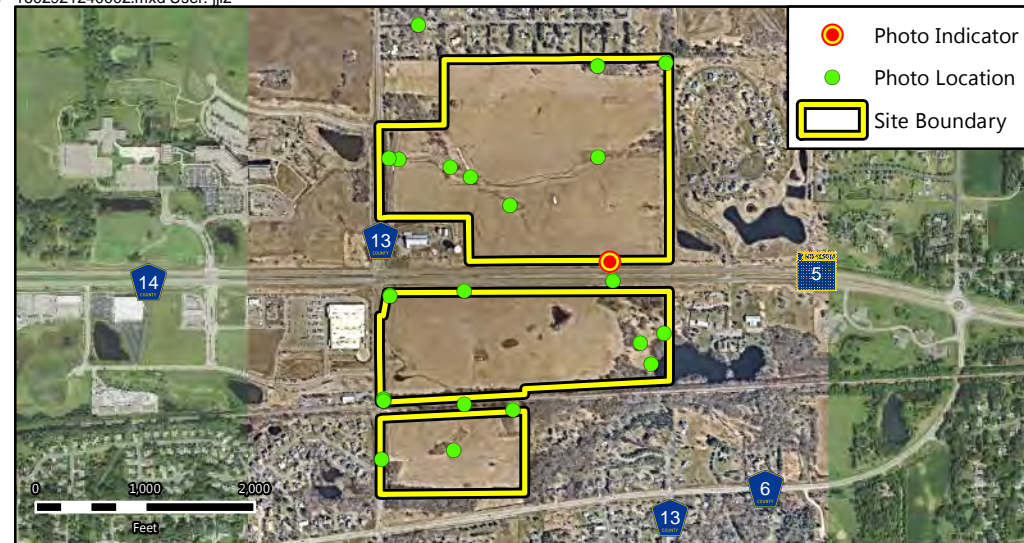
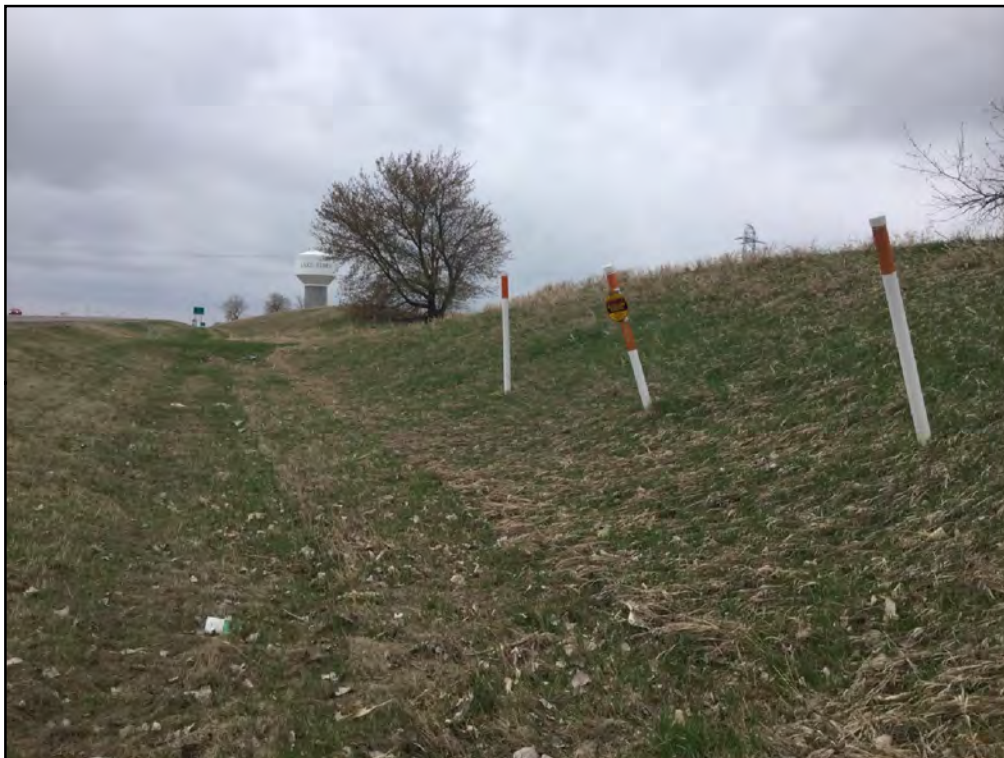
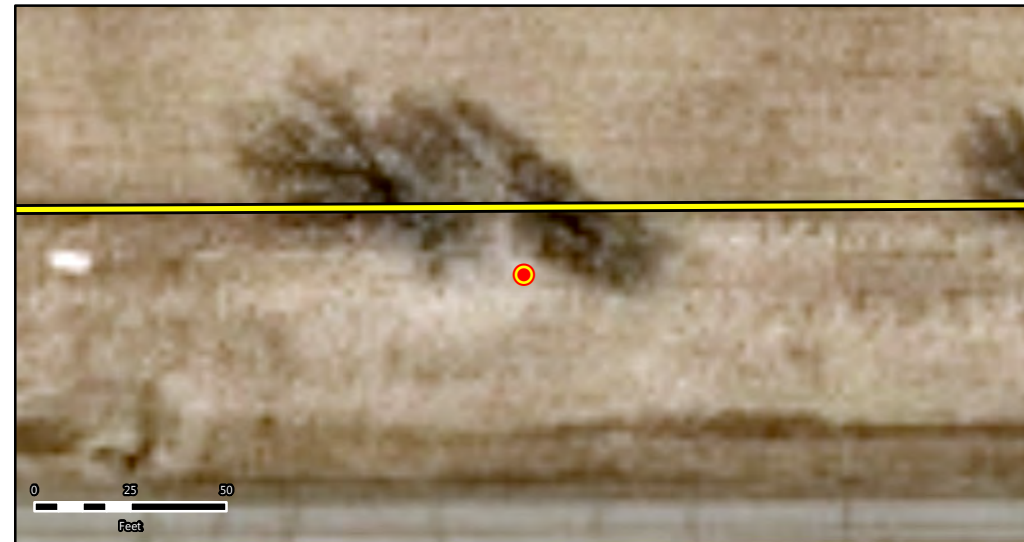
Map 10 of 22
**PROPERTY INSPECTION
PHOTOGRAPHS**
Parcel ID 1602921240002
Lake Elmo, MN

Date: 4/29/2019
Comment: Petroleum pipeline markers
near property boundary, north of 34th

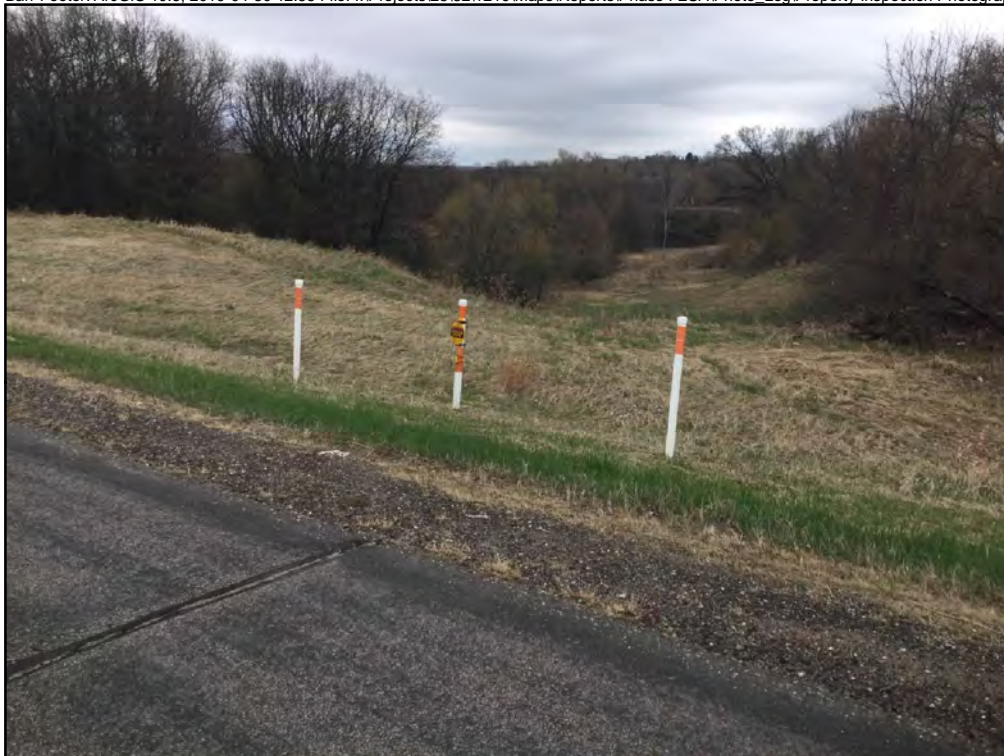
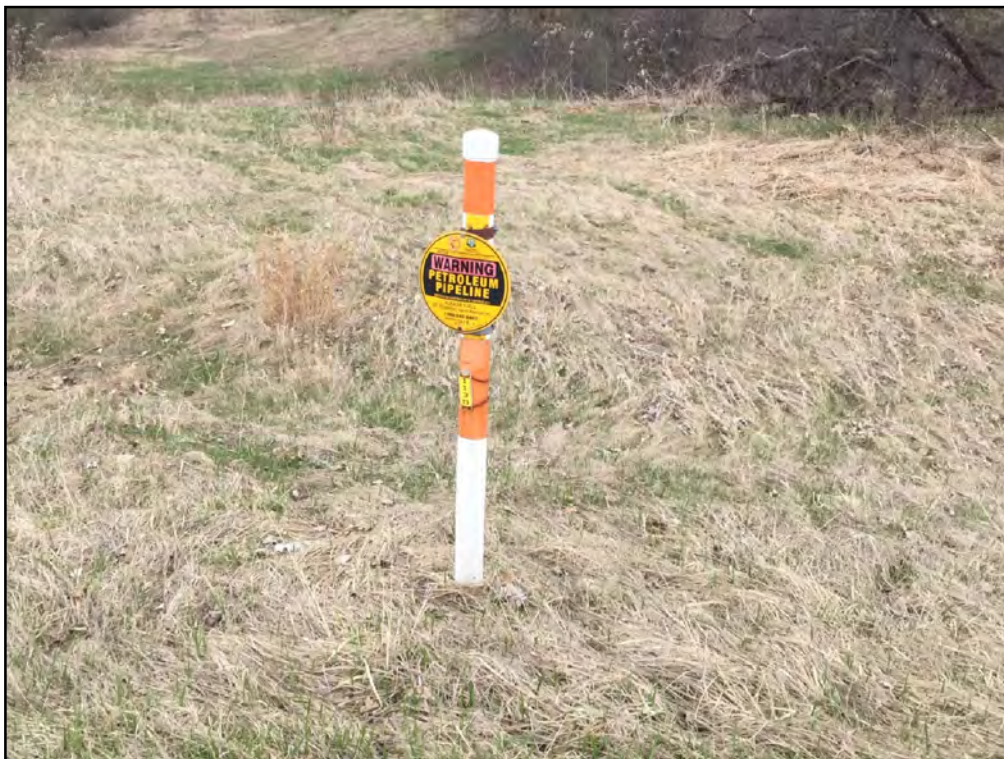
Map 11 of 22
**PROPERTY INSPECTION
PHOTOGRAPHS**
Parcel ID 1602921240002
Lake Elmo, MN

Date: 4/29/2019
Comment: Petroleum pipeline markers
near property boundary, south of 34th

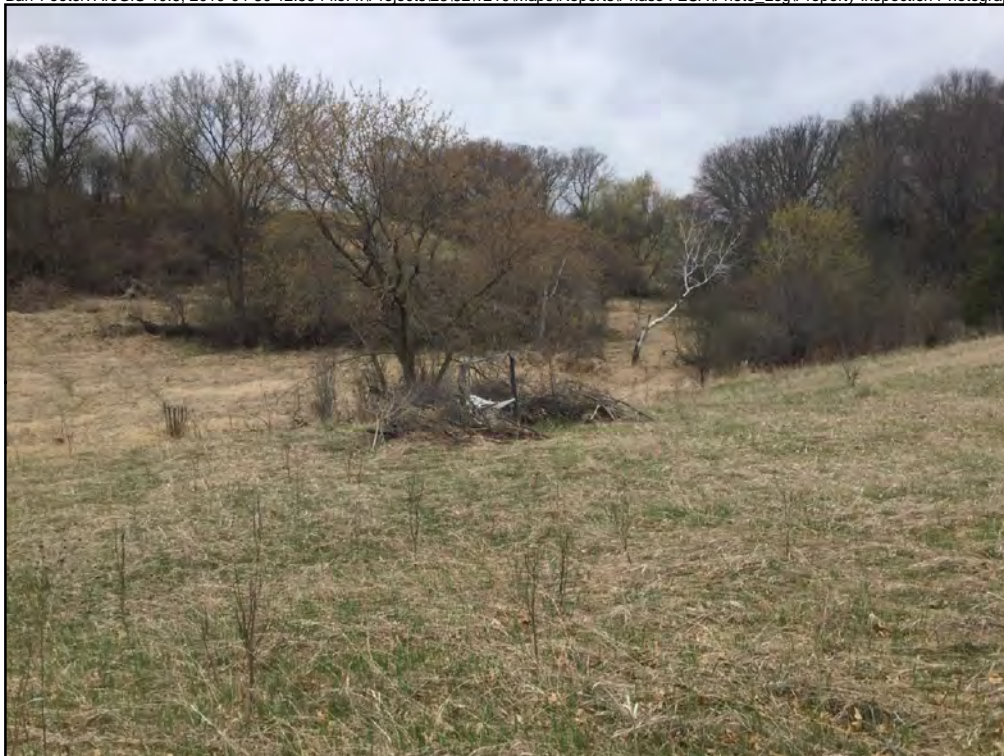
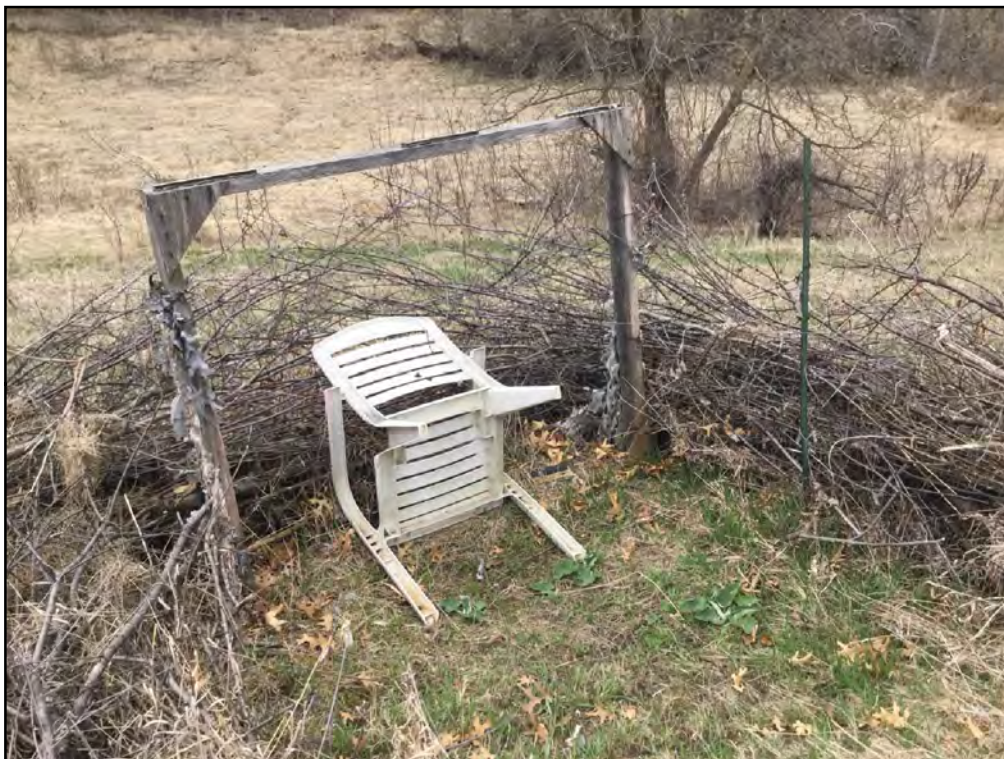
Map 12 of 22
**PROPERTY INSPECTION
PHOTOGRAPHS**
Parcel ID 1602921240002
Lake Elmo, MN

Date: 4/29/2019
Comment: Wood and debris pile on east
property edge

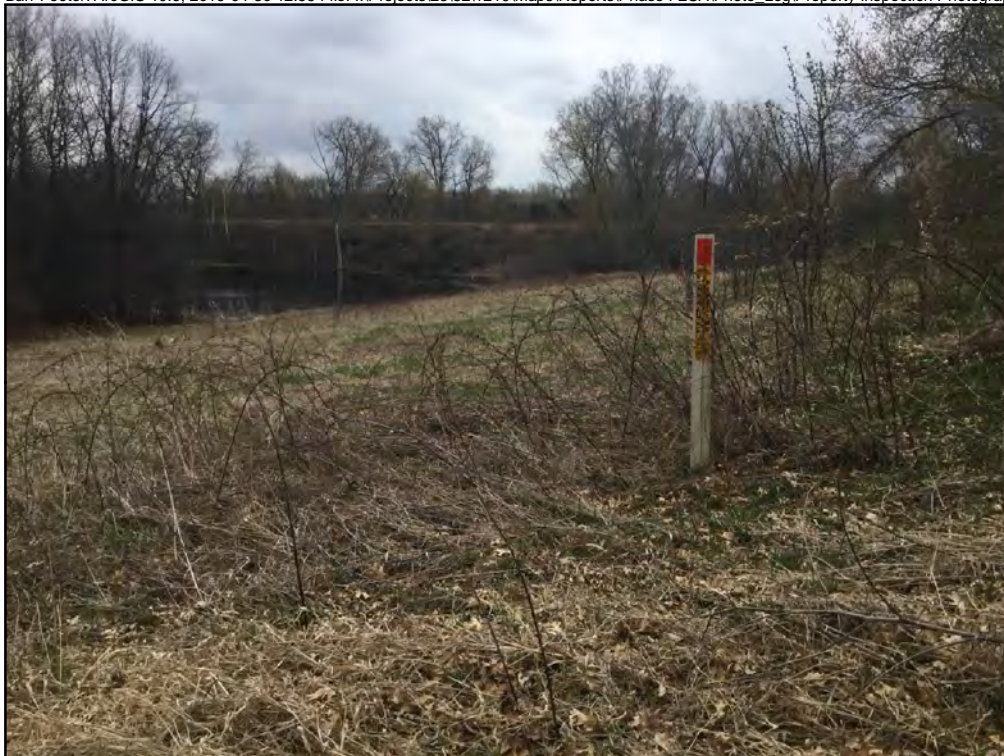
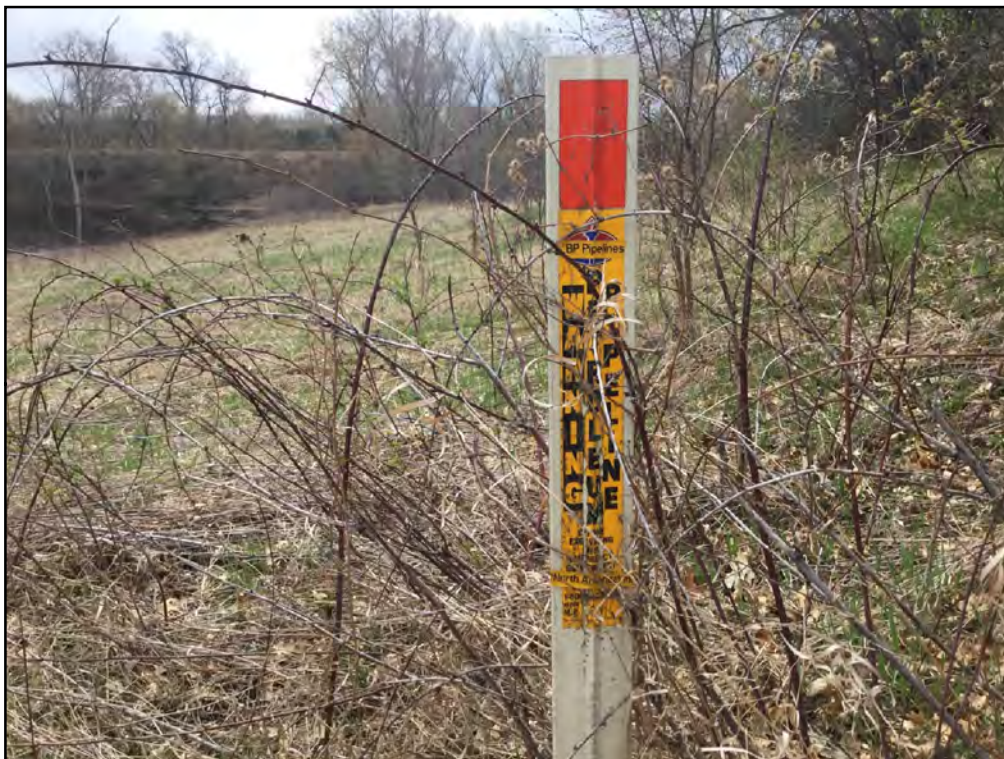
Map 13 of 22
**PROPERTY INSPECTION
PHOTOGRAPHS**
Parcel ID 1602921240002
Lake Elmo, MN

Date: 4/29/2019
Comment: Petroleum pipeline marker

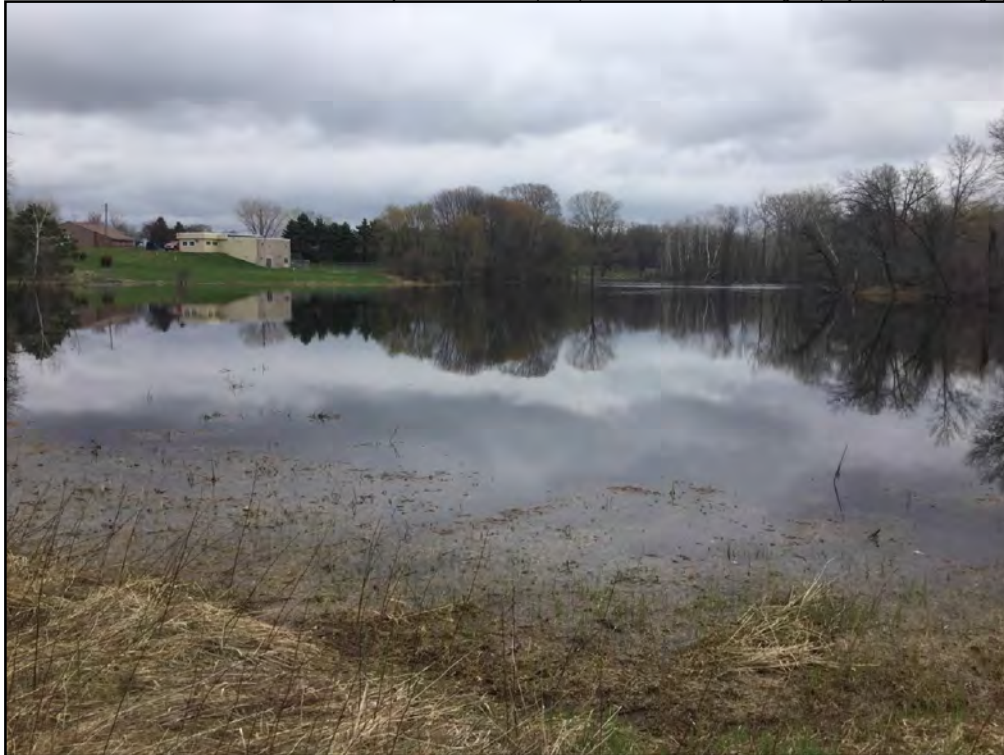
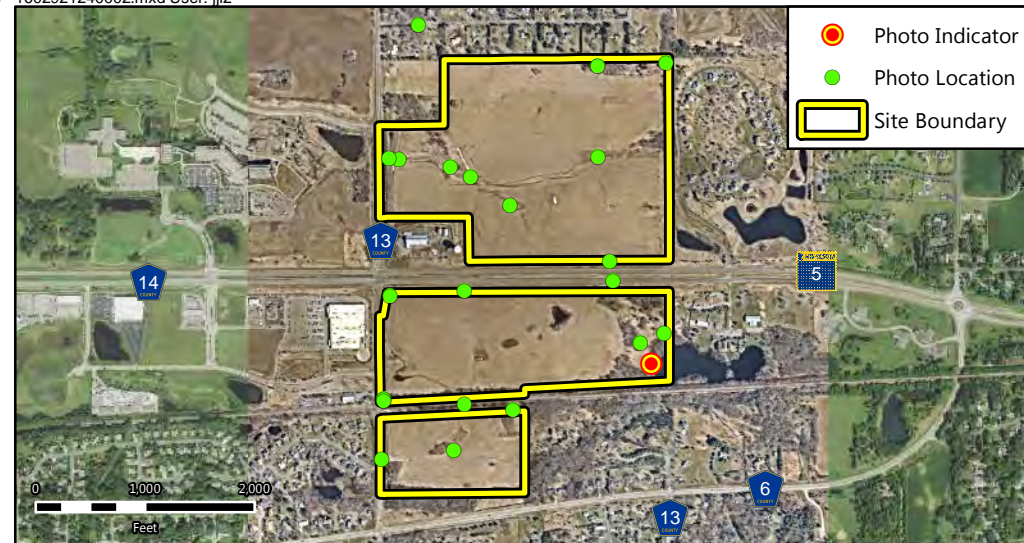
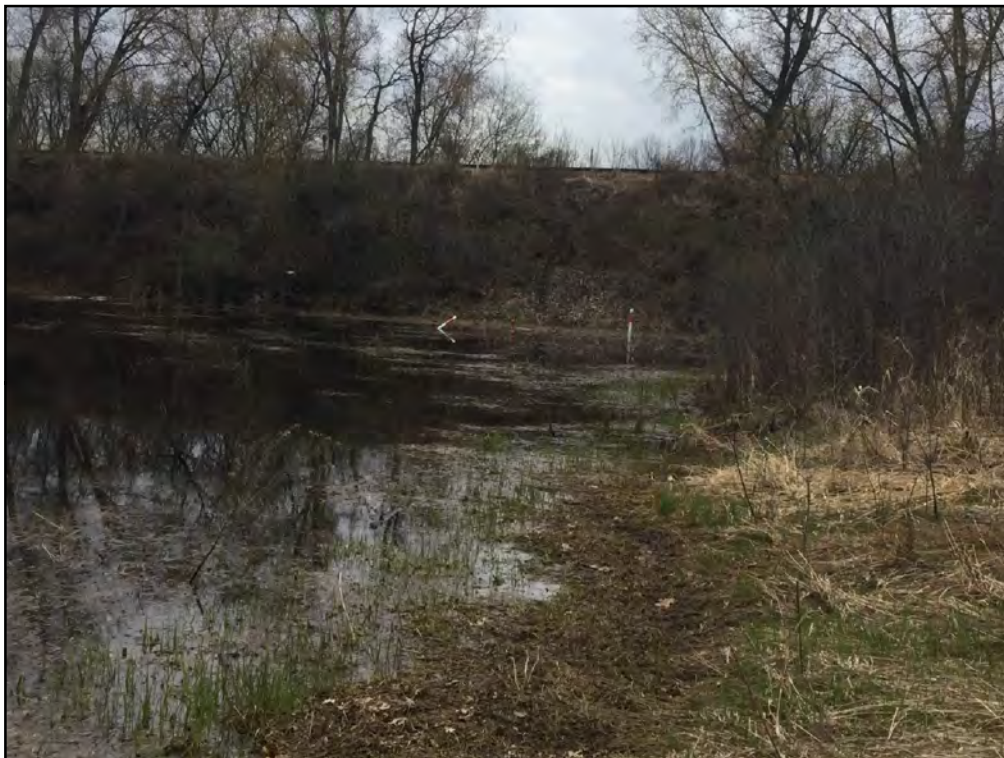
Map 14 of 22
**PROPERTY INSPECTION
PHOTOGRAPHS**
Parcel ID 1602921240002
Lake Elmo, MN

Date: 4/29/2019
Comment: Low spot, ponded water,
petroleum pipeline continues to railroad
to the south

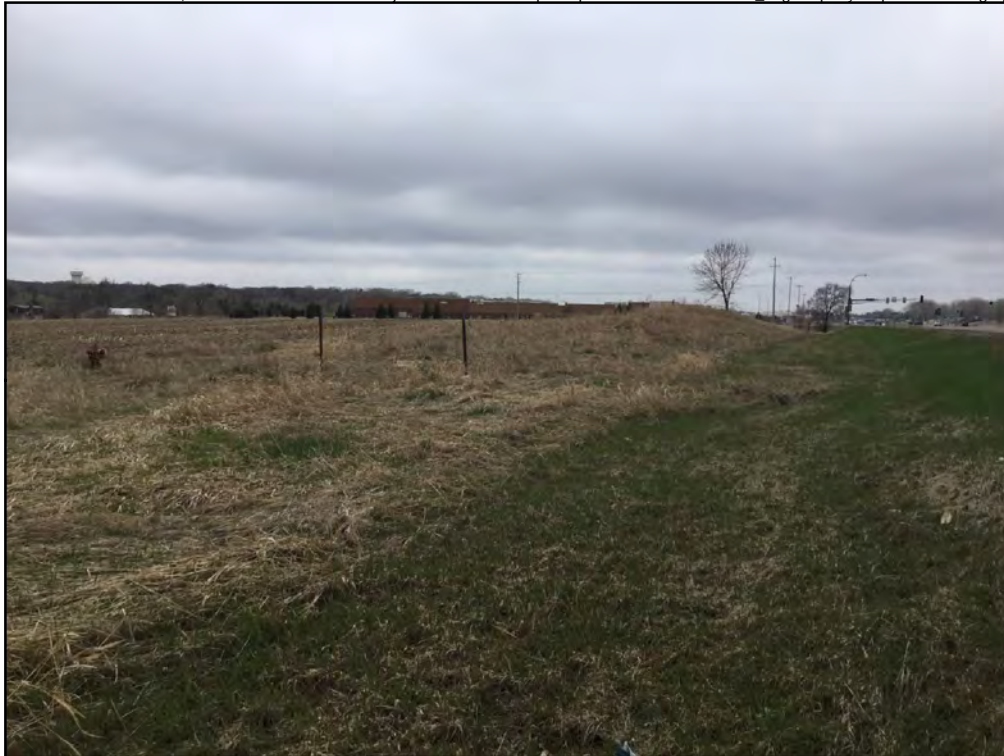
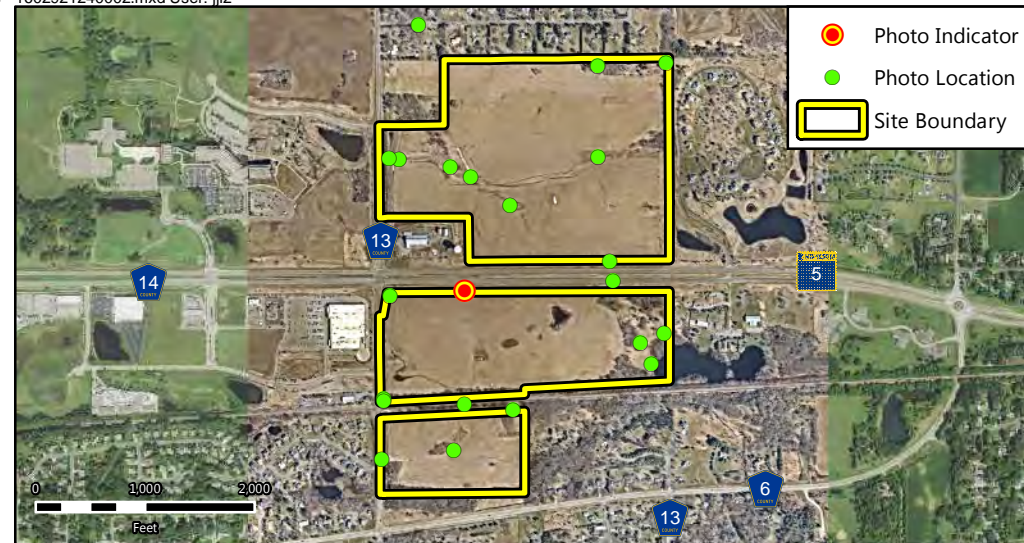
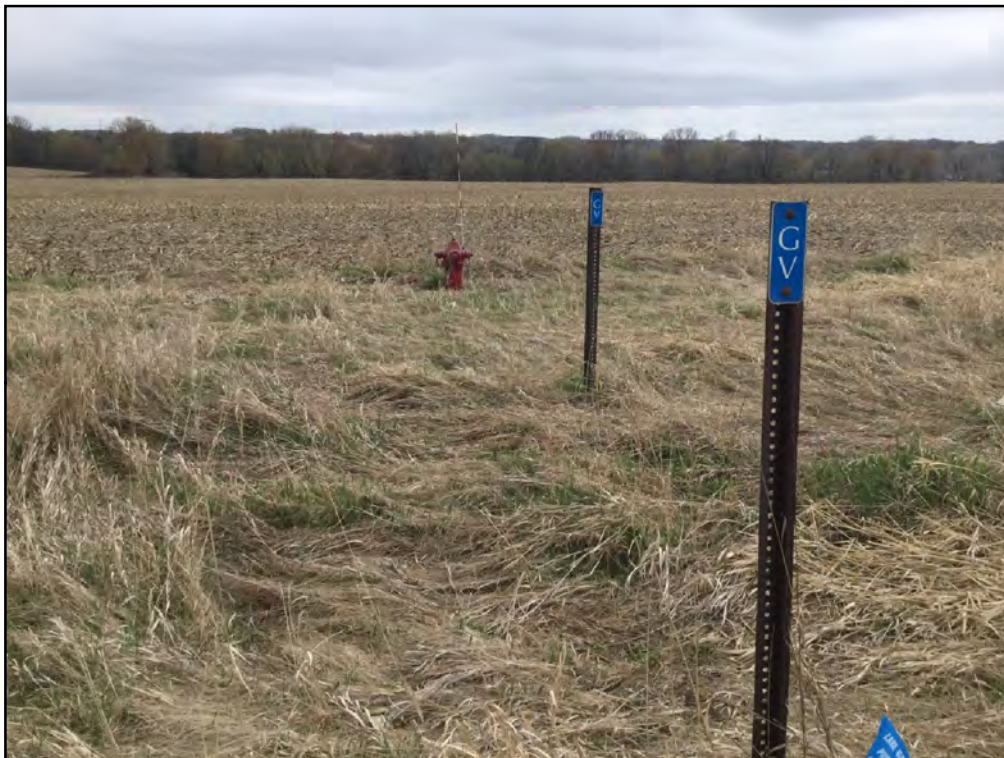
Map 15 of 22
**PROPERTY INSPECTION
PHOTOGRAPHS**
Parcel ID 1602921240002
Lake Elmo, MN

Date: 4/29/2019
Comment: Water utility, hydrant and gate
valve markers near property boundary
along 34th

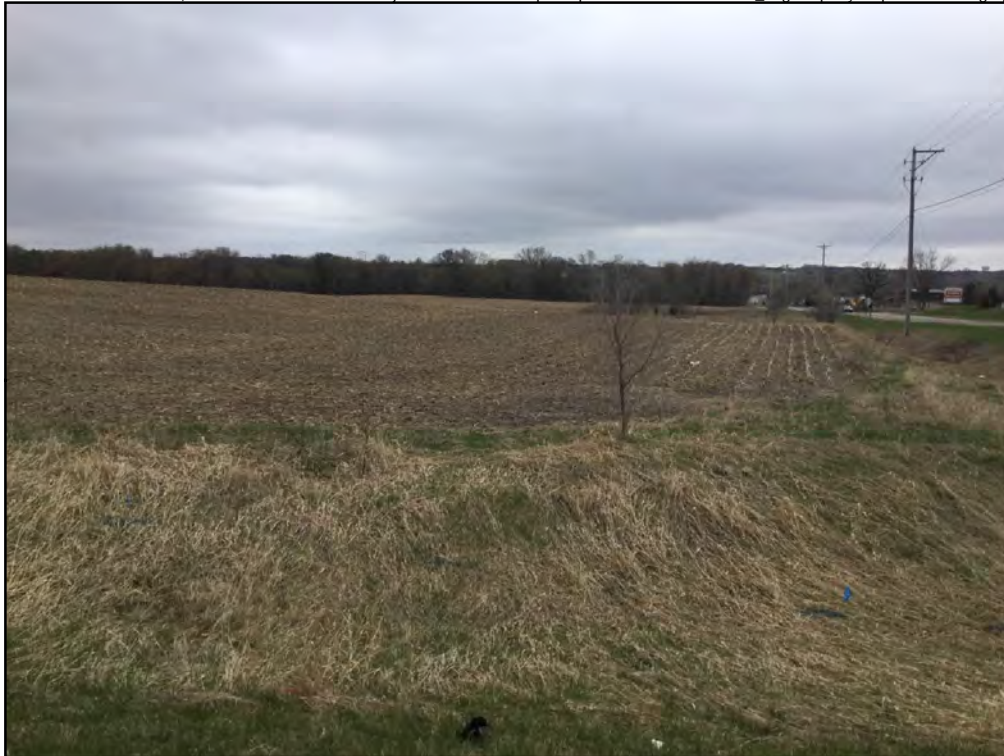
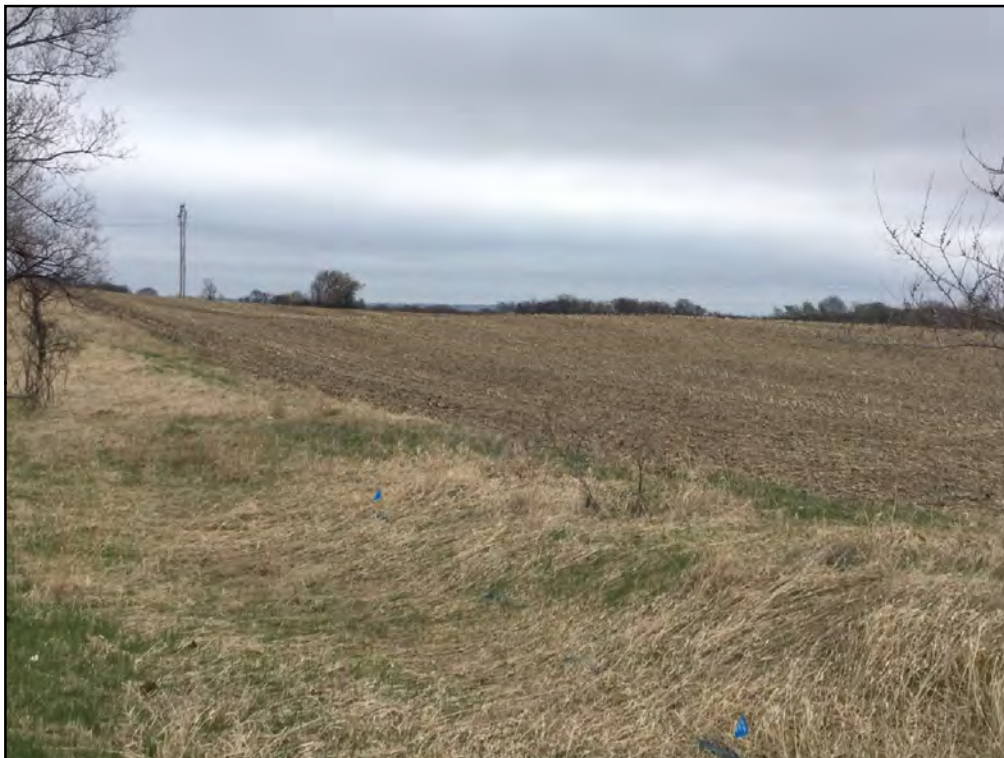
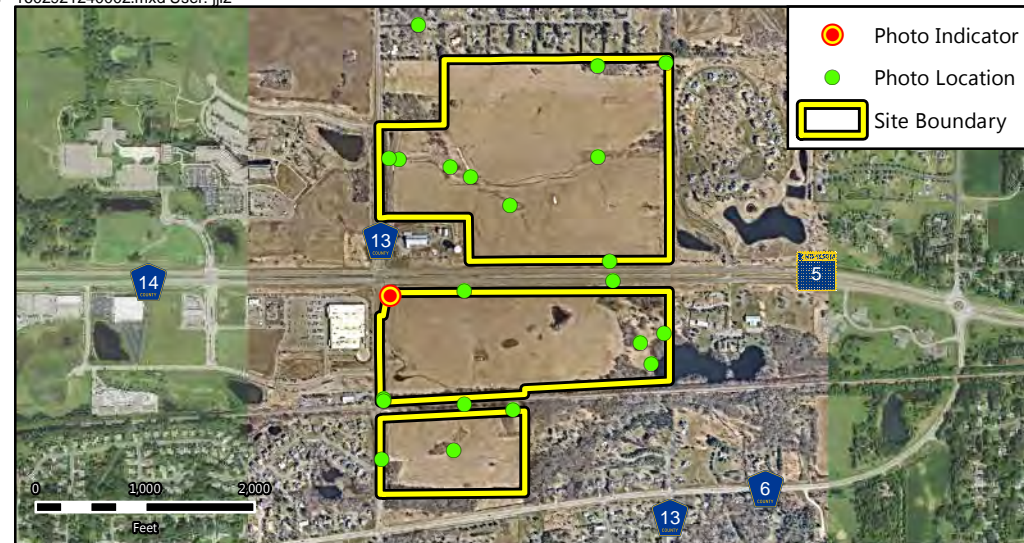
Map 16 of 22
**PROPERTY INSPECTION
PHOTOGRAPHS**
Parcel ID 1602921240002
Lake Elmo, MN

Date: 4/29/2019
Comment: Property at corner of Ideal Ave
and 34th, views south and east, typical
agricultural use on property

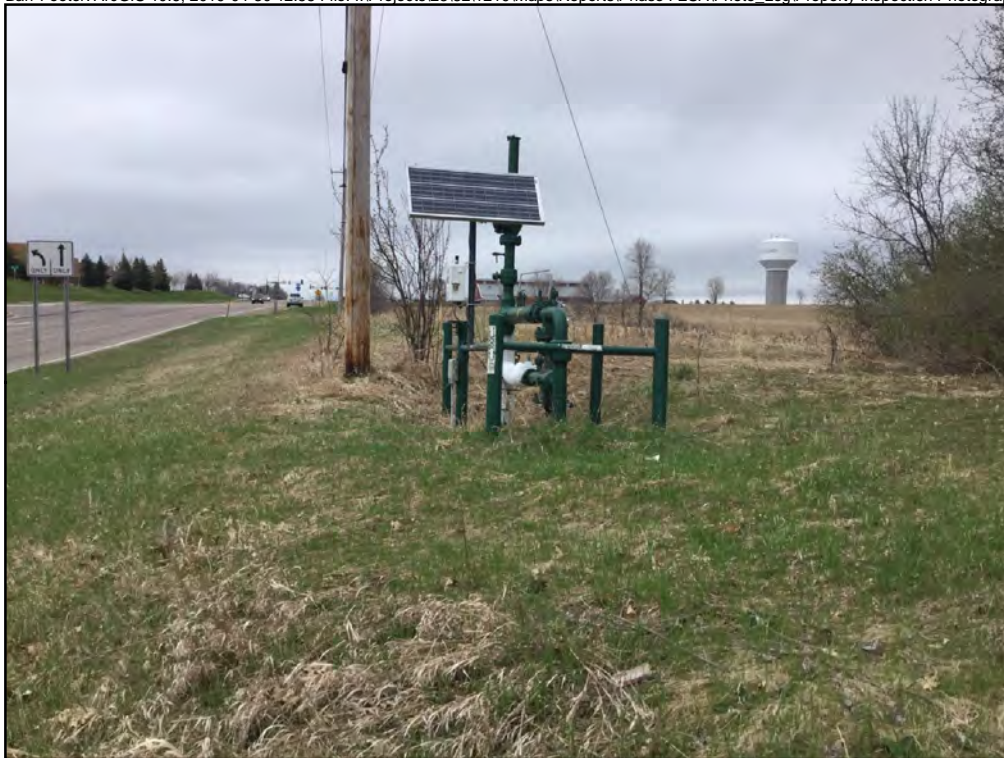
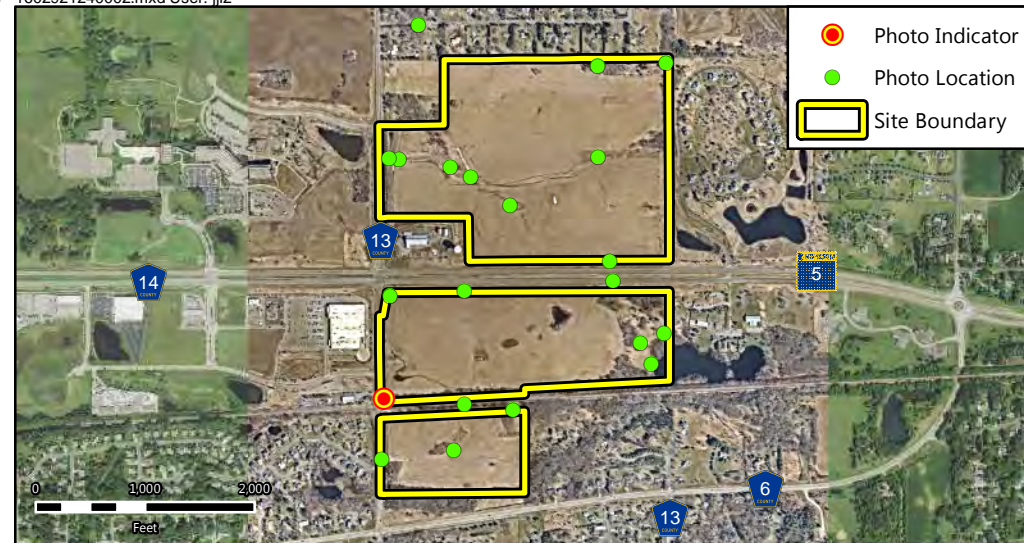
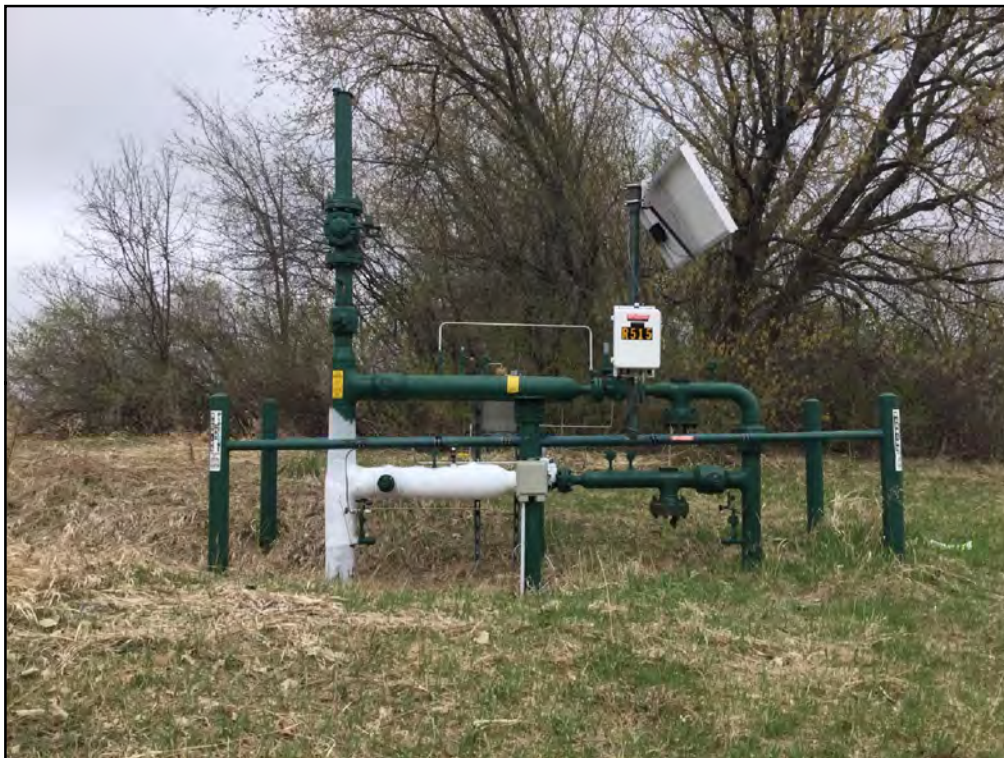
Map 17 of 22
**PROPERTY INSPECTION
PHOTOGRAPHS**
Parcel ID 1602921240002
Lake Elmo, MN

Date: 4/29/2019
Comment: Gas pipeline above ground
equipment

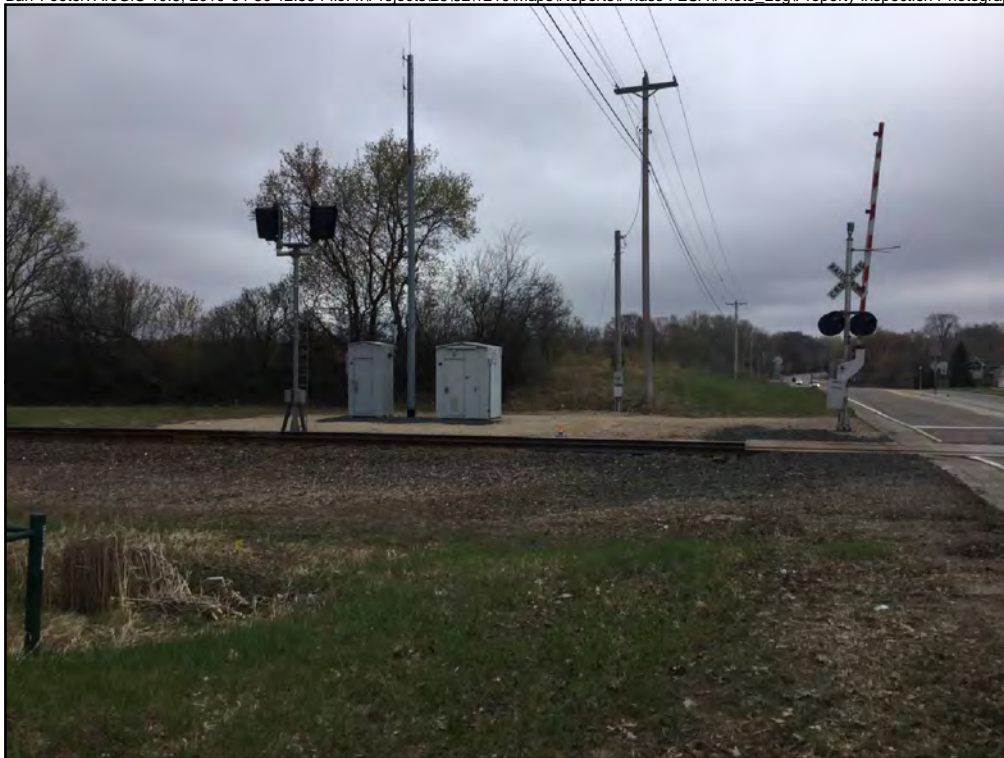
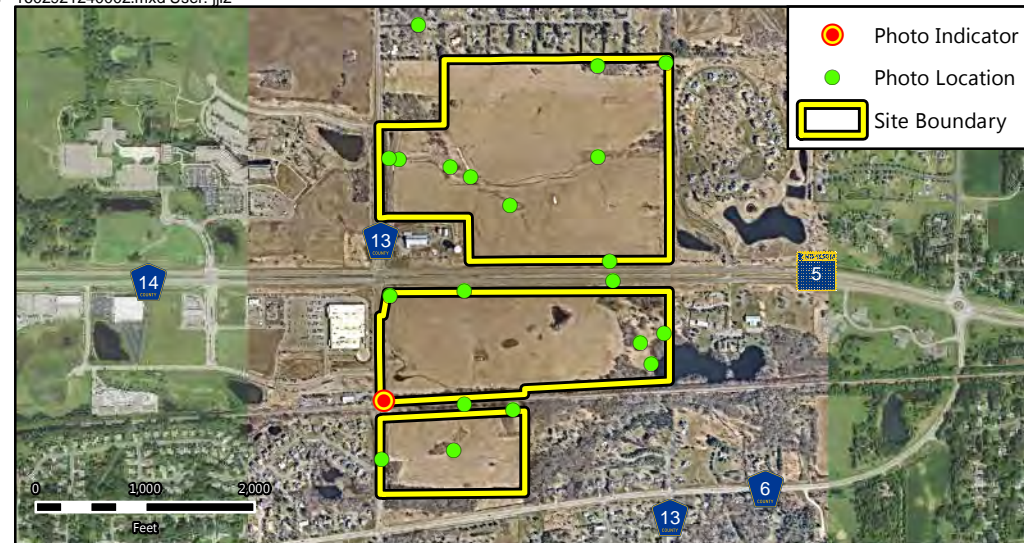
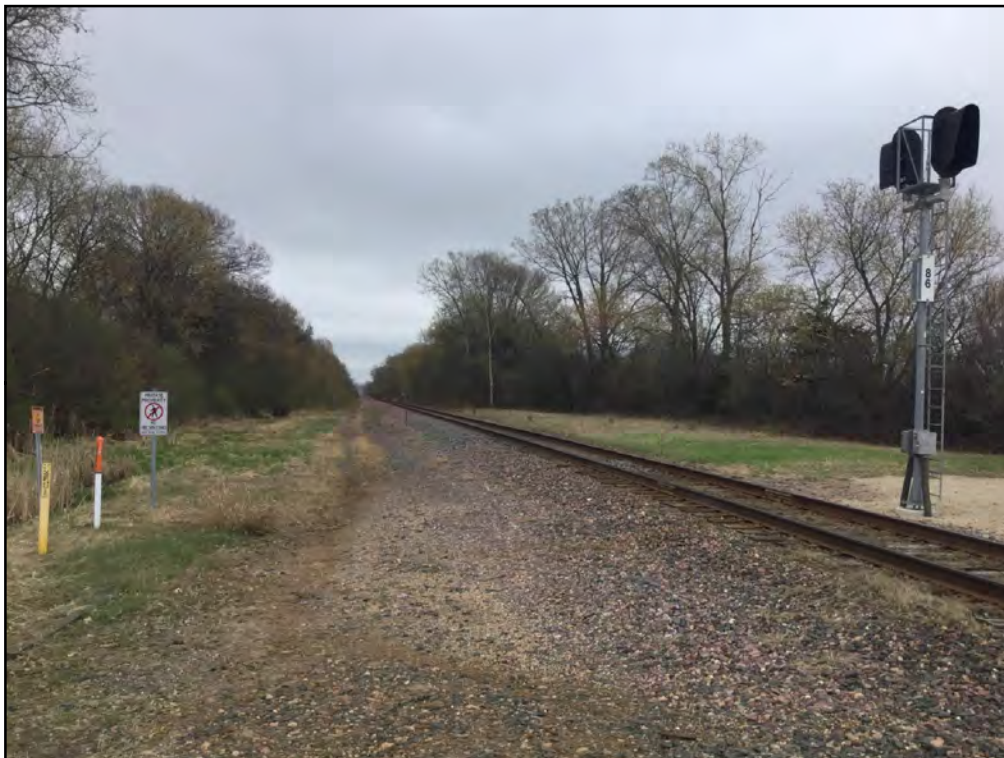
Map 18 of 22
**PROPERTY INSPECTION
PHOTOGRAPHS**
Parcel ID 1602921240002
Lake Elmo, MN

Date: 4/29/2019
Comment: Railroad and above ground
equipment between south and middle
sections of property

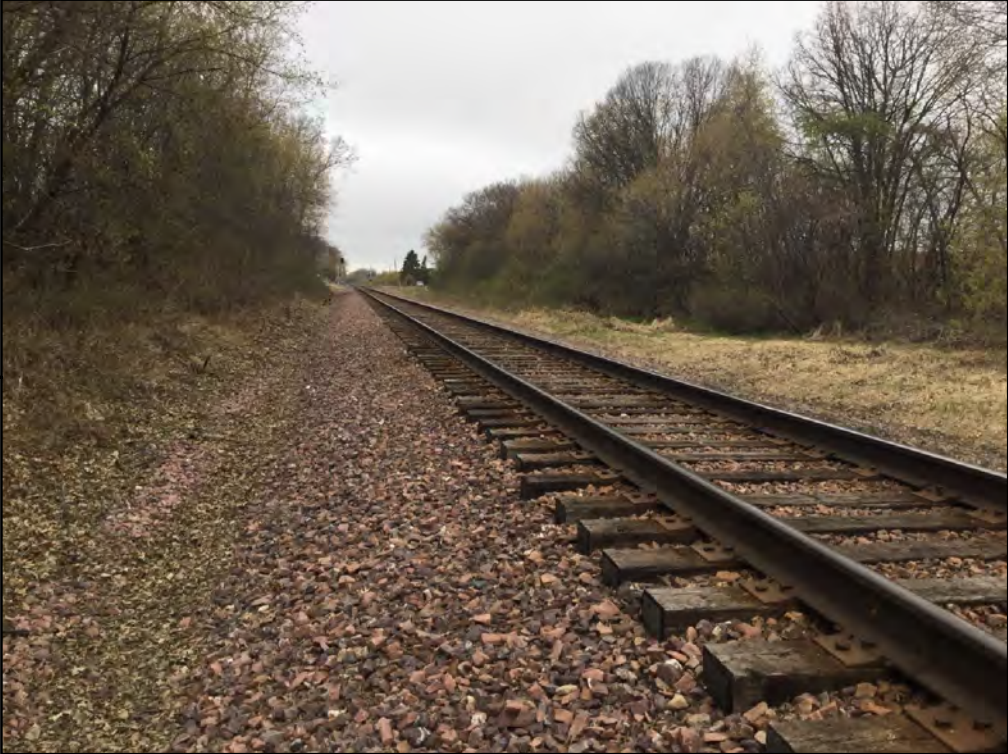
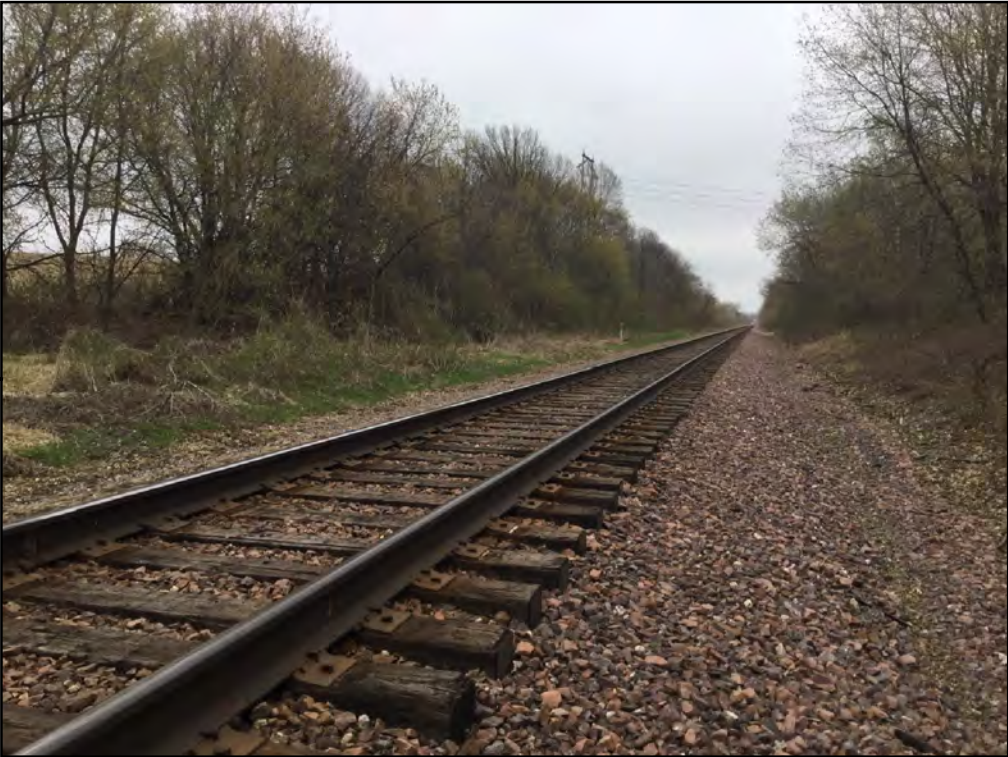
Map 19 of 22
**PROPERTY INSPECTION
PHOTOGRAPHS**
Parcel ID 1602921240002
Lake Elmo, MN

Date: 4/29/2019
Comment: Railroad tracks through
property, tracks run east-west

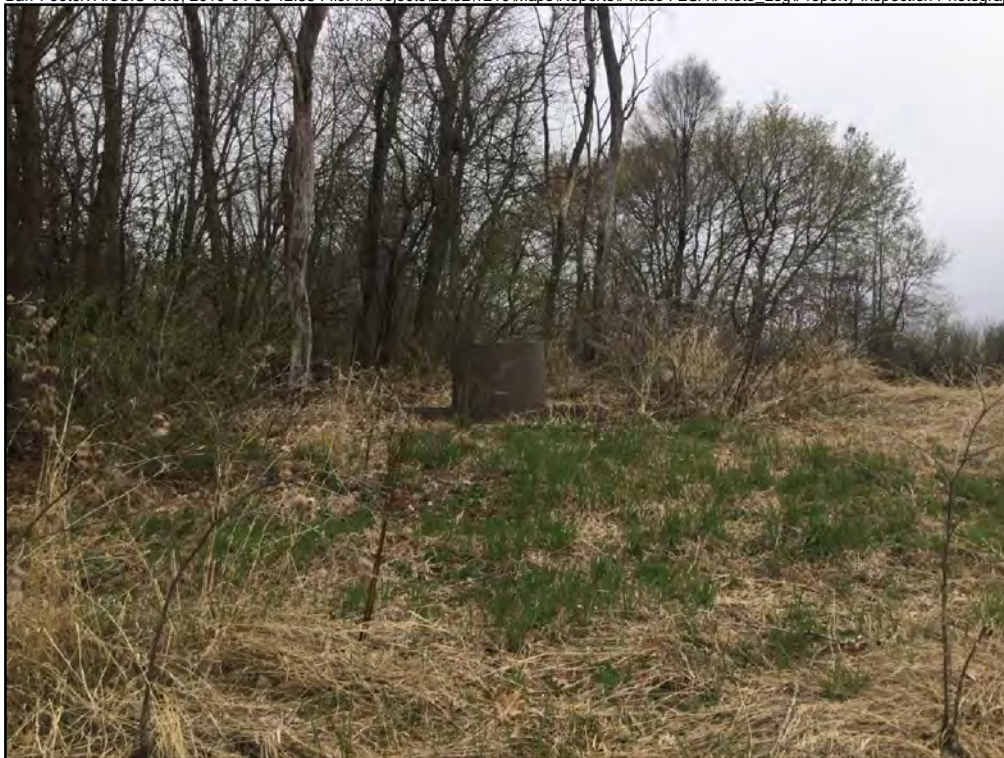
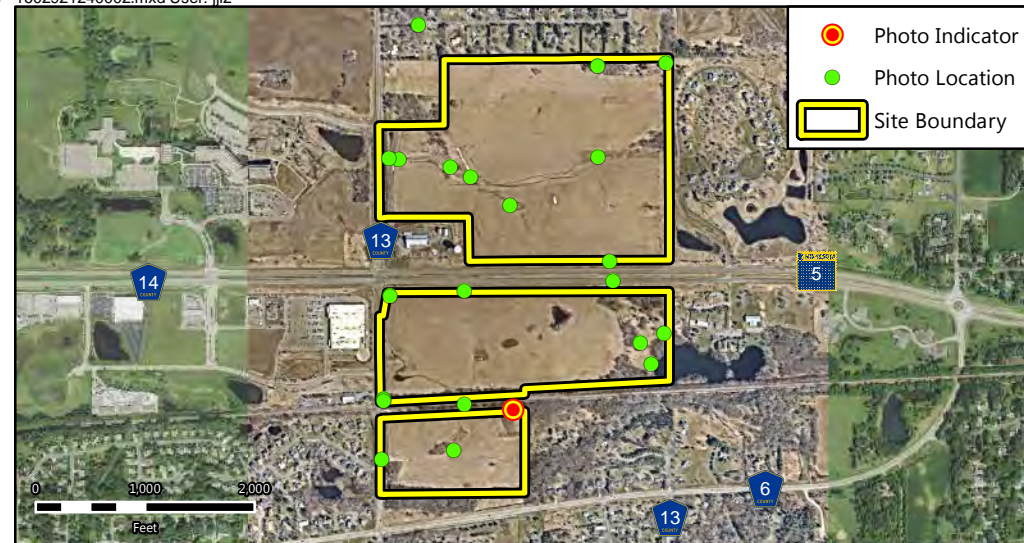
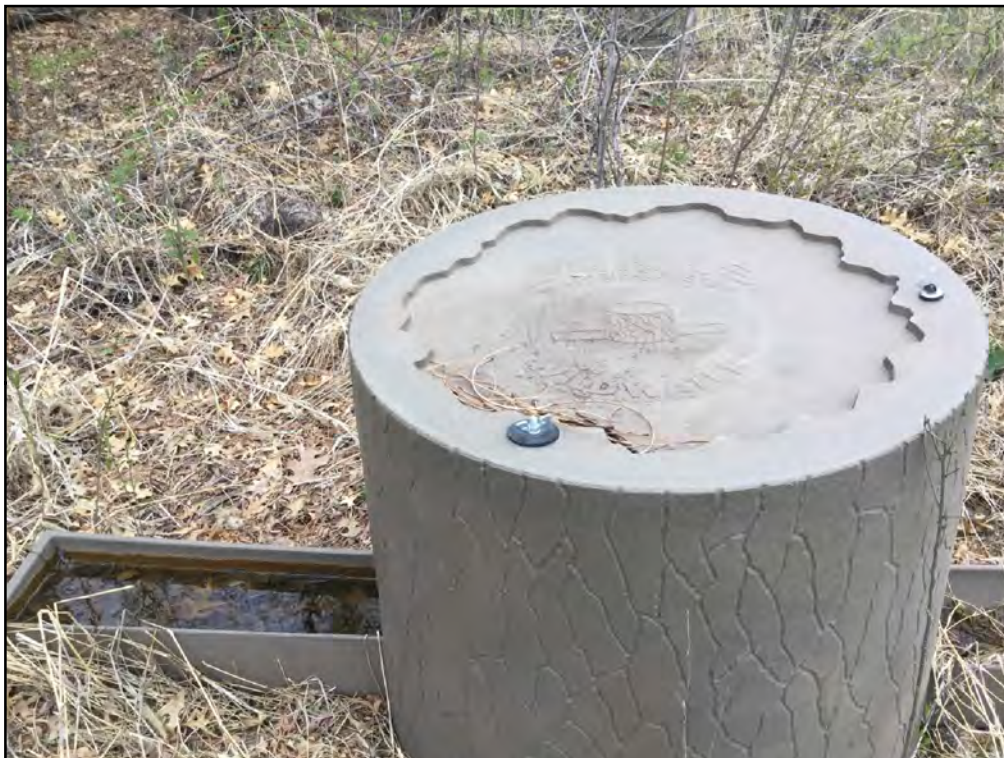
Map 20 of 22
**PROPERTY INSPECTION
PHOTOGRAPHS**
Parcel ID 1602921240002
Lake Elmo, MN

Date: 4/29/2019
Comment: Watering tank

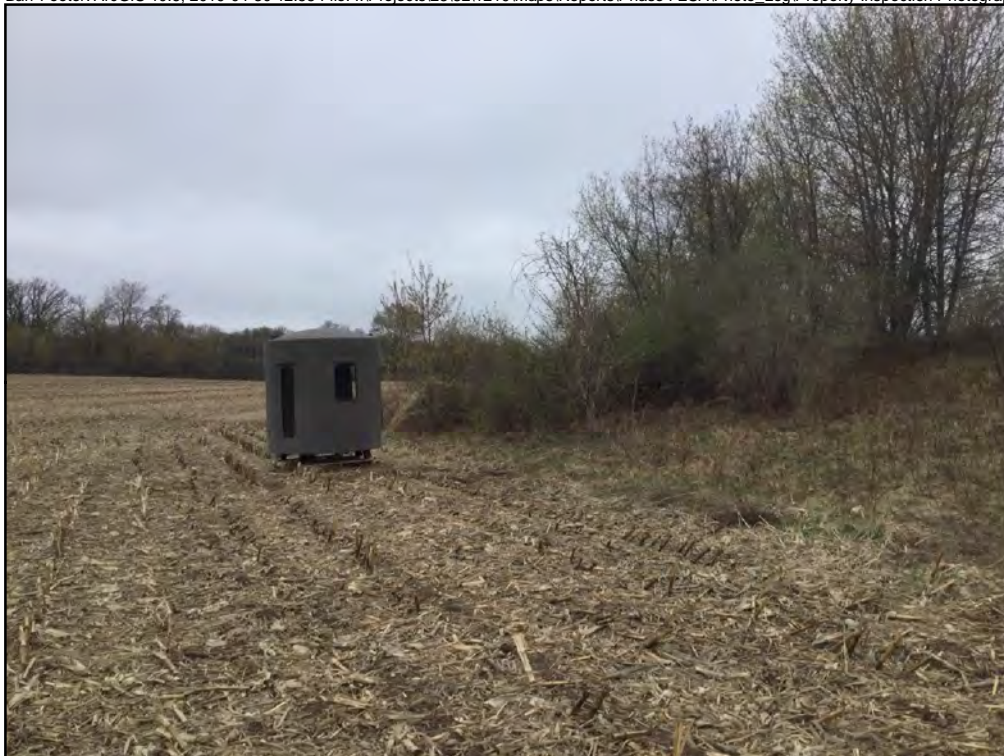
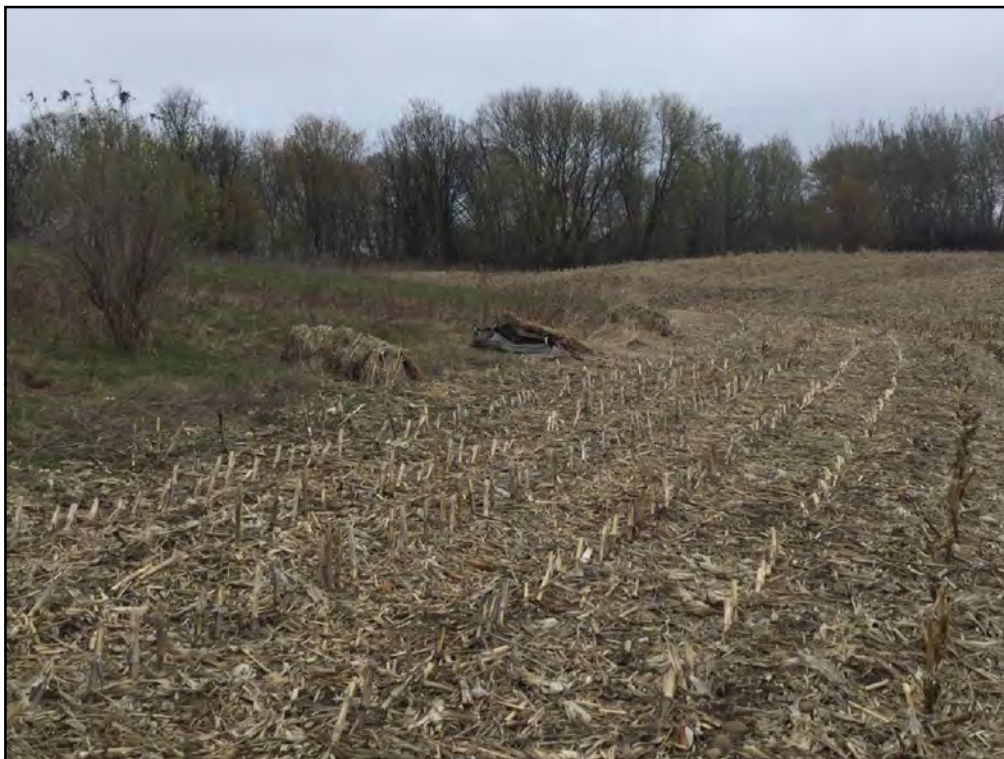
Map 21 of 22
**PROPERTY INSPECTION
PHOTOGRAPHS**
Parcel ID 1602921240002
Lake Elmo, MN

Date: 4/29/2019
Comment: Hunting blind and feeders in
field
