AGENDA ITEM: 180 acres of City Property on Ideal Ave

Phase I Environmental Site Assessment

PIN #1602921240002

Lake Elmo, Minnesota

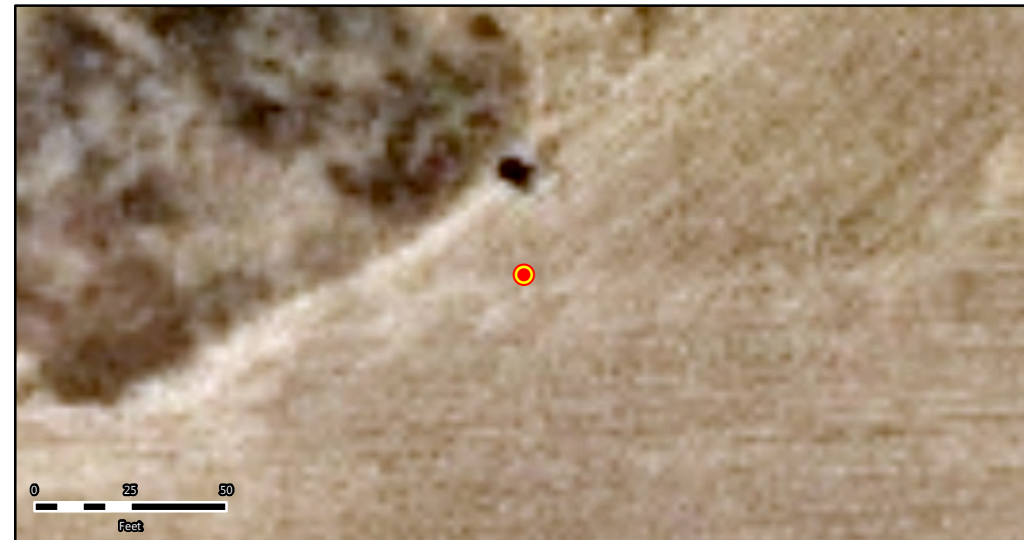
Map 21 of 22
**PROPERTY INSPECTION
PHOTOGRAPHS**
Parcel ID 1602921240002
Lake Elmo, MN

Date: 4/29/2019
Comment: Watering tank
