STAFF REPORT

TO: Planning Commission
FROM: Ben Hetzel, Lake Elmo City Planner
AGENDA ITEM: **8265 Hidden Bay Trail N Variance**
REVIEWED BY: Ben Hetzel, City Planner

The proposal is to construct a mound septic system to replace the existing failing septic system that was installed in 1963. To do this, the applicant is proposing to install a 10 foot by 45 foot rock bed mound system, corresponding absorption area, and three tanks. The three tanks would be located outside of the required 75 foot wetland setback. A wetland delineation was completed on September 10, 2022 to identify the appropriate wetland boundary. These components would be installed within 75 feet of the wetland:

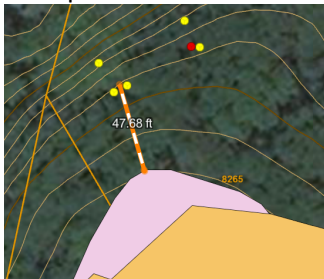
I am contacting you as you are listed as the application contact. I conducted a site and soil review for the system at the address above, report attached. On the site map the designer states that B1 and B5 are 75 feet from Wetland/Start of cattails. I believe that the wetland begins before the start of cattails. There is a change in vegetation from broad leaf plants to grasses approximately 54' from borings B5 and B1. This corresponded to the location of the start of the Freshwater Emergent Wetland as identified by the [Nation Wetland Inventory](#). The map below shows the designers boring locations, yellow dots, and the wetland boundary, solid pink.

To address this discrepancy I would propose that the wetland boundary is identified and located on the ground by a trained professional. This would allow for an accurate place to measure the setback from. If the

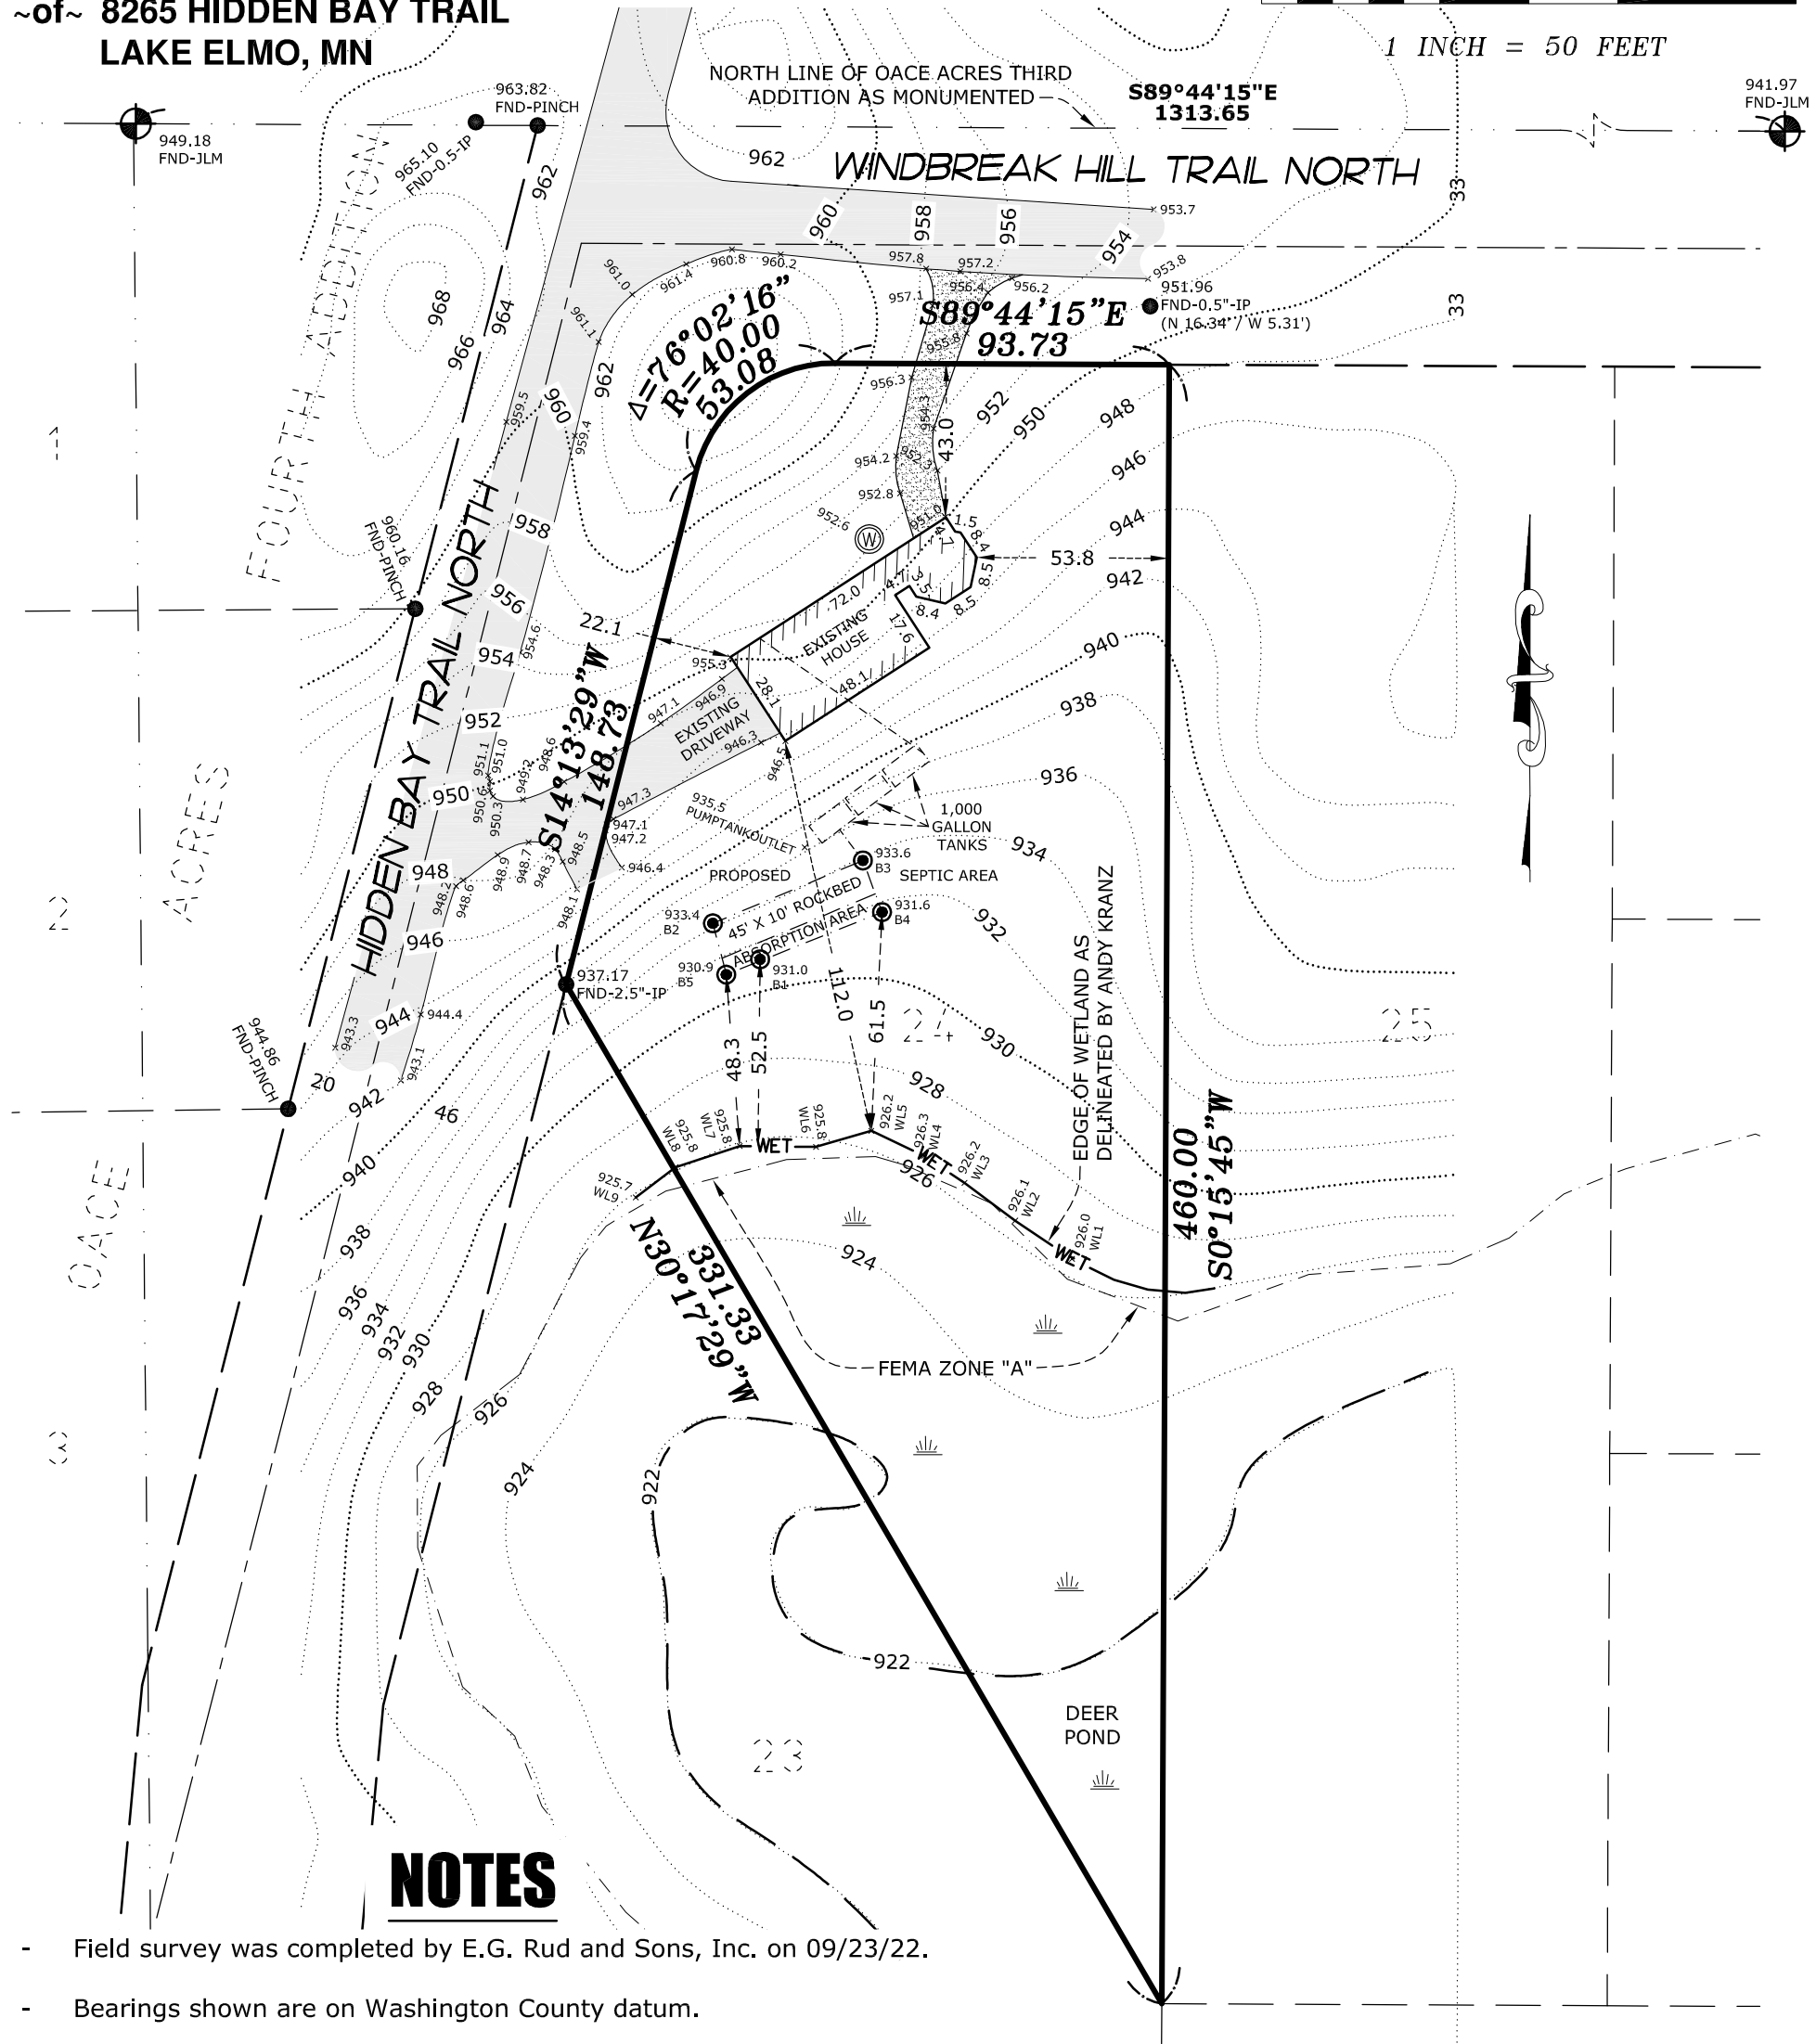
CERTIFICATE OF SURVEY

A property land survey was completed on 9/28/22 by EG Rud surveyor. Survey locates the home, wetland markers, septic mound markers, and the property boundary.

~for~ DAVID KRANZ
~of~ 8265 HIDDEN BAY TRAIL
LAKE ELMO, MN

5. This variance approval is for a reduced wetland setback in the proposed component locations as per the revised site survey dated October 18, 2022. Any deviation in system component locations would require approval from the City of Lake Elmo.

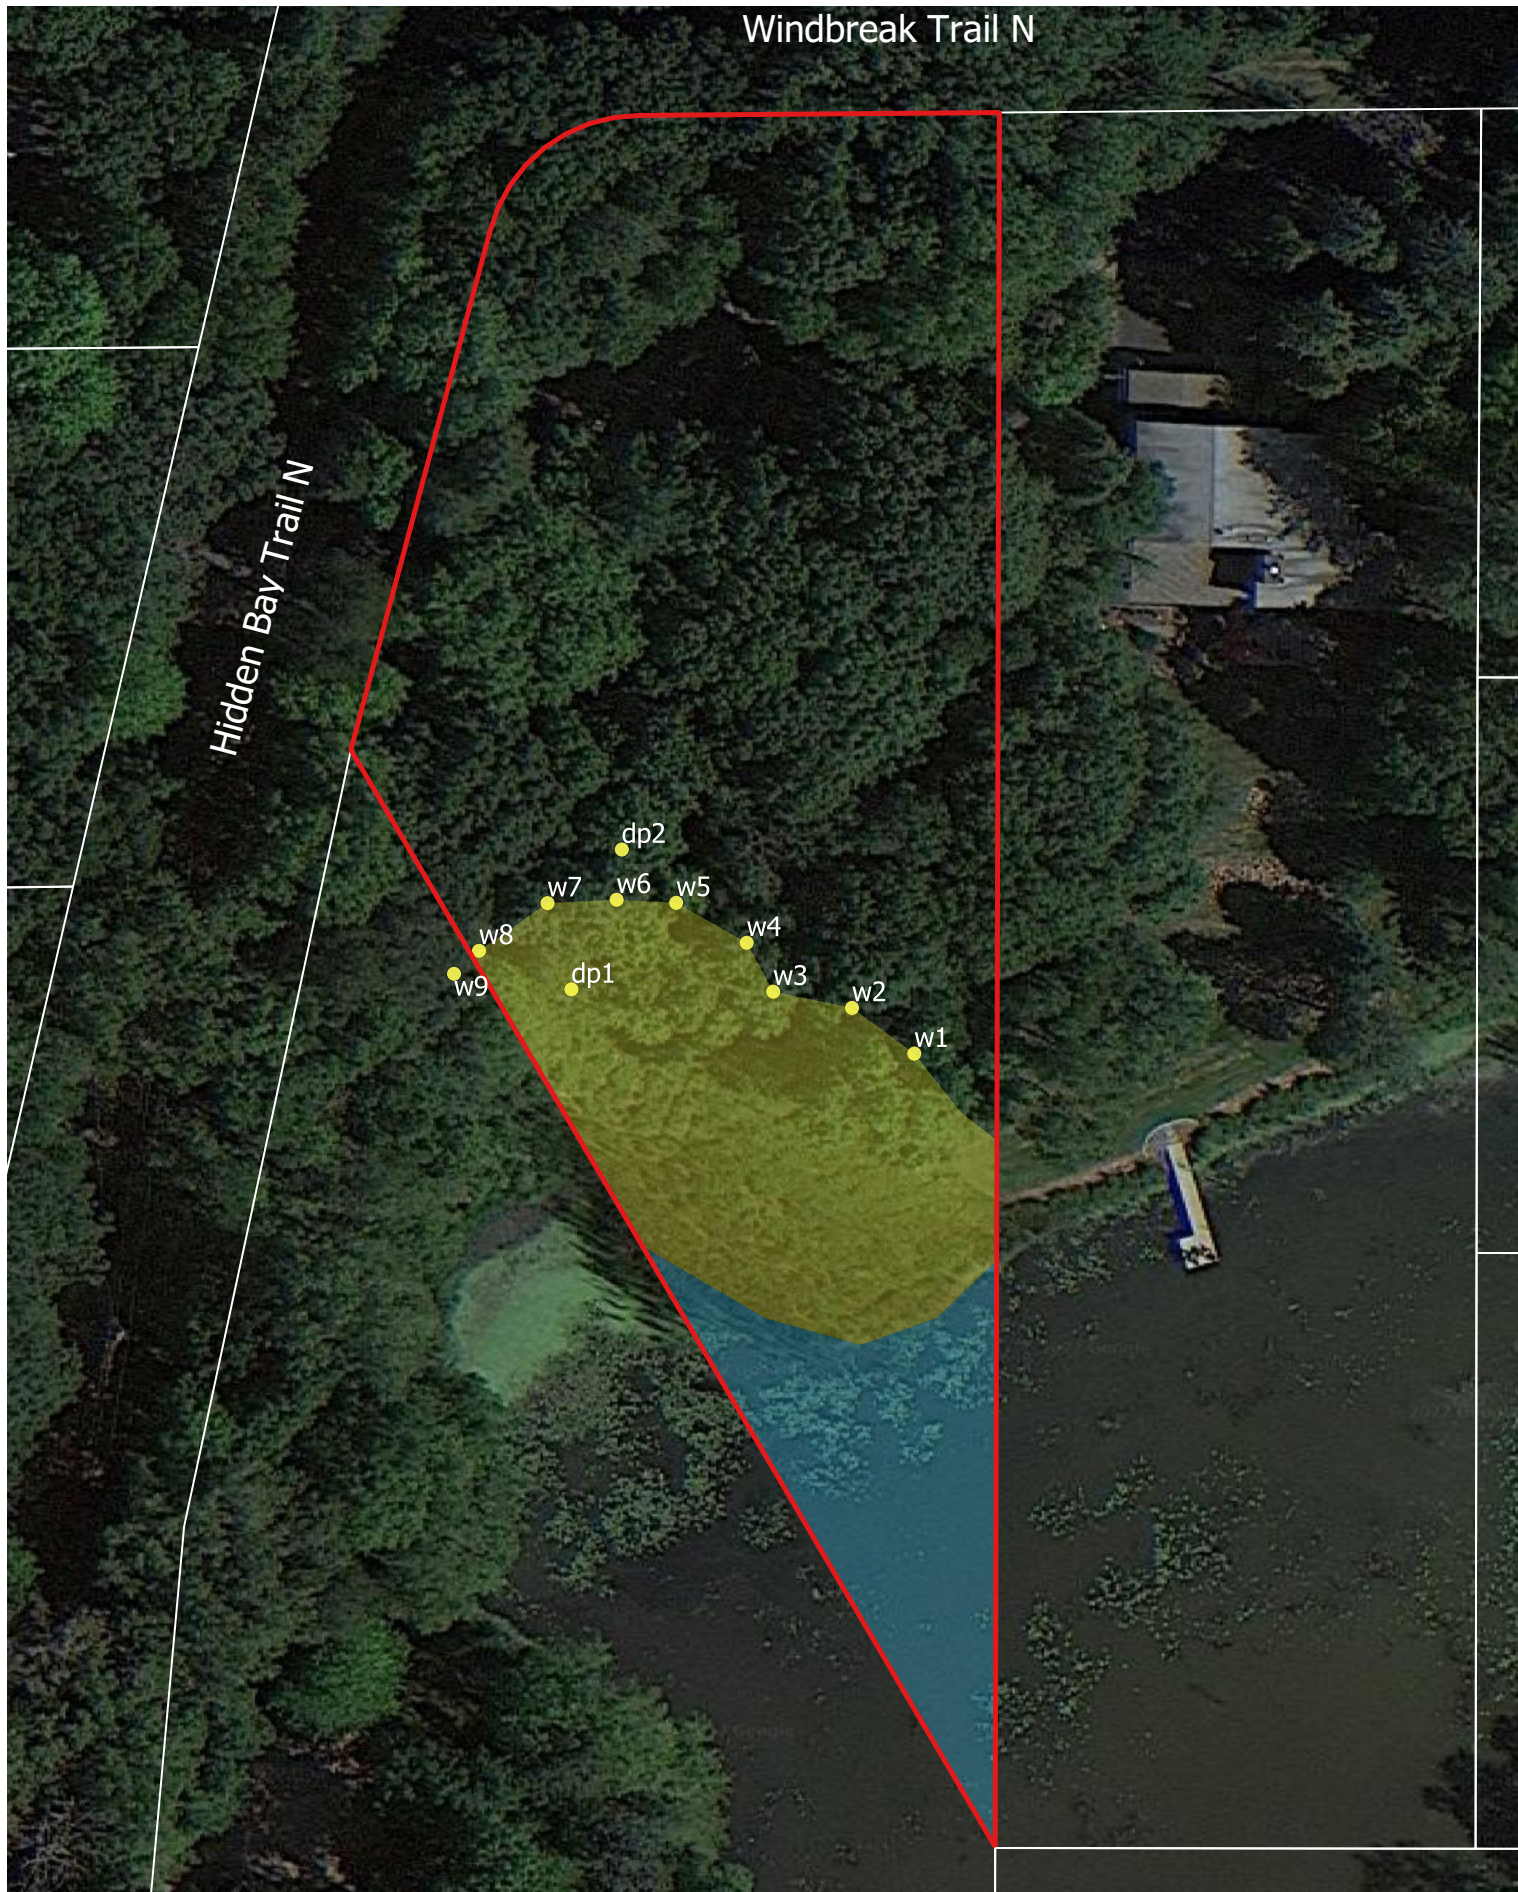
Wetland Delineation Map 8265 Hidden Bay Trail N Washington County, MN

- Property Boundary
- Wetland_Delineation
 - Deep Marsh and Shallow Open Water
 - Fresh (Wet) Meadow
- Wetland Data Points

Upland-wetland boundary spatial data were collected and vertices (w1-w9) were flagged on the ground. USACE determination data (dp1, dp2) were collected at representative upland and wetland positions (enclosed map). Spatial data was captured with a GNSS receiver capable of submeter accuracy. Representative photographs of the Property are enclosed.

Hybrid cat-tail (*Typha × glauca*) becomes dominant to the south of the wet meadow, and the wetland transitions to deep marsh and shallow open water communities. A boundary between the wet meadow and adjacent communities was delineated using desktop resources including multi-year aerial photograph interpretation. See the enclosed Wetland Delineation Map and Determination Data Sheets.

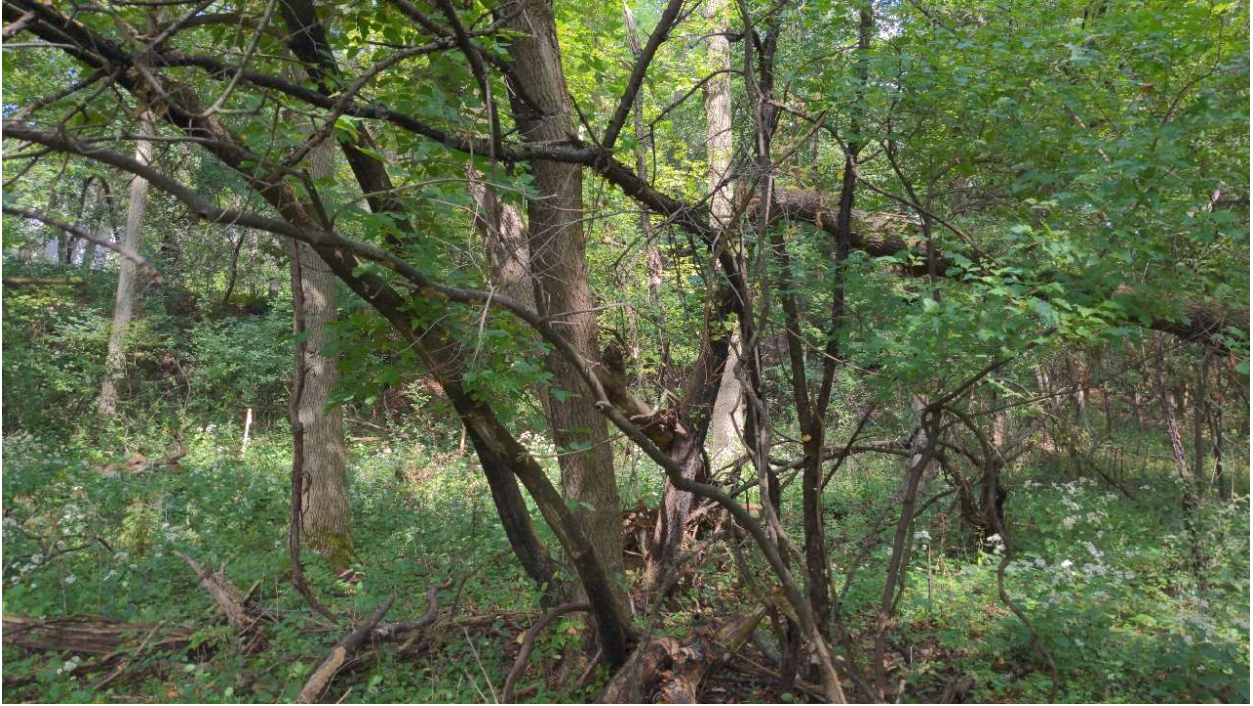
View north from the upland-wetland boundary.

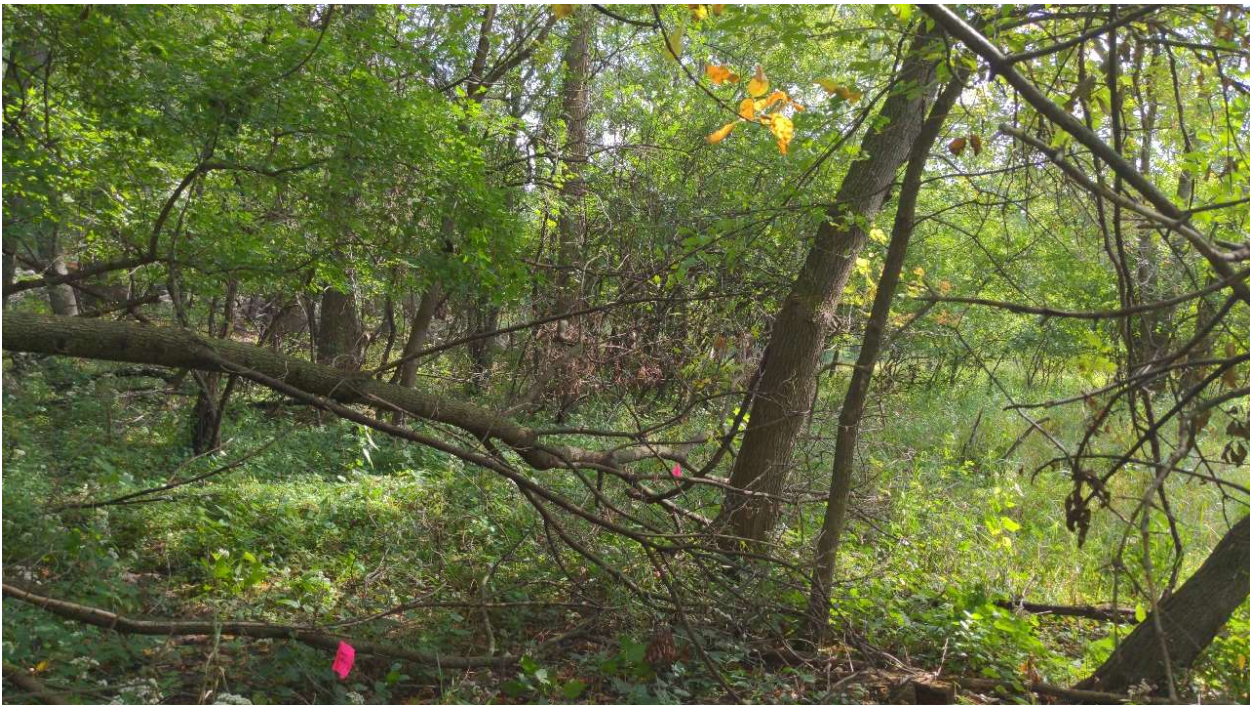
View east from the upland-wetland boundary.

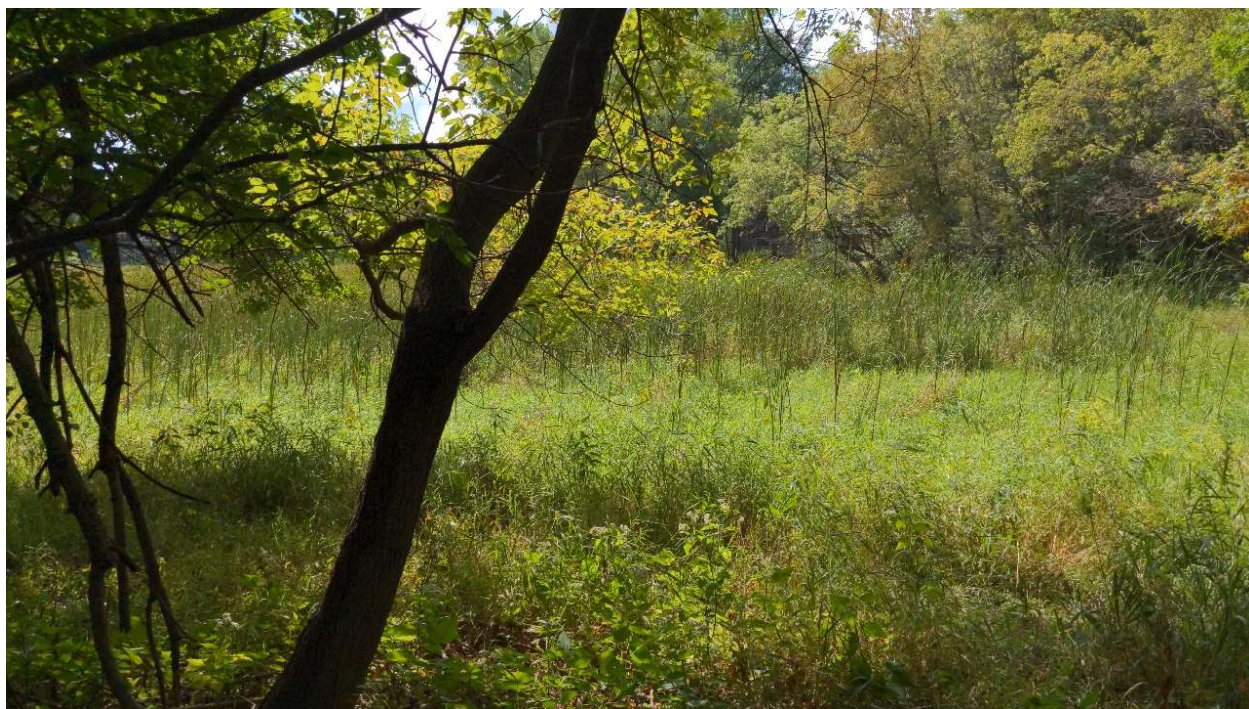
View south from the upland-wetland boundary.
